**Asbestos Inspection
for
921-923 East Main Street
Stamford, Connecticut**

**Third Floor Apartment
and
Exterior Roof**

prepared
for
City of Stamford
Government Center
888 Washington Boulevard
Stamford, Connecticut

June 13, 2012

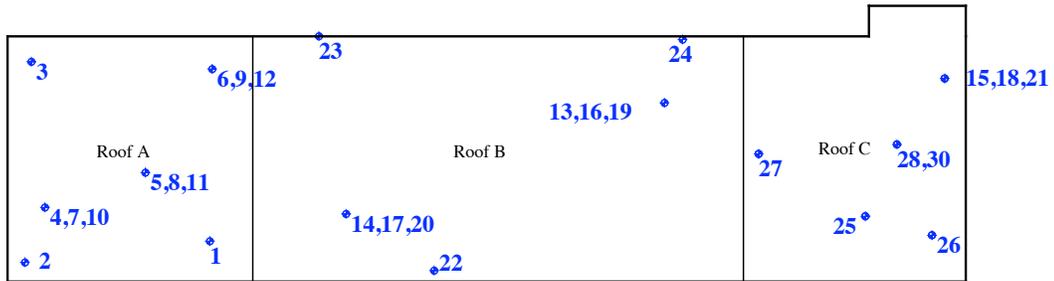
**Exterior Roof
133 Mytle Avenue**

There is approximately 96 square feet of gray flashing cement applied on the parapet walls. The gray flashing cement was found to contain 10 percent asbestos.

There is approximately 192 square feet of gray flashing felt applied on the parapet walls. The gray flashing felt was found to contain 10 percent asbestos.

There is approximately 10 square feet of gray felt flashing applied around the hatch door. The gray felt flashing was found to contain 10 percent asbestos.

There is approximately 32 square feet of gray felt flashing applied on the parapet walls. The gray felt flashing was found to contain 10 percent asbestos.

There is approximately 1 square feet of felt flashing applied on the roof pitch box. The felt flashing was found to contain 8 percent asbestos.

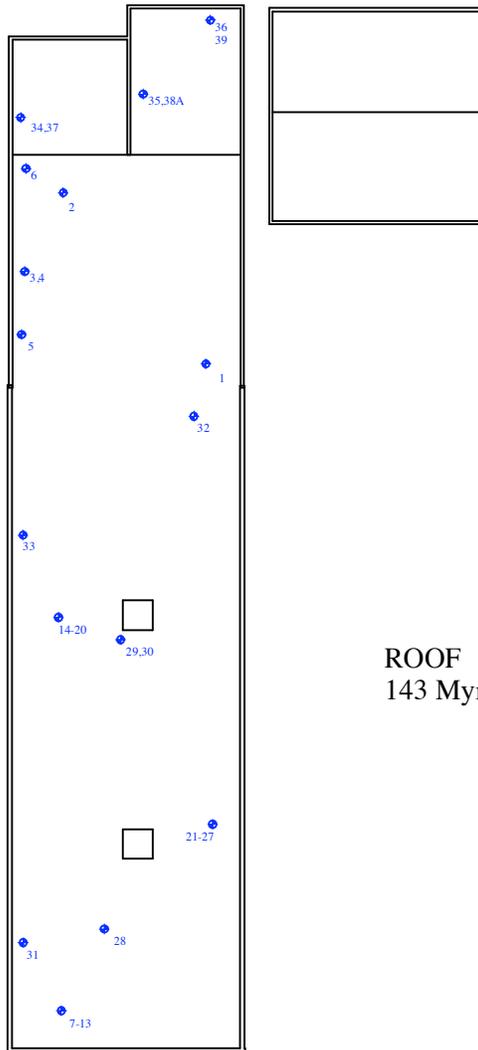
ROOF
143 Myrtle Avenue

There is approximately 270 square feet of black felt flashing on the roof perimeter. The black felt flashing was found to contain 20 percent asbestos.

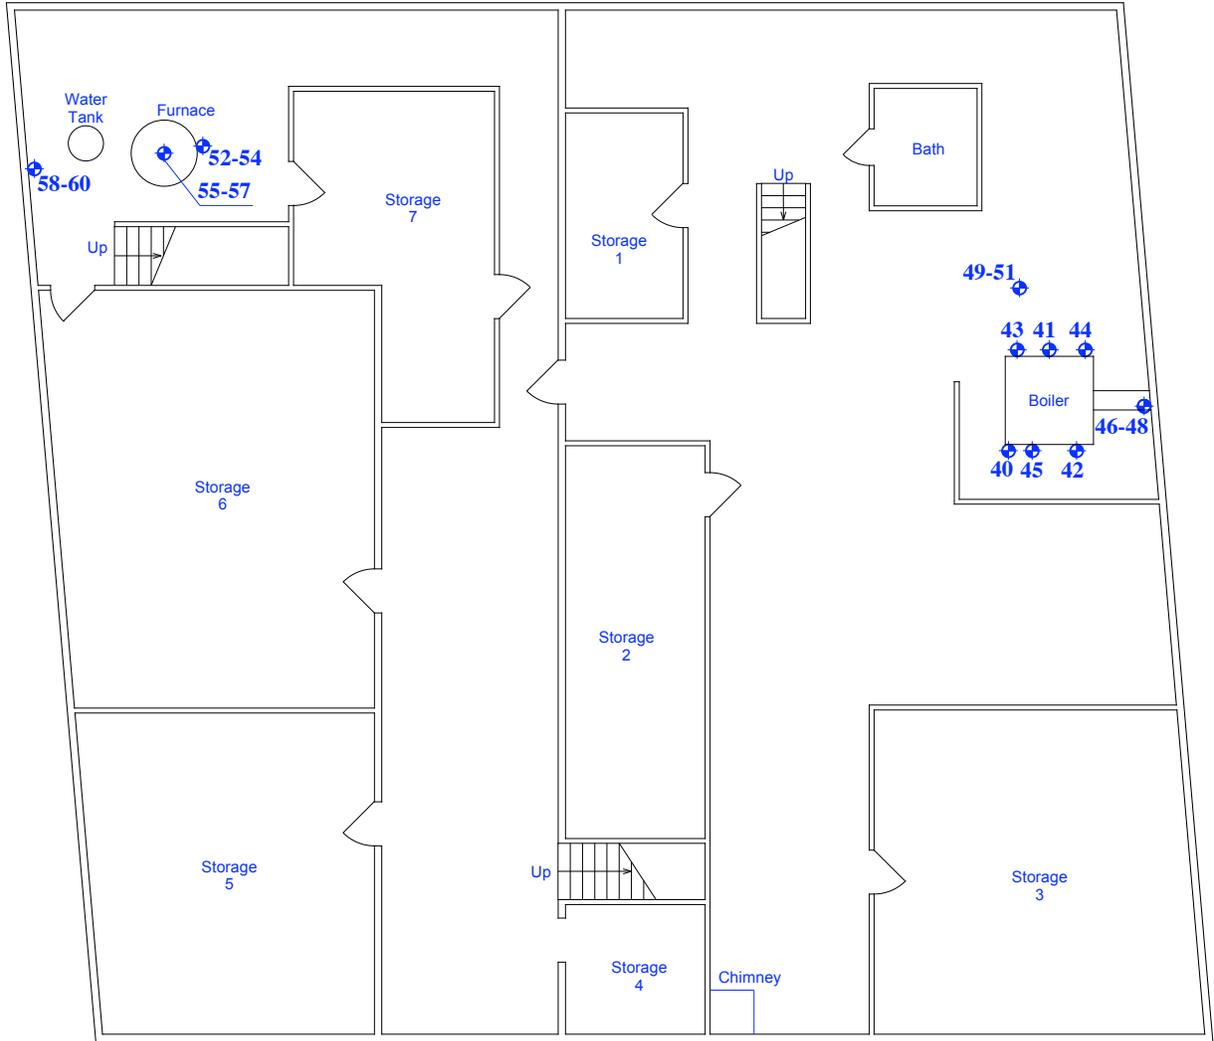
Basement Plan

There is approximately 102 square feet of boiler insulation. The boiler insulation was found to contain 65 percent asbestos.

There is approximately 6 square feet of furnace packing cement. The packing cement was found to contain 40 percent asbestos.

There is approximately 100 linear feet of pipe joint insulation. The pipe joint insulation was found to contain 65 percent asbestos.

There is approximately 3 square feet of chimney breeching cement. The chimney breeching cement was found to contain 40 percent asbestos.

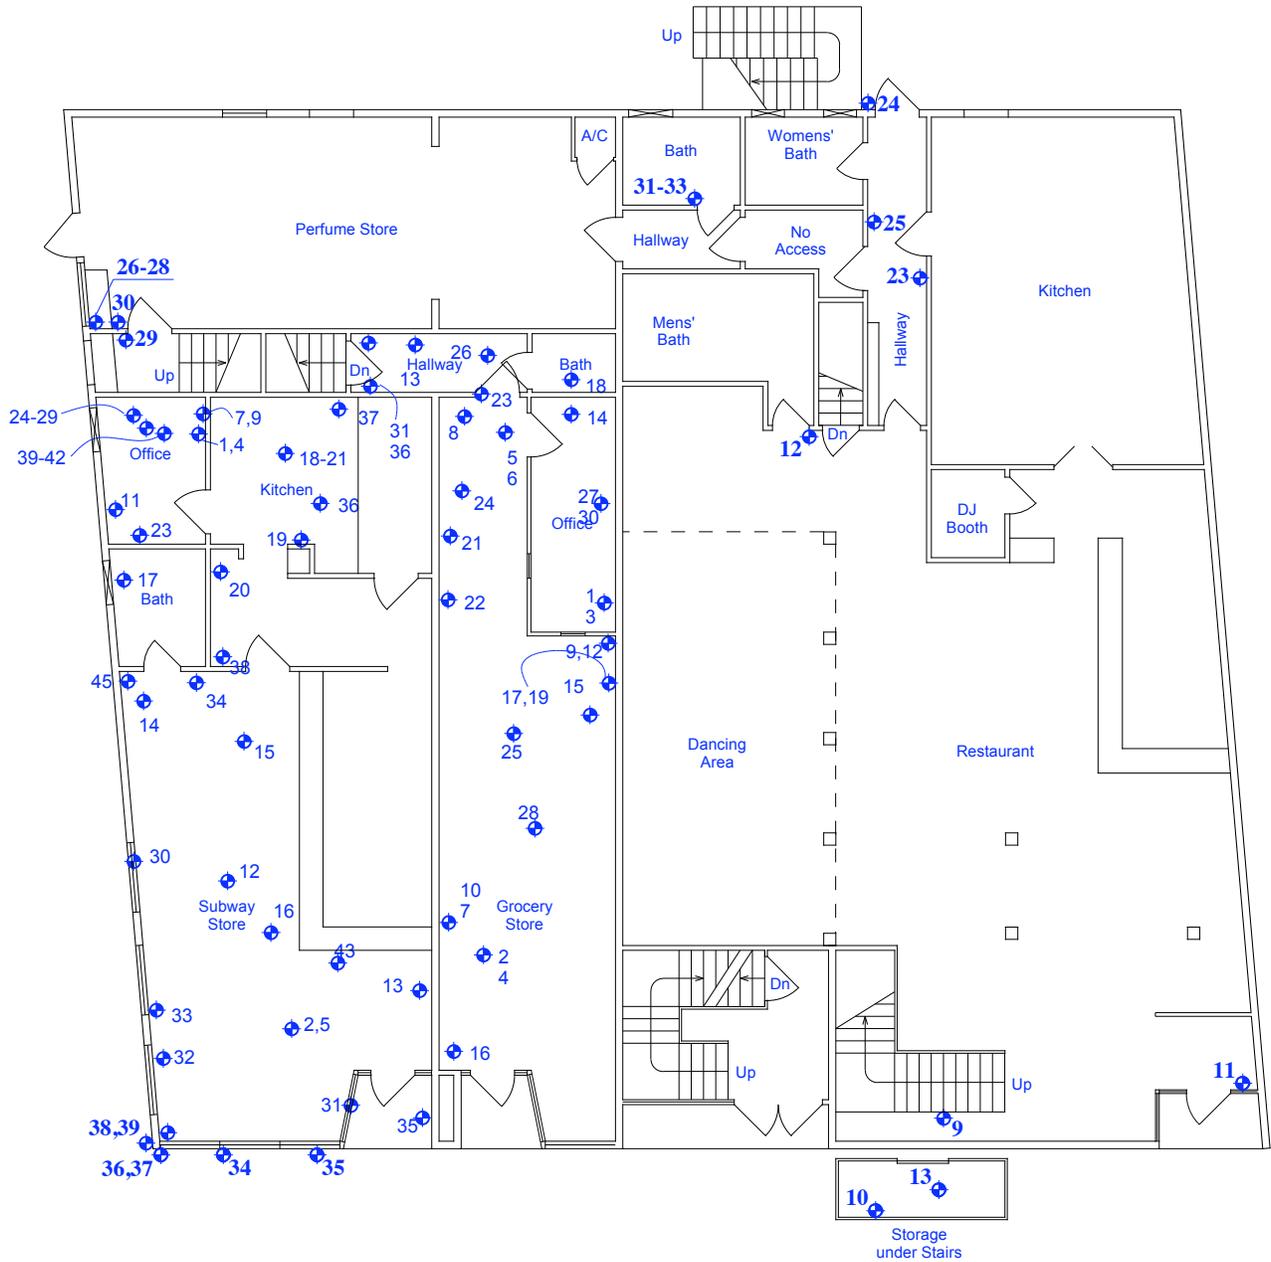
First Floor Plan

There is approximately 650 square feet of vinyl floor coverings. The bottom layer of 9"x9" gray vinyl floor tile was found to contain 4 percent asbestos. The associated top layer vinyl floor tile and all layers of mastic were found to have no asbestos detected.

There is approximately 1900 square feet of floor coverings. The bottom layer of 9"x9" cream vinyl floor tile was found to contain 4 percent asbestos. The associated layers of floor coverings and all layers of mastic were found to have no asbestos detected.

There is approximately 175 square feet of ceramic flooring. The bottom layer of vinyl floor tile was found to contain 3 percent asbestos. The associated layers of floor coverings and all layers of mastic were found to have no asbestos detected.
