**CULTURAL RESOURCE SURVEY  
FOR THE PROPOSED  
STAMFORD URBAN TRANSITWAY PHASE II PROJECT**

**STAMFORD, CONNECTICUT**

TRC Project 51043

June 2006

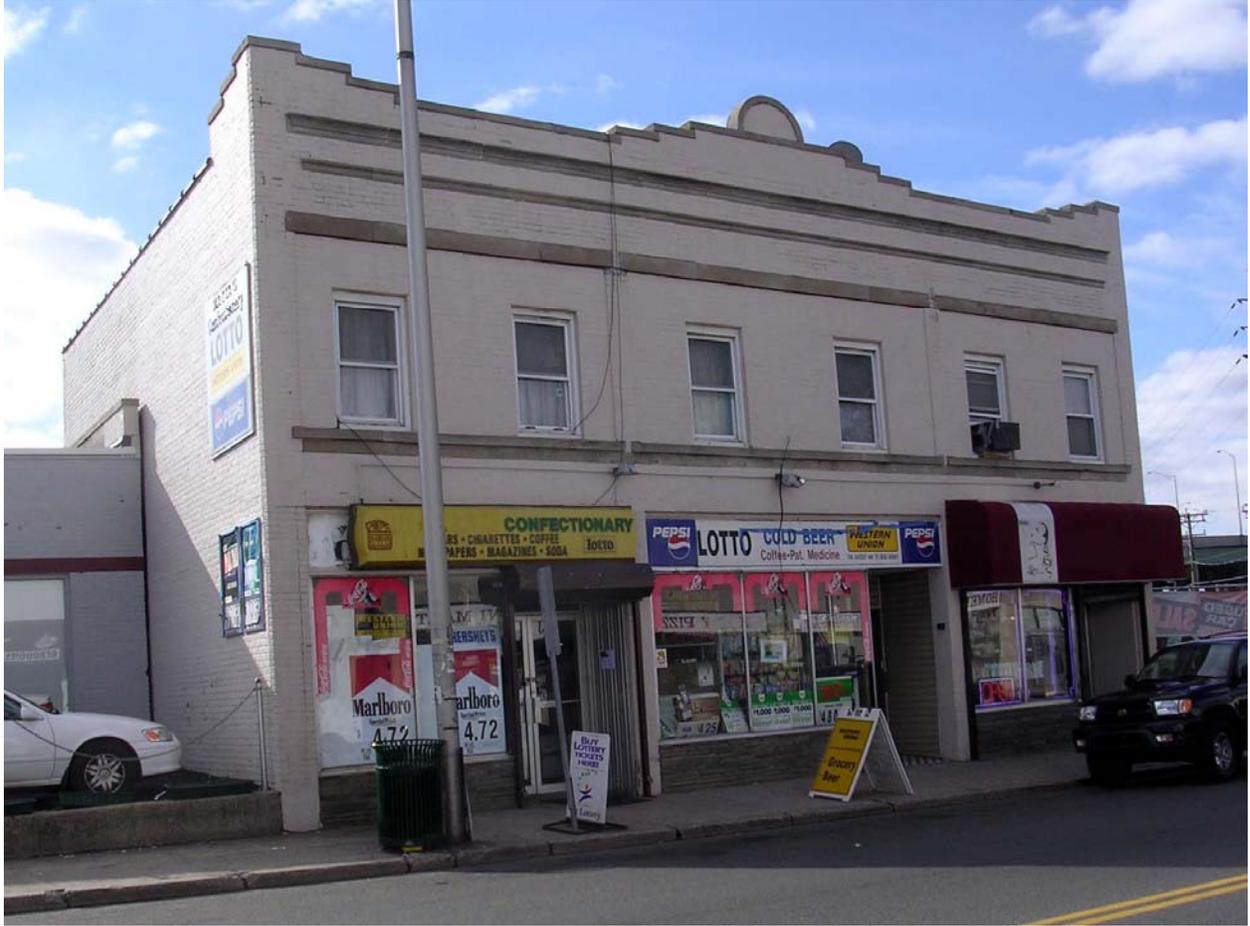
**Figure 3. 909-911 East Main Street, north and east sides, view southwest.**

This two story structure is a pared down example of the Art Deco style (Figure 3). The approximate date of construction is estimated at 1920. Its original use was, and continues to be, mixed residential and commercial.

The structure is a double wide, six bay, painted brick building with flat roof and stepped, raised parapet. Decorative banding on the façade is unpainted grey concrete. Trim at roof line is unpainted grey concrete facing the street and glazed terra cotta tiles on the sides of the building. The original windows on second floor have been replaced, and the first floor has modern storefront windows. The second story houses residential/commercial units, while the first floor houses a convenience store and beauty salon. This structure has undergone extensive alterations, primarily confined to the first floor, and retains only a moderate amount of historical integrity, and is not eligible for the NRHP.

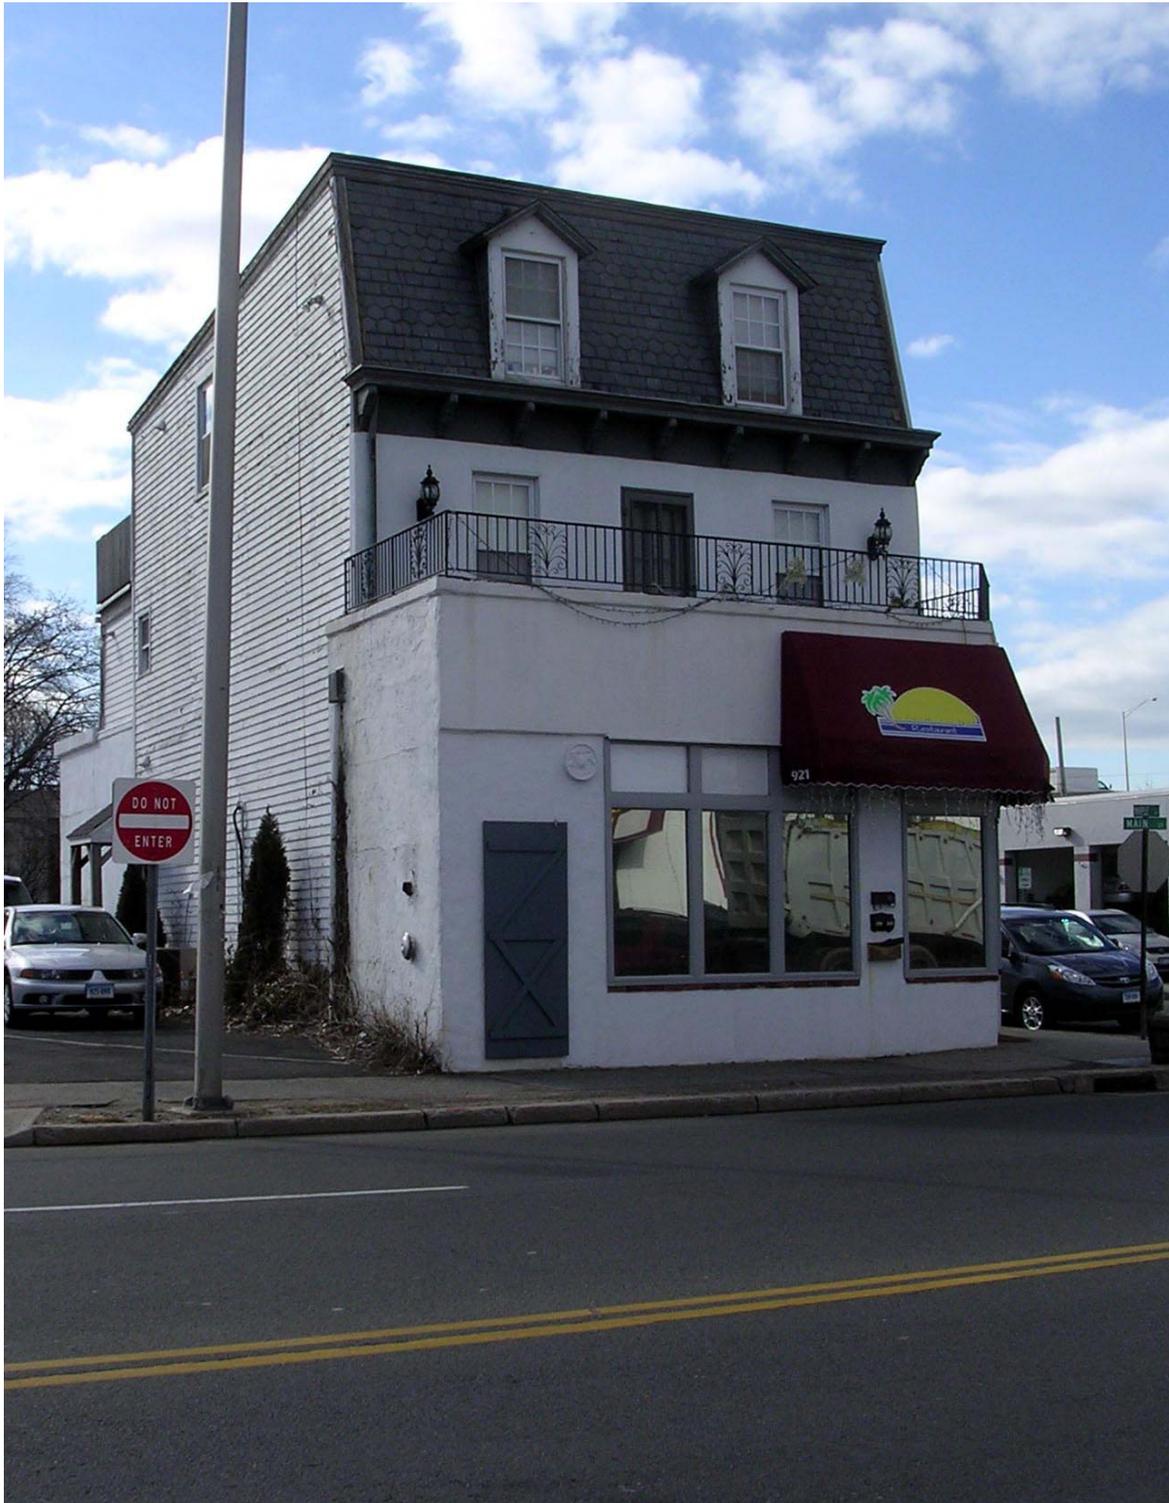
**Figure 4. 921/923 East Main Street, north and east sides, view southwest.**

This structure is an example of French Second Empire architecture with a vernacular addition (Figure 4). Its approximate date of construction is estimated at 1890 with a 1930s addition. It was historically used as a single family residence, with a later commercial addition. Currently it is a multi-family residential structure with a commercial addition.

The original structure on this property is a 3-story residence with mansard roof. The roof is marked by ornamental slate tiles and two original dormer windows. The façade of the residence has been parged with stucco. The sides of the building are clapboard. A one and two story modern ell has been added to the rear. The first floor of the residence had a one story, flat roof addition added in the 1930s. A historic building survey done between July 1977 and March 1979 by Renee Kahn Associates describes this storefront addition as “distinguished by Cobalt Blue glass panels which give it a distinctive 1930s look.” These (and any other historic details) have all been removed. The addition now houses a restaurant. Due to the removal of almost all historic architectural details, this property is viewed to have a low level of historic integrity, and is not eligible for the NRHP.

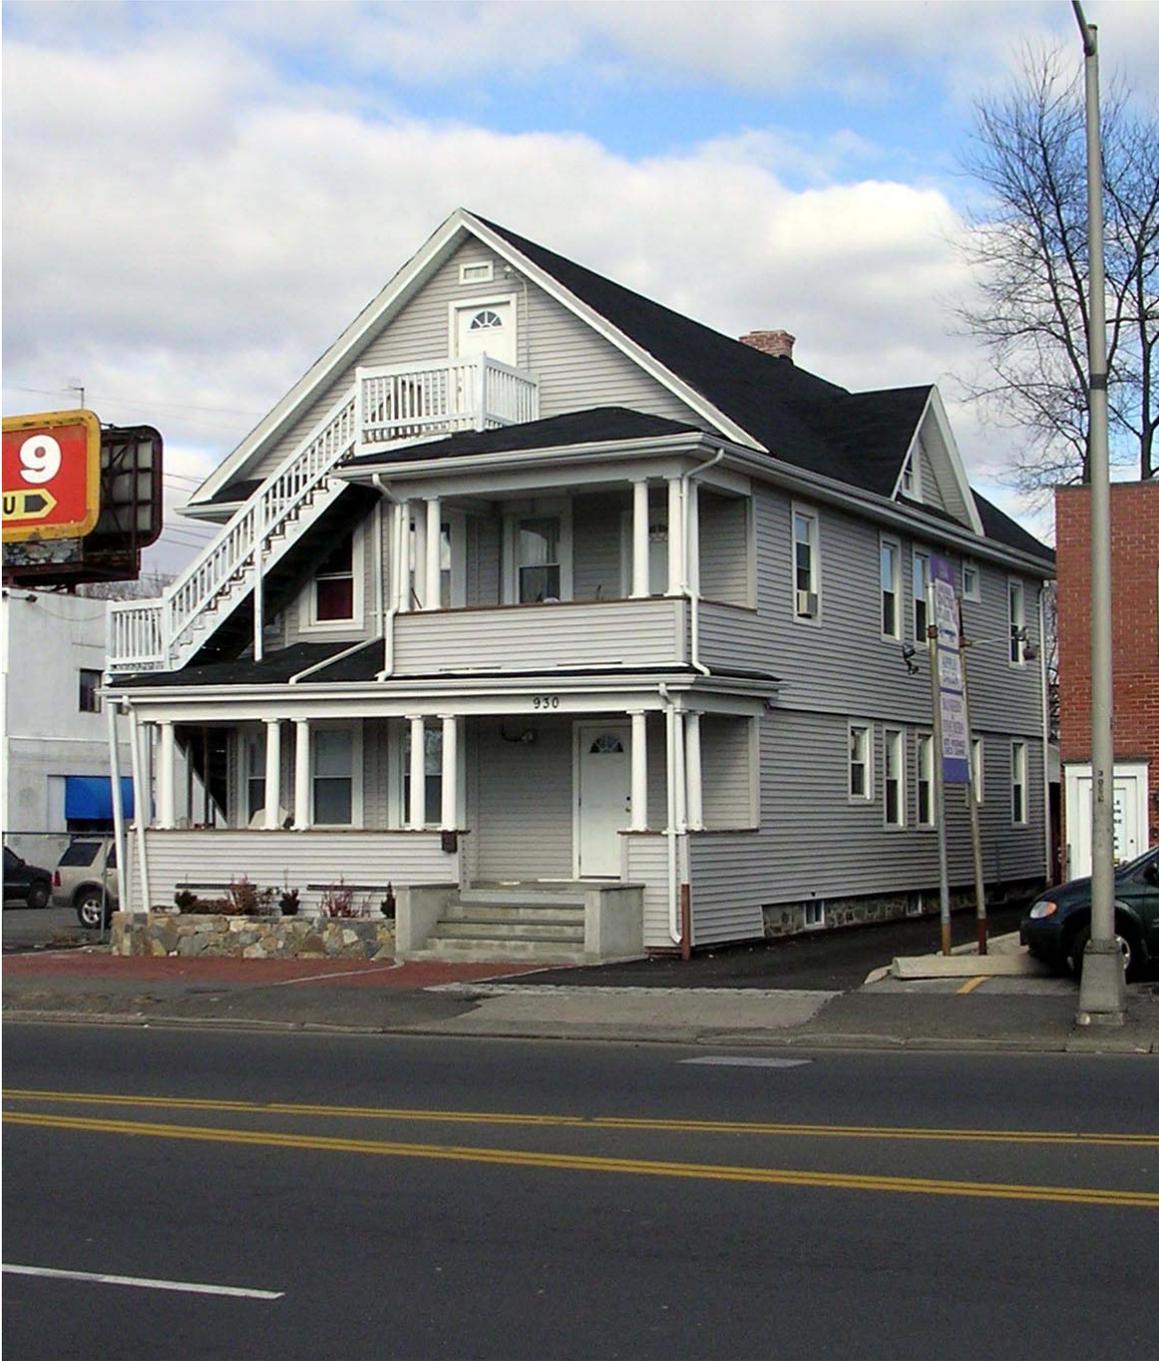
**Figure 5. 930 East Main Street, south and east sides, view northwest.**

This structure is an example of vernacular architecture with Classical Revival elements (Figure 5). Its approximate date of construction is estimated around 1900. Its historic use was as a single family home, but today is used as mixed residential and commercial.

The building is 2½-stories tall, with a pedimented end-gable with cross gable at center of ridge line. The building is 3-bays wide with a three part bay window on the first and second floors. A three part bay window also rises from the first to second floor under the cross gable on the west side of the building. It is marked by a full-width front porch with Doric columns and knee wall. The second story has a porch one bay wide centered over the main entrance on the first floor. A staircase addition on the façade permits access to an apartment/office in what was originally attic space. The building rests on a granite foundation, and the roof is asphalt shingle. All original doors and windows have been replaced, and the original cladding (most likely a combination of wood shingle and clapboard) has been replaced by vinyl. The front steps to the building come to the sidewalk edge. Side and rear yards have been replaced by paved parking lots. Due to the extensive renovations and alterations, this building retains a minimal amount of historic integrity, and is not eligible for the NRHP.

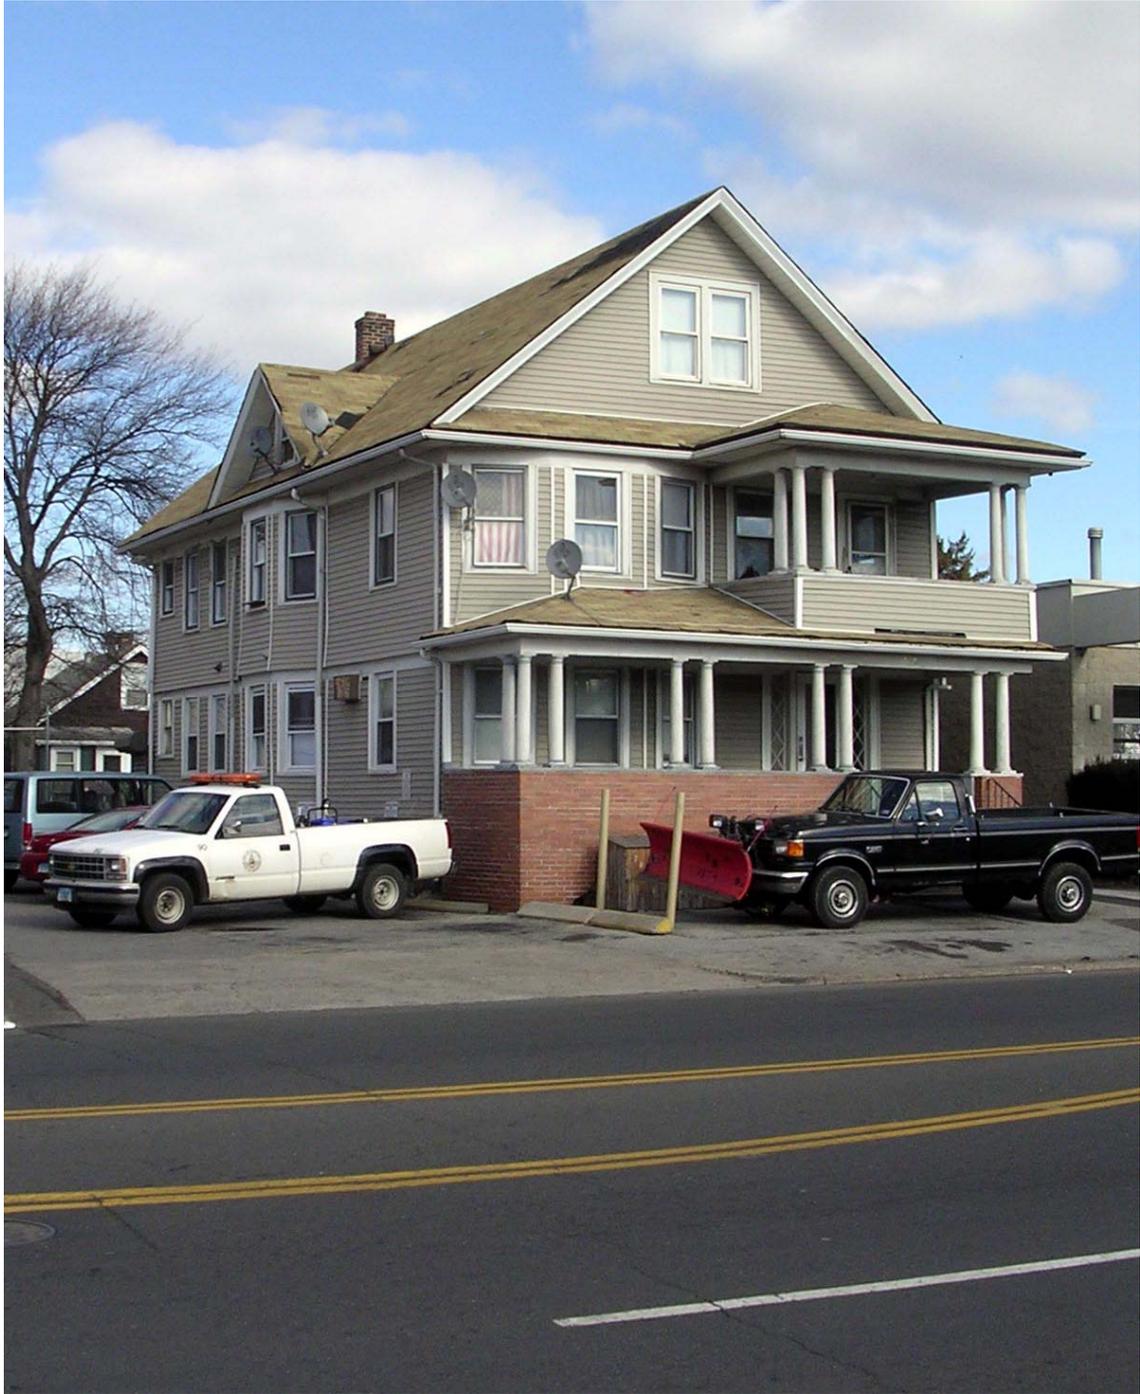
**Figure 6. 936 East Main Street, south and west sides, view northeast.**

This structure is an example of vernacular architecture with Classical Revival elements (Figure 6). Its approximate date of construction is estimated around 1900. Its historic use was as a single family home, but today is used as mixed residential and commercial.

The building is 2½-stories tall, with a pedimented end-gable with cross gable at center of ridge line. Building is 3-bays wide with a three part bay window on the first and second floors. A three part bay window also rises from the first to second floor under the cross gable on the west side of the building. It is marked by a full-width front porch with Doric columns. The knee wall and foundation of the porch have been rebuilt with brick. The second story has a porch one bay wide centered over the main entrance on the first floor. The building rests on a granite foundation, and the roof is asphalt shingle. All original doors and windows have been replaced, and the original cladding (most likely a combination of wood shingle and clapboard) has been replaced by vinyl. A historic building survey done between July 1977 and March 1979 by Renee Kahn Associates describes this house as having egg and dart molding and dentils in the cornice. These elements are no longer in place. The front steps to the building come to the sidewalk edge. Side and rear yards have been replaced by paved parking lots. Due to the extensive renovations and alterations, this building retains a minimal amount of historic integrity, and is not eligible for the NRHP.

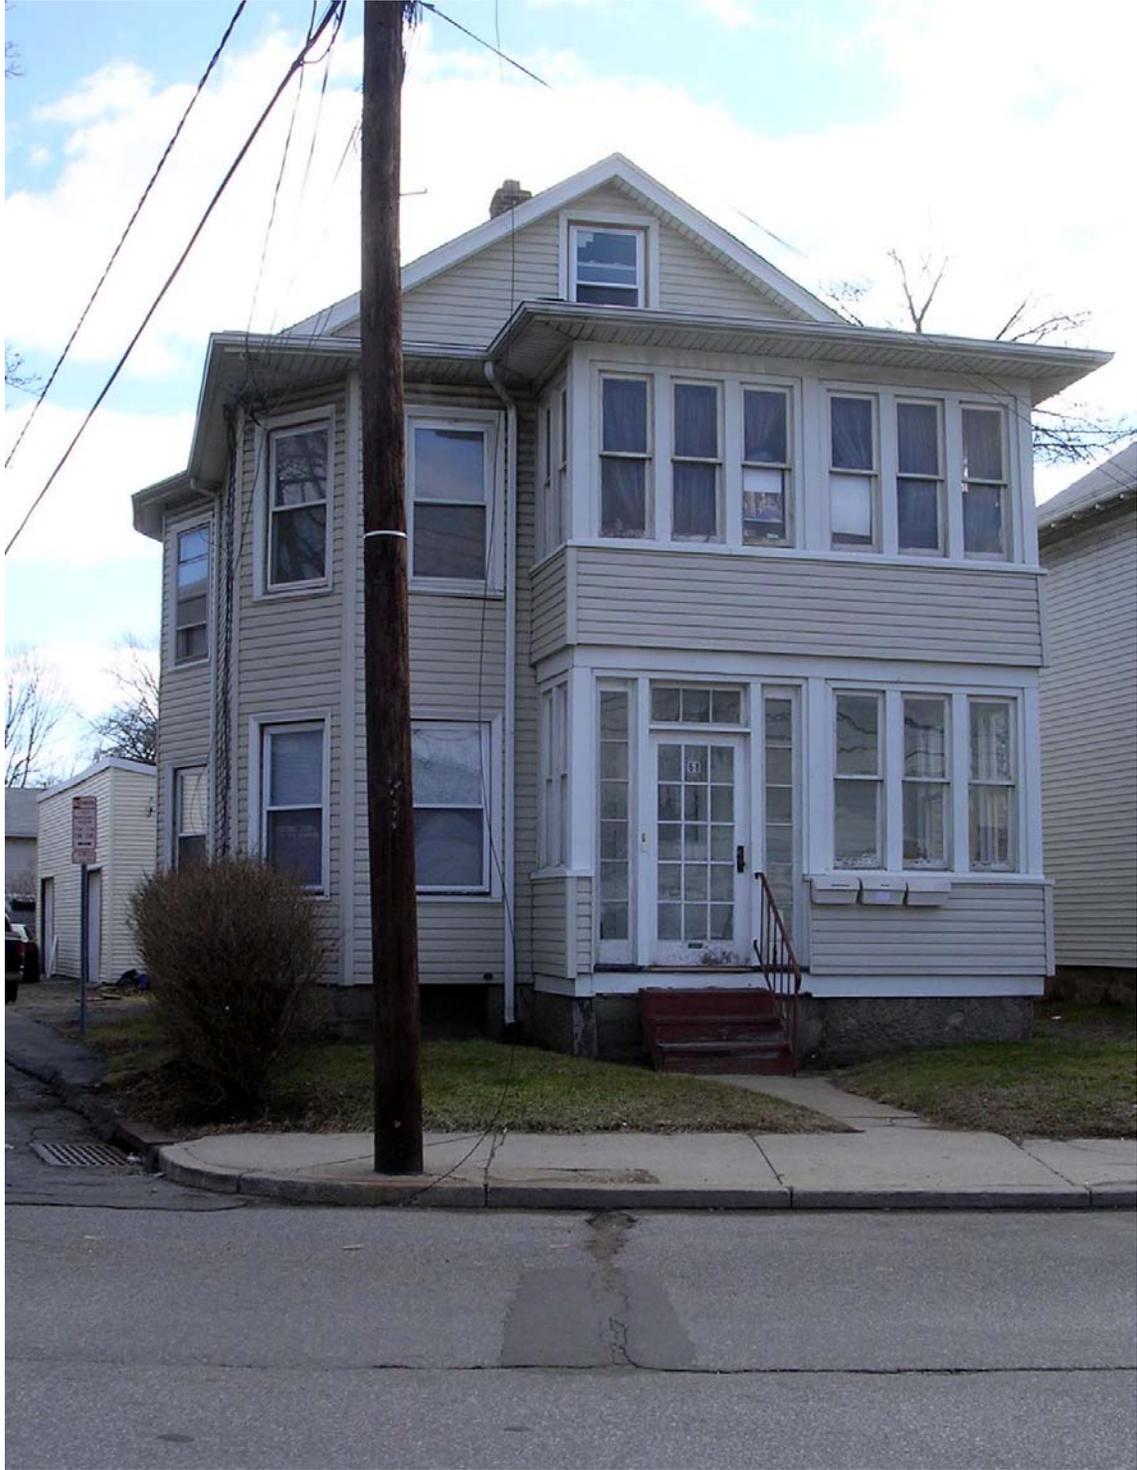
**Figure 7. 68 Myrtle Avenue, north and west sides, view southeast.**

This structure is an example of vernacular residential architecture (Figure 7). The approximate date of construction is estimated around 1910. Its original use was, and continues to be, residential.

The structure is a 2½-story, end-gable, 3-bay wide building. A two-story, two bay wide, flat-roofed entrance porch projects from the façade with an adjacent two-story bay window. The roof lines are marked by deep overhanging eaves. The windows in the porch are all original, but all the others in the house are replacement. The roof is asphalt shingle and the house sits on a granite foundation. Original cladding (probably a combination of wooden shingles and clapboards) has been replaced by vinyl siding. Due to extensive renovations, this structure retains only moderate historic integrity, and is not eligible for the NRHP.

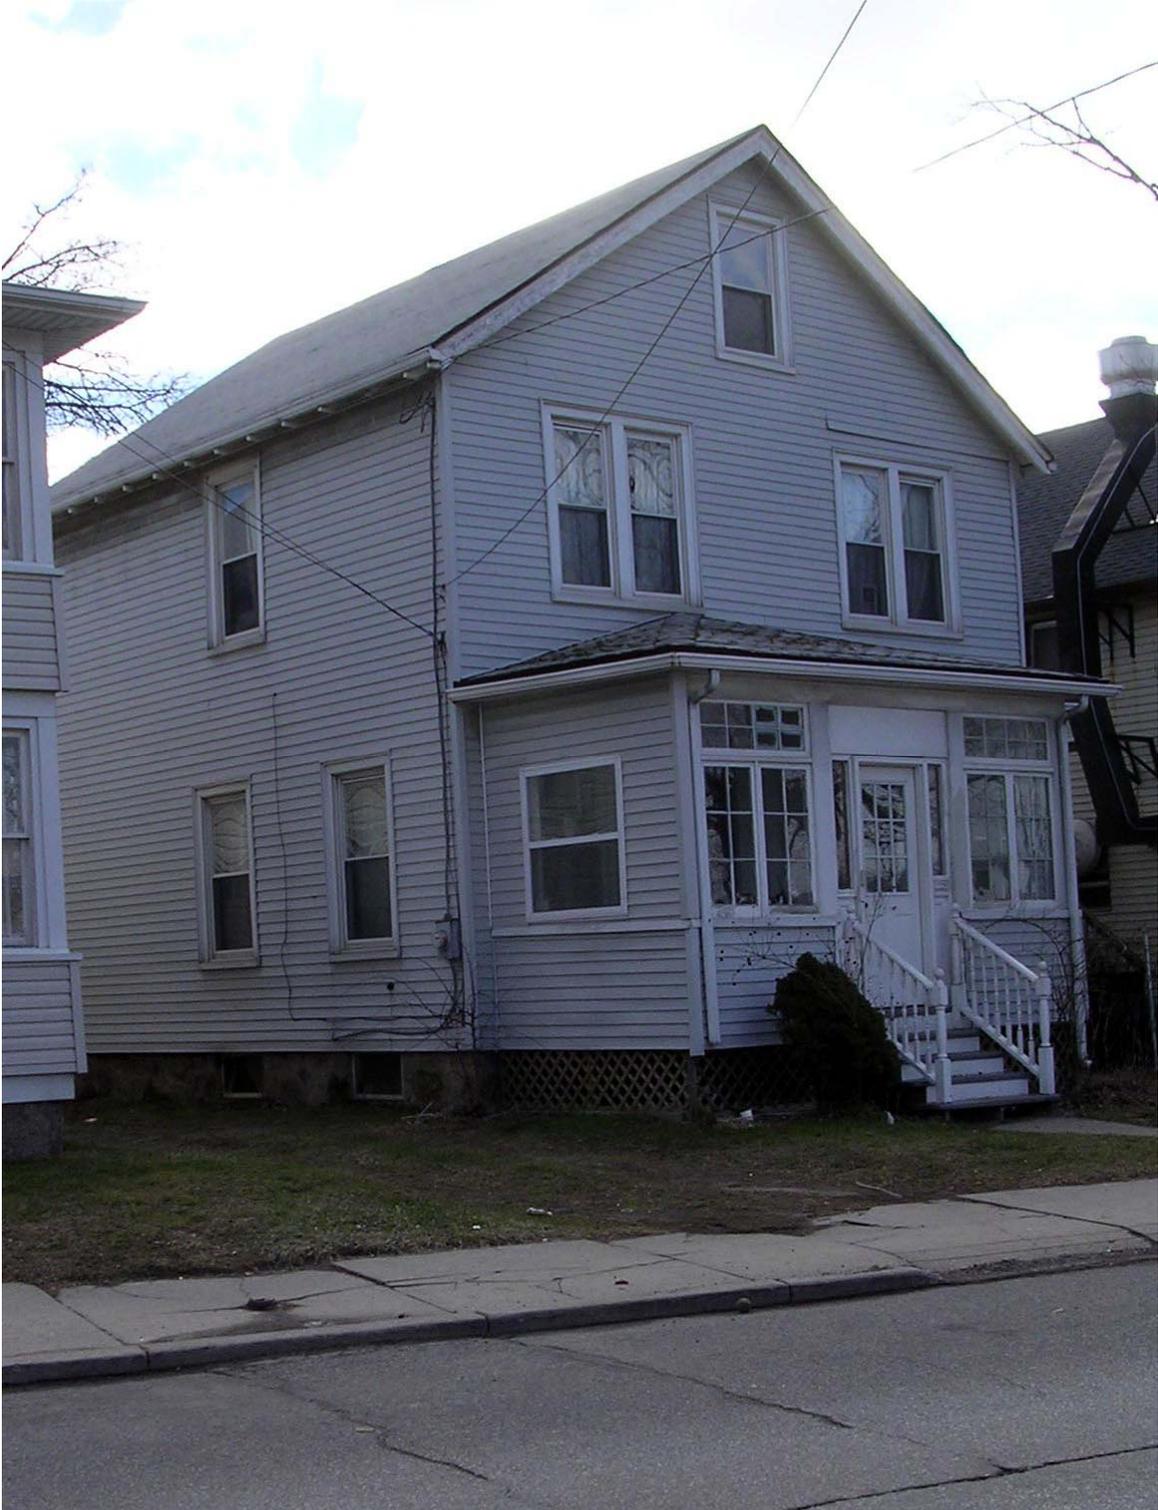
**Figure 8. 70 Myrtle Avenue, north and west sides, view southeast.**

This structure is an example of vernacular residential architecture (Figure 8). The approximate date of construction is estimated around 1910. The original use was, and continues to be, residential.

The building is a 2½-story, end gable, two-bay wide building. The first floor has 1-story, hipped-roof, enclosed entry porch. The sides of the house reveal shallow, projecting, scrolled eave brackets. The house has had all of its original windows replaced, although those on the front of the porch are replacements meant to echo the original fenestration. The house rests on a granite foundation and has a roof of asphalt shingle. The original cladding (most likely wooden clapboard) has been replaced with vinyl siding. Due to extensive remodeling, this structure retains only moderate historical integrity, and is not eligible for the NRHP.

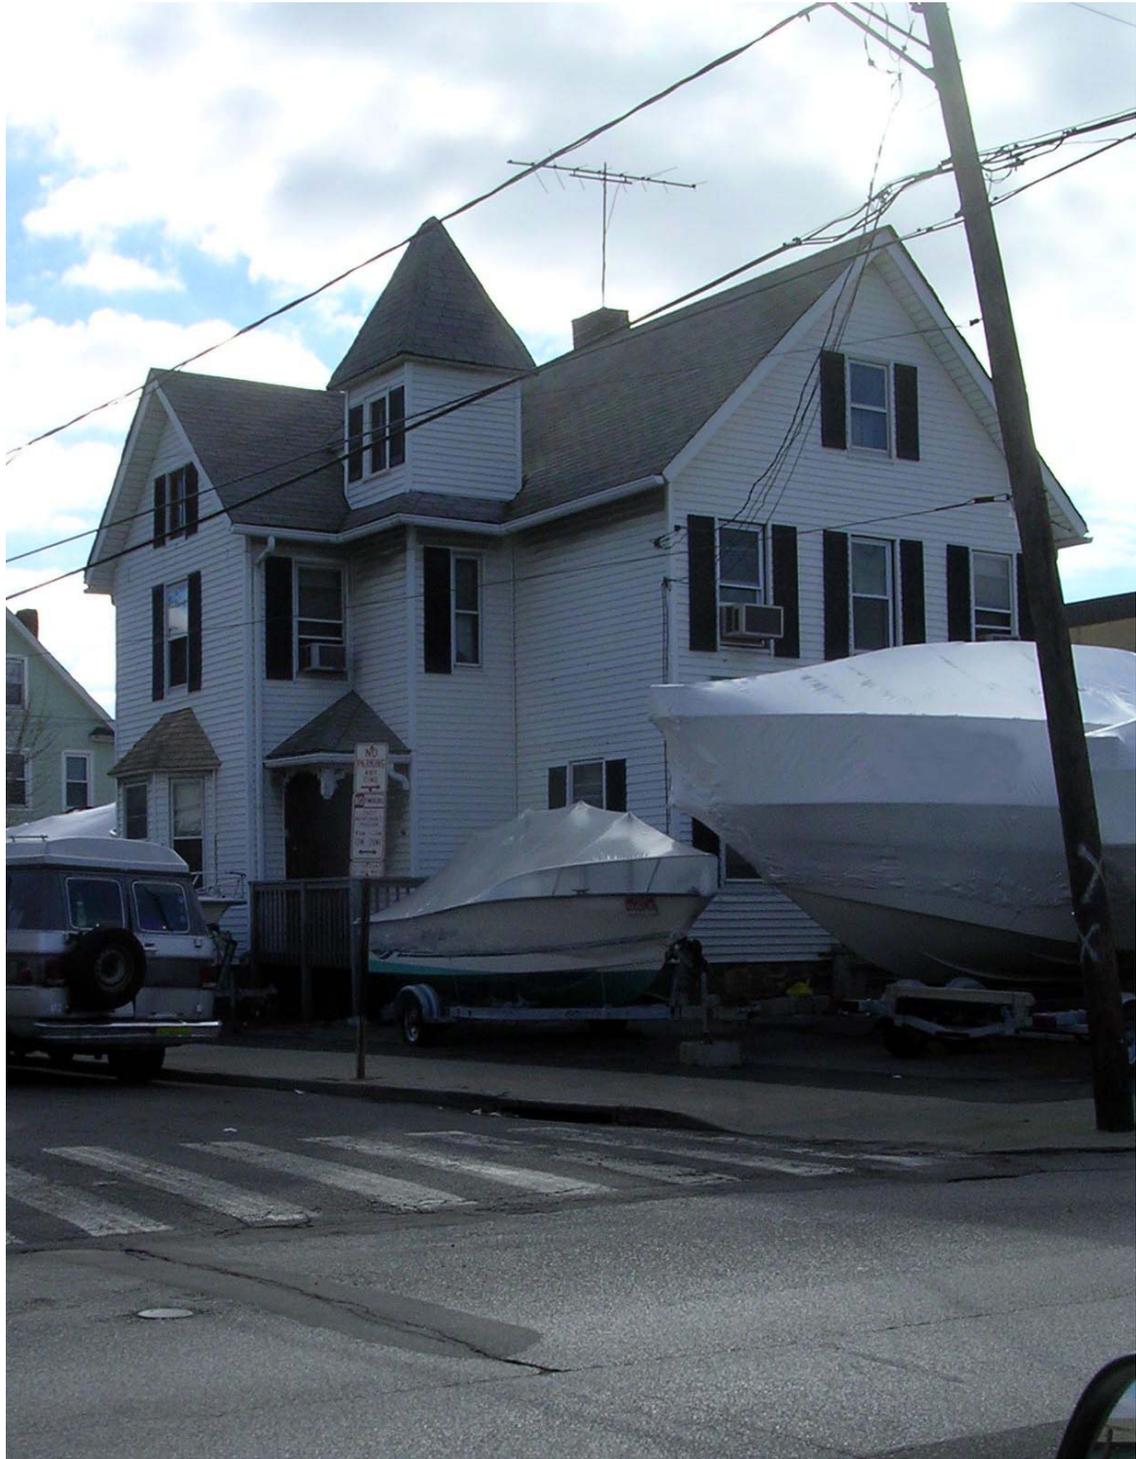
**Figure 9. 80 Myrtle Avenue, north and west sides, view southeast.**

This structure is an example of Queen Anne architecture (Figure 9). The approximate date of construction is estimated around 1890. The original use was residential. Today it appears to be a combination of residential and commercial space.

The structure is a 2½-story, crossed gable, three bay wide building. The plan is cruciform with main entrance adjacent to a 3½-story, through-roof tower. A historic building survey done between July 1977 and March 1979 by Renee Kahn Associates notes that the “original plate and panel front door is distinguished by applied scalloped shell ornamentation. Decorative elements retained in porch pediment, spindles, and brackets.” Only the original scrolled brackets supporting the entrance roof remain. The original front steps and porch have been replaced with pressure treated decking and rails. All original doors and windows have been replaced. The roof is asphalt shingle and the foundation is granite. The original cladding (most likely wooden clapboard and shingles) has been replaced by vinyl siding. Due to extensive remodeling, this structure retains only moderate historical integrity, and is not eligible for the NRHP.

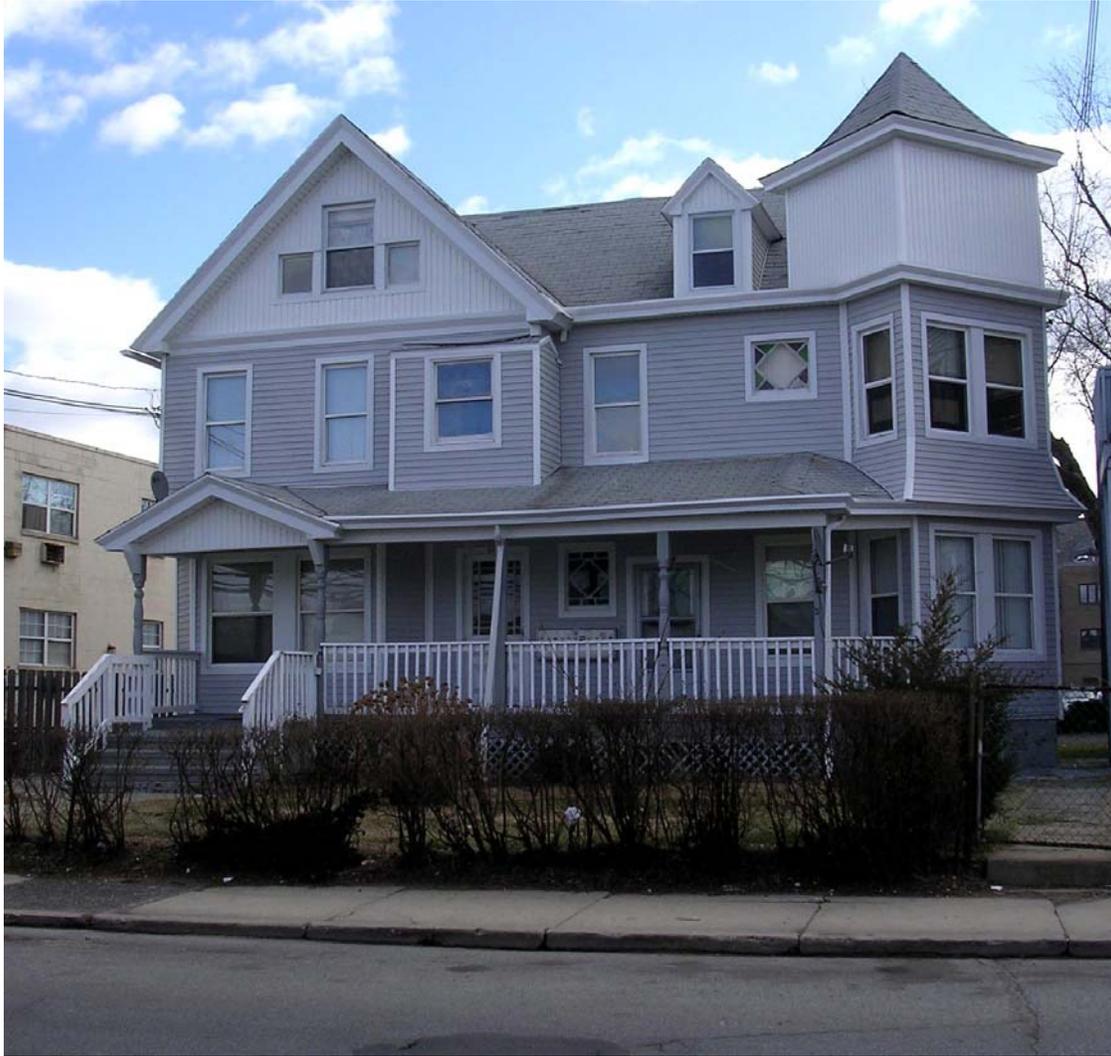
**Figure 10. 148-150 Myrtle Avenue, west side, view east.**

This structure is an example of Queen Anne architecture (Figure 10). The approximate date of construction is estimated around 1890. The original use was single residential; today it is multi-family residential.

The structure is a 2½-story, end gable building with 3½-story tower and full length front porch. The porch retains its original turned columns. Three original leaded glass windows remain on the first and second floors, although all remaining windows are replacements. The original windows in the corner tower have been closed over. The roof is asphalt shingles and the foundation is granite. A historic building survey done between July 1977 and March 1979 by Renee Kahn Associates states that there are “scallop shingles in the pediment” and the house is sheathed in clapboard. All of the original cladding has been replaced by vinyl siding. Due to extensive remodeling, this structure retains only moderate historical integrity, and is not eligible for the NRHP.

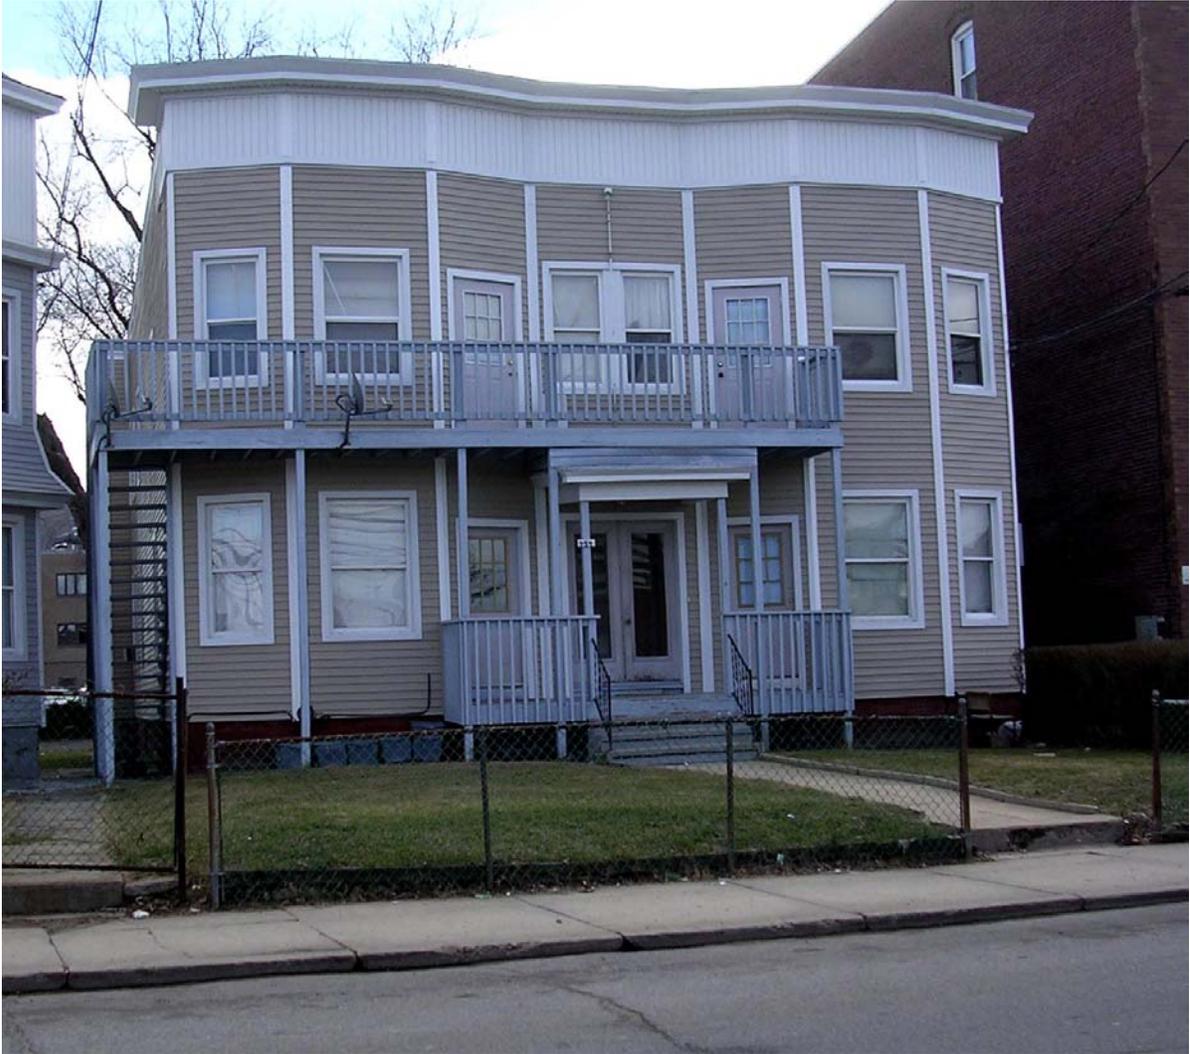
**Figure 11. 154 Myrtle Avenue, north and west sides, view southeast.**

This structure is an example of Neo Classical style architecture (Figure 11). The approximate date of construction is estimated around 1910. The original use was twin residential; today it is multi-family residential.

The structure is a 2-story, flat roofed building with a three bay façade comprised of full height three-part bays flanking a central entrance. The original front entrance porch has been replaced and exterior steps on the side of the house provide access to a porch and second floor apartments. The building sits on a brick foundation and is clad in vinyl siding. The original double front door with large plate glass panels is intact, but all of the remaining original windows and doors have been replaced. Vertical siding with crown molding at the roof line suggests a previous ornamental parapet. Due to extensive remodeling, this structure retains a low level of historical integrity, and is not eligible for the NRHP.

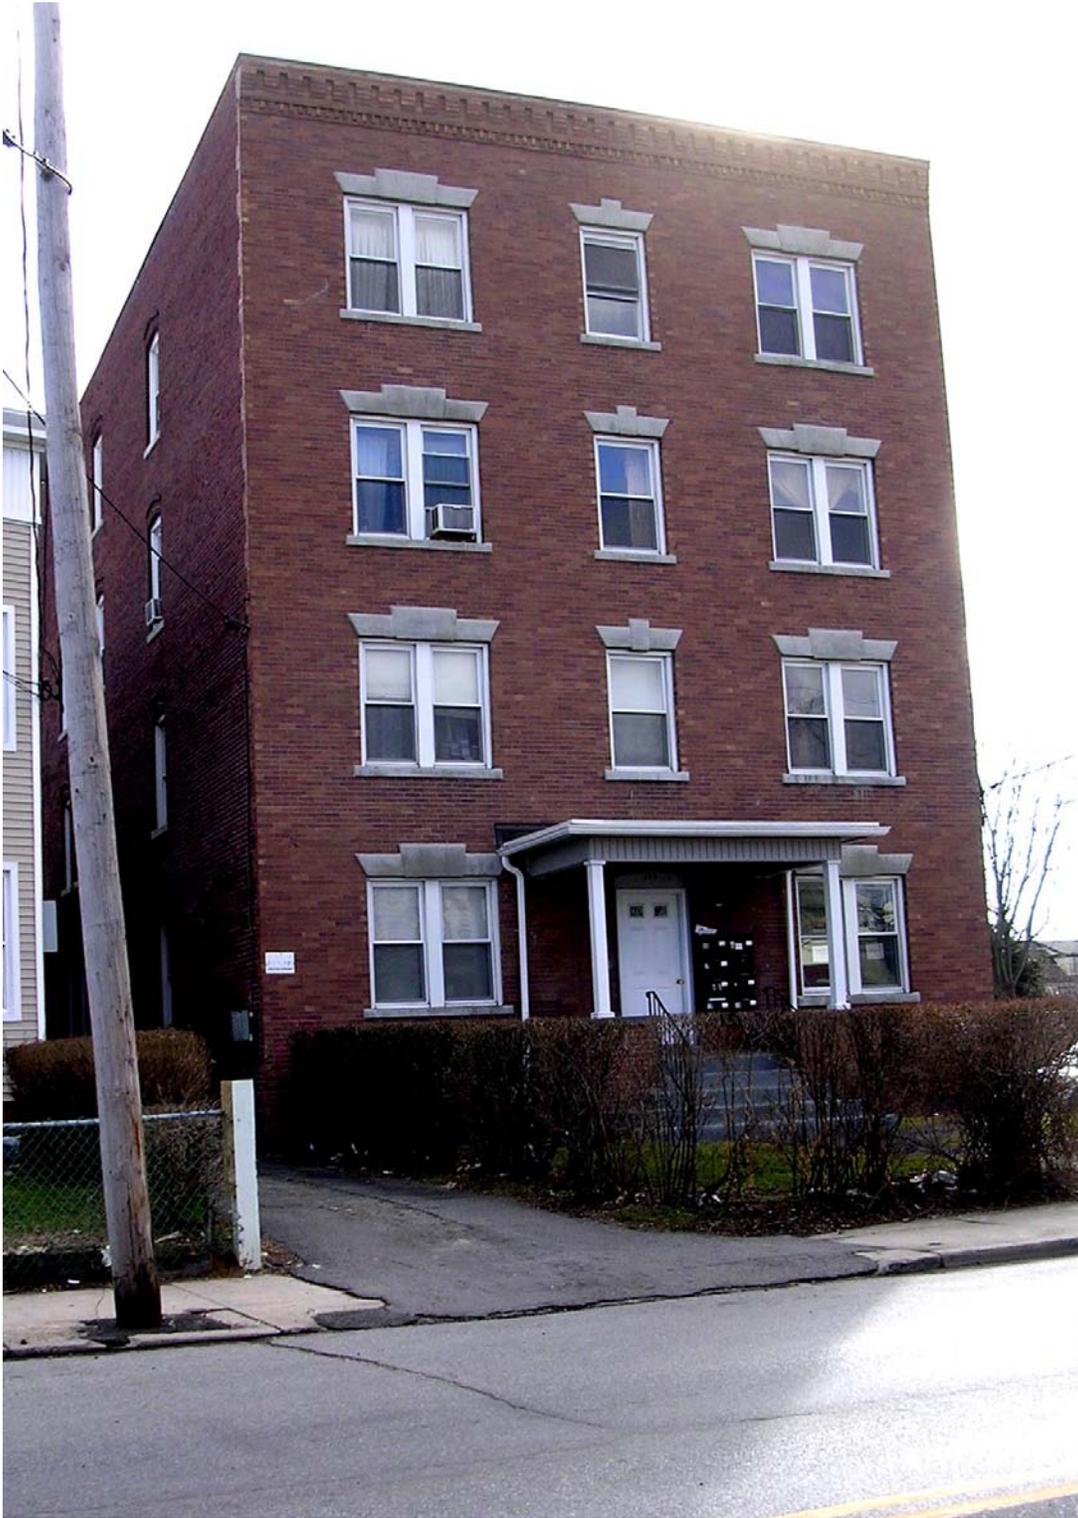
**Figure 12. 162 Myrtle Avenue, north and west sides, view southeast.**

This structure is an example of Classical Revival style architecture (Figure 12). The approximate date of construction is estimated around 1910. The original use was, and continues to be, multi-family residential.

The building is a 4-story, brick, flat roofed structure. The façade is 3-bays wide. The original roof over the entry porch has been altered (replaced and aluminum clad, or perhaps only clad) but retains its squared Doric columns. The windows on the façade have concrete sills and lintels with wide keystones. Windows on the sides of the building have concrete sills, but arched, inset eyebrow lintels. The roofline on the façade has stepped corbelling and dentil details. The rear of the building has wooden porches. Despite having minor alterations done to the front porch and replacement windows, this building would be considered to have a high level of historical integrity, although not eligible for the NRHP.

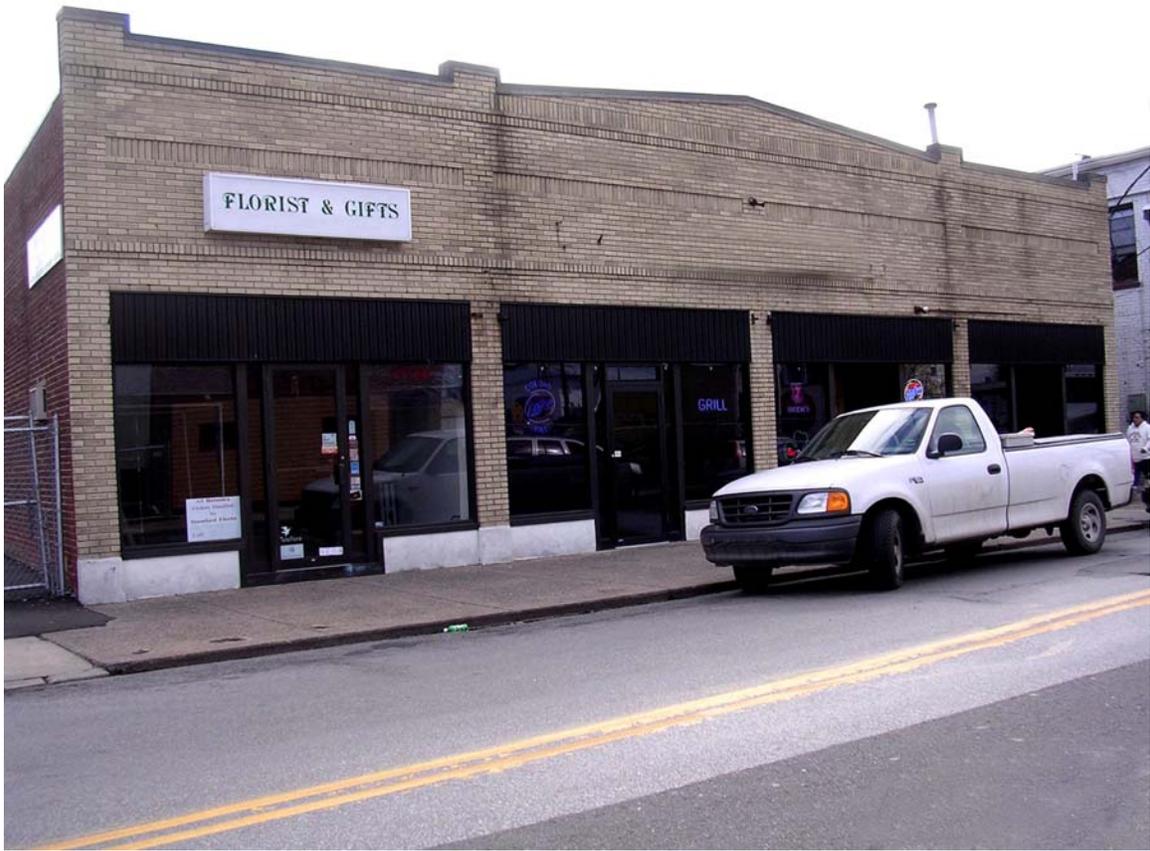
**Figure 13. 168 Myrtle Avenue, north and west sides, view southeast.**

This structure is an example of pared down Art Deco style architecture (Figure 13). The approximate date of construction is estimated around 1920. The original use was, and continues to be, commercial.

The structure is a 1-story, flat roofed, brick structure. The façade is 4 bays wide, each with modern plate glass and aluminum store front entrances. The sides of the structure are of red brick, while the façade is of yellow brick. The parapet is marked by a concrete cap, with a shallow central peak and four low posts marking the edges of the outer two bays on the first floor. The façade is also marked by subtle ornamentation of horizontal soldier courses of brick, with bands set at 90- and 45- degree angles. Due to extensive remodeling, this structure retains only moderate historical integrity, and is not eligible for the NRHP.

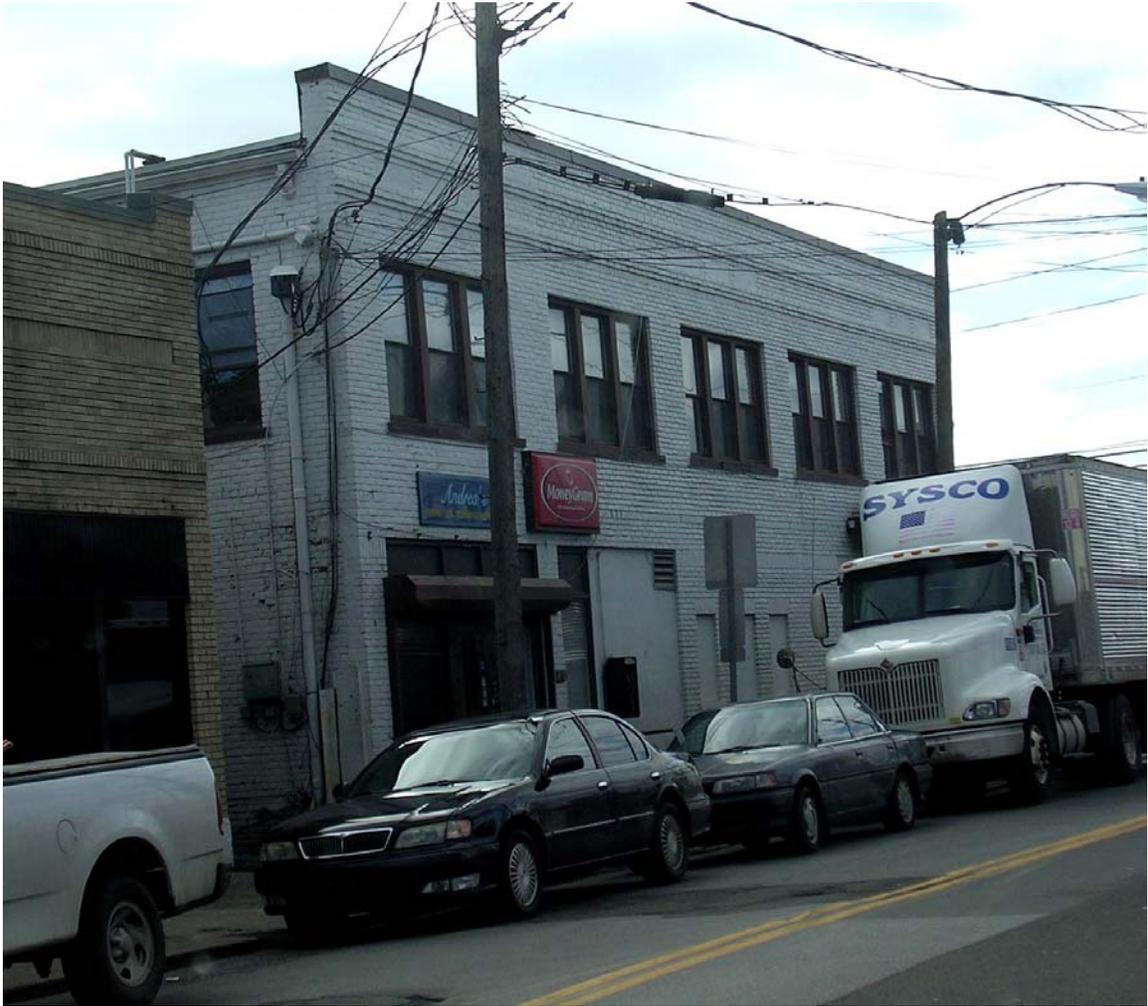
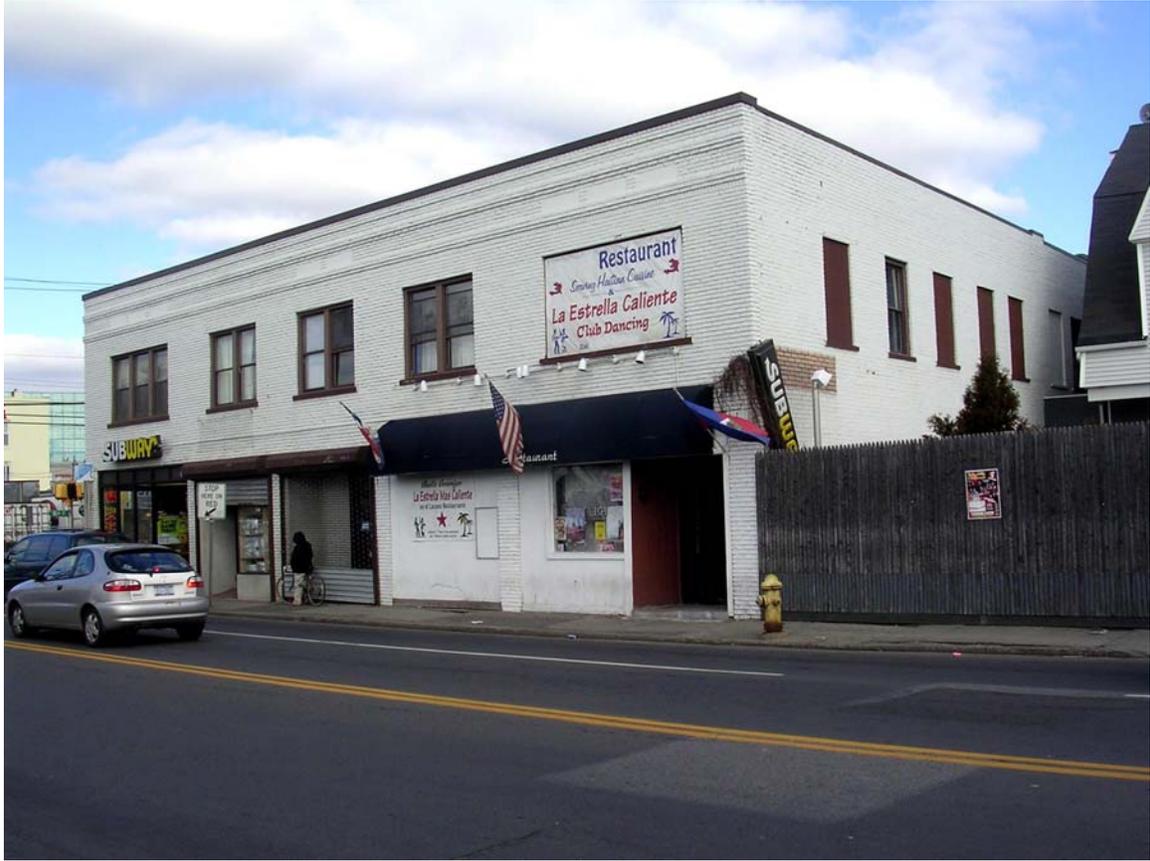
This structure is an example of vernacular, industrial architecture (Figures 14 and 15). The approximate date of construction is estimated around 1920. The original use was, and continues to be, mixed commercial.

The structure is a 2-story, flat roofed, painted brick structure. The façade (facing Elm Street) is 5 bays wide with 5 narrower spaced bays on the Myrtle Street side. The building has a parapet roof edge with pairs of simple decorative brick banding. The remaining windows on the second floor appear to be original, although a number of them have been filled in on both the second and first floors. All of the original doors and storefront entrances on the first floor have been replaced with modern glass and aluminum units, in-filled, or considerably altered. Due to extensive alterations to the first floor, this building would be considered to have a low level of historical integrity and not eligible for the NRHP.
