TECHNICAL COMMITTEE MEETING
Tuesday November 19, 2013
2nd Floor Conference Room
Plant Site, 111 Harbor View Avenue, Stamford, CT 06902

SUBJECT Stamford WPCA - Air Balancing

**PROJECT: STAMFORD WPCA
SLUDGE PROCESSING BUILDING
ODOR CONTROL SYSTEM
PRELIMINARY READINGS**

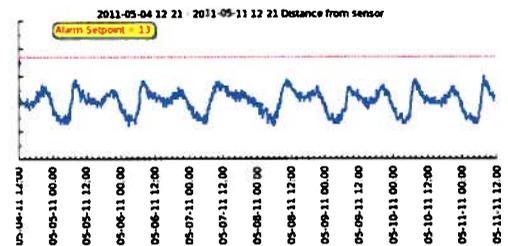
Level Sensing

- Ultrasonic Sensor Monitors Liquid Level
- Intrusion Alarm
- Continuous Real Time Monitoring

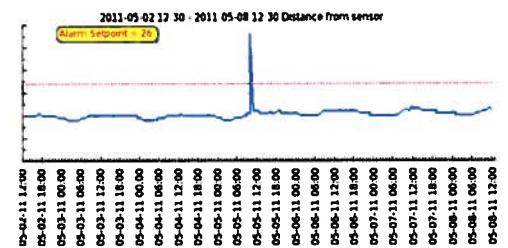
Alarm

- Instant alarming for level
- Alarms to: Mobile Phones, Pagers, and Emails
- System Maintenance Alerts

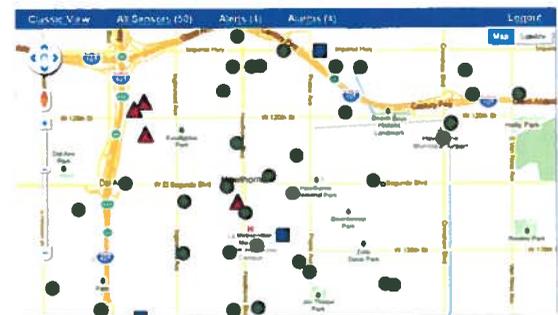
- Web Based Map Interface is Easy to Use
- No Software to Purchase or Install
- Operator Friendly
- Units are Easy to Relocate
- Plug and Play Components
- Onboard PowerPack Lasts 1 year
- Smart Phone Compatible

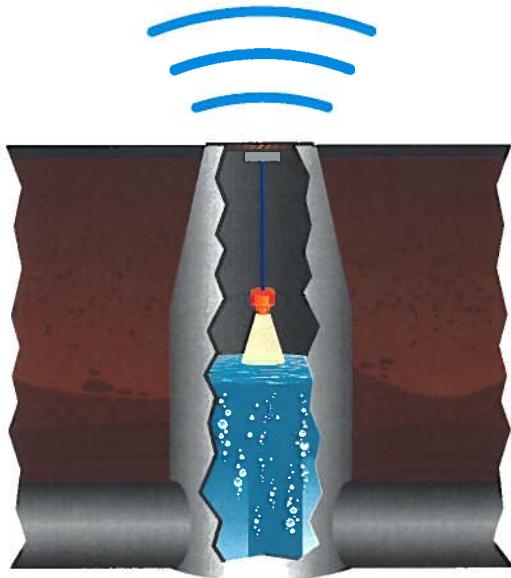
The SmartCover[®] is a wireless, self-contained monitoring system with onboard power • Designed for the most extreme environments, the device attaches directly underneath a cover or hatch, and is capable of communicating from anywhere on Earth directly to a Low Earth Orbit satellite system • The unit requires no confined space entry for installation and is easily relocated by field crews • The SmartCover[®] provides continuous data collection for long term trending and sends an immediate alarm whenever a customer determined alarm point is reached • Alarms are sent directly to end users • All the data is available through a secure website from any computer • There is no proprietary software to purchase • The simple design and operation of the SmartCover[®] system adds value, not complexity.

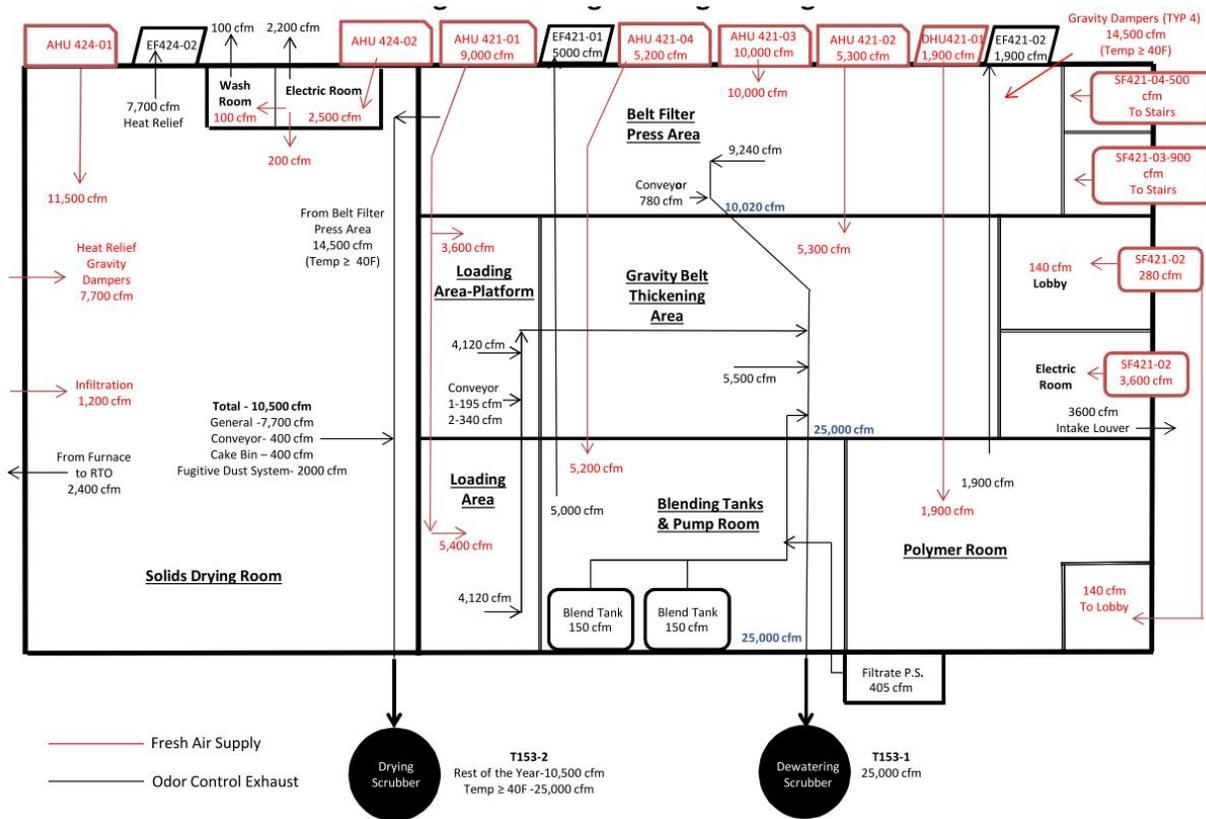
**Figure 1
 Town of Stamford WPCF
 Sludge Processing Building Design Flow Rates**

Air Balancing conducted testing of the ductwork system on October 29, 2013. The firm utilized a Monarch Photo Tach meter, Shortridge Airdata Multimeter and a Fluke Ammeter to verify if the current air flow rates matched the design air flow rates as shown in Figure 1.

Air Balancing was able to obtain air flow measurements to compare with original design flows but was not able to conduct any balancing because many of the dampers are not operable as described in their report. Results of the flow measurements collected are summarized in Table 1 below. Although it was not possible to adjust the air balance of the system, based on the results in Table 1 most areas appeared to be operating within 10% of original design flows. The main area with the most significant difference was the truck loading area (first floor). Air Balancing reported that the air volume damper to the first floor is 90% closed and broken and cannot be

adjusted. This is resulting in more air being pulled from the second floor loading area and less being pulled from the first floor.

Based on the results, there does not appear to be a need to re-balance the entire system. However improvements are necessary. We have divided recommendations into short and long-term improvements.

- Replace the fire damper on the duct between the sludge room and the truck loading area. This should be done as soon as possible.
- Replace the broken volume damper serving the 1st floor truck loading area.
- Clean grills of all intake louvers and remove debris.
- Place rubber mats over opening in access hatches at filtrate pump station.
