# YERWOOD CENTER

## DRAINAGE REPAIR

WORK TOOK PLACE  
FROM 4/21/16 TO 4/28/16

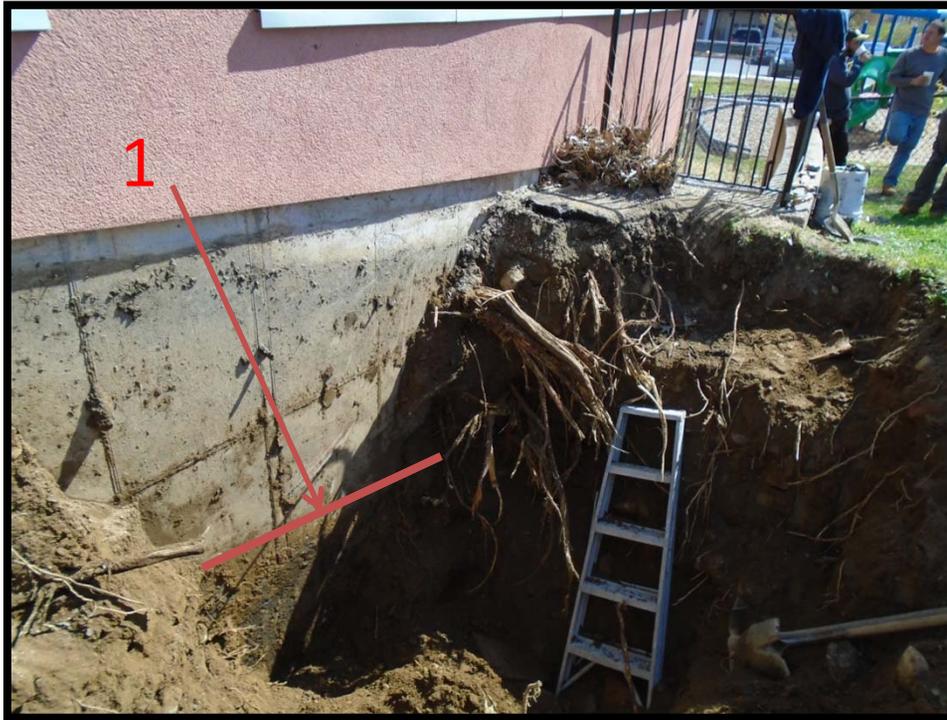
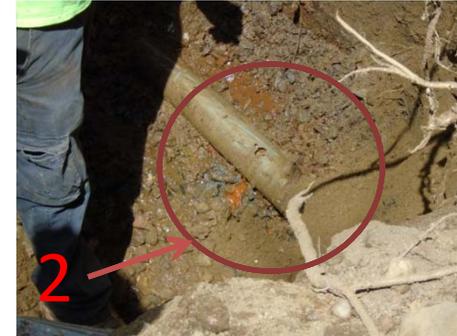
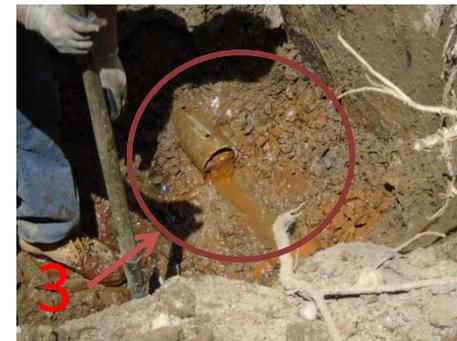
## DAY 1: EXPLORATORY EXCAVATION

1. Waterproofing on foundation wall started 5' below grade, not reaching the footing.
2. Footing drain with perforations atop and on side of the pipe.
3. Footing drain is broken and clogged with silt with open joints.
4. There was no filter fabric wrapped around the footing drain. Instead it was wrapped with plastic.

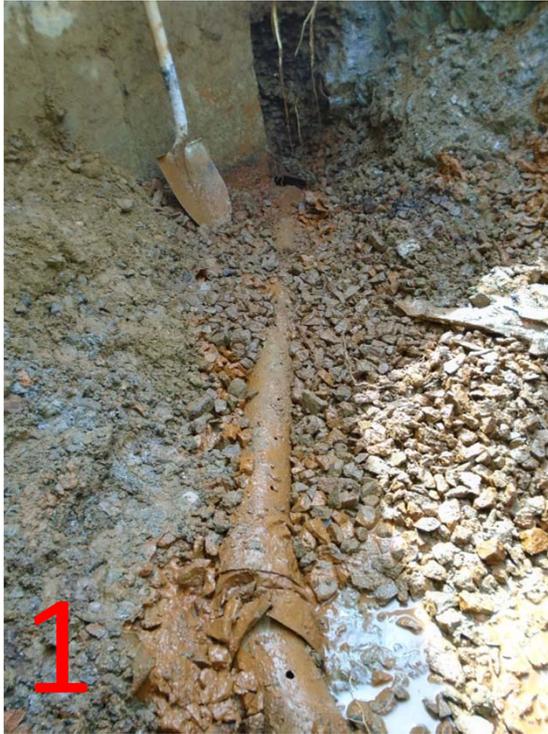
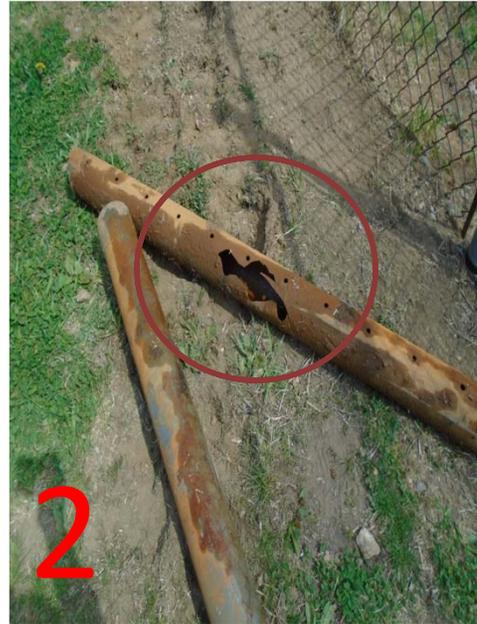
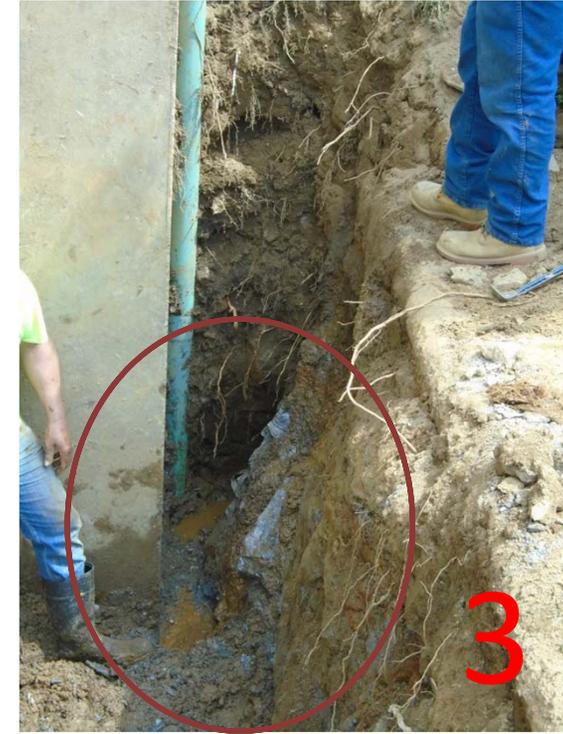
## DAY 2: EXPLORATORY EXCAVATION FOLLOWING THE LOCATION OF EXISTING FOOTING DRAIN

Existing footing was improperly installed:

1. open joints
2. broken and clogged
3. not pitched to drain due to the ledge (backpitched in corner where internal flooding was taking place)

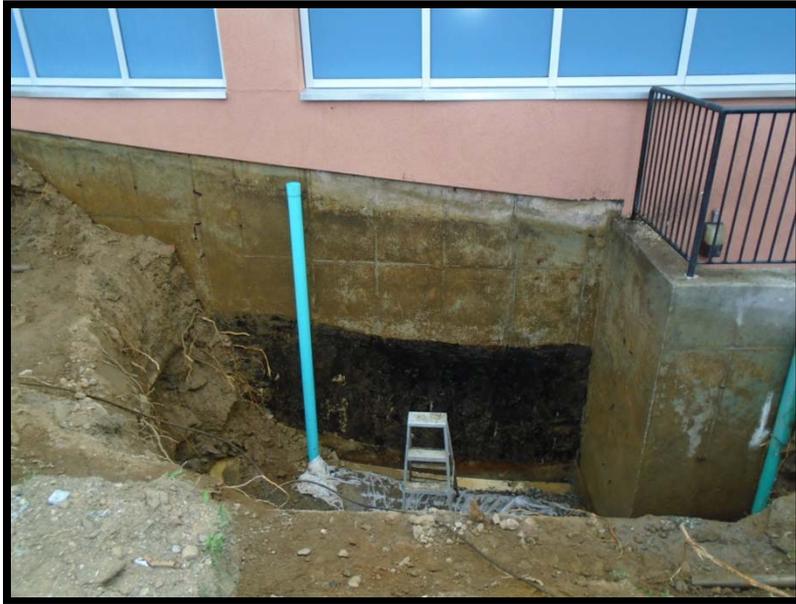
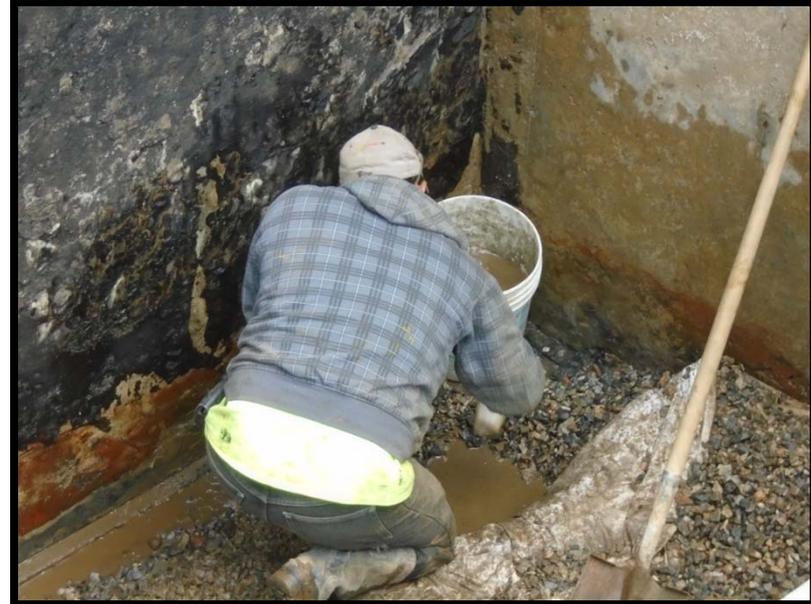
## DAY 3: POWER WASHING THE FOUNDATION WALL AND FOOTING

1. Foundation wall and footing was power washed in preparation of applying new waterproofing.
2. Drain/pump excess water to work in the dry.

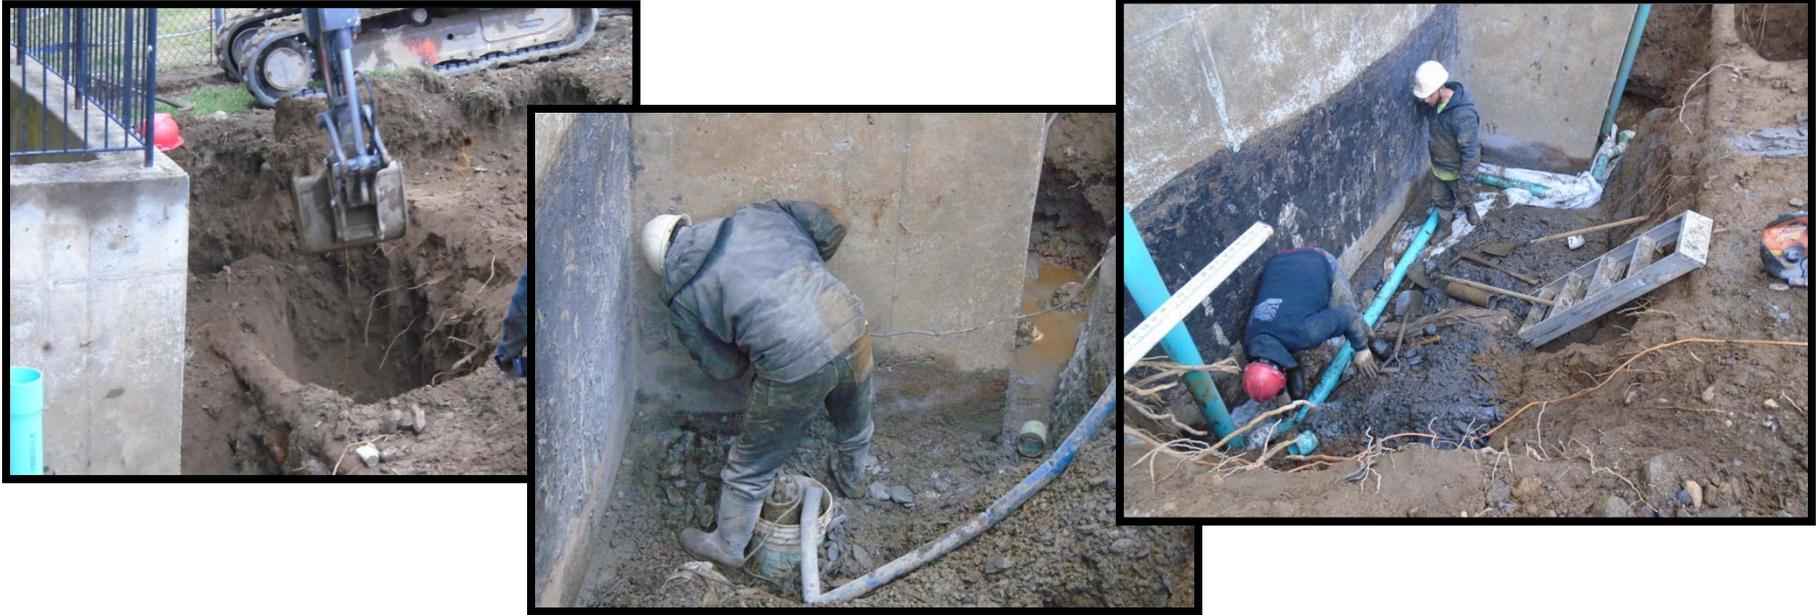
## DAY 4: FURTHER EXCAVATION & START OF REPAIR

1. Further excavation was needed to reach the 6" outlet connection.
2. Ledge was in the way. Laborers chipped away at stone with hydraulic hand held drill around the connection and at the foundation footing.
3. Replaced perforated footing drain with new 4" diameter pipe and pitched it correctly, now that the ledge was removed.
4. Wrapped footing drain with filter fabric and covered with crashed stone.

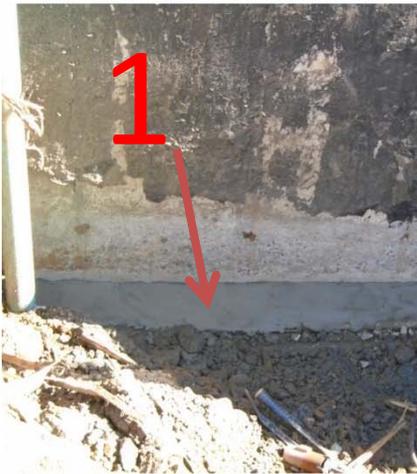
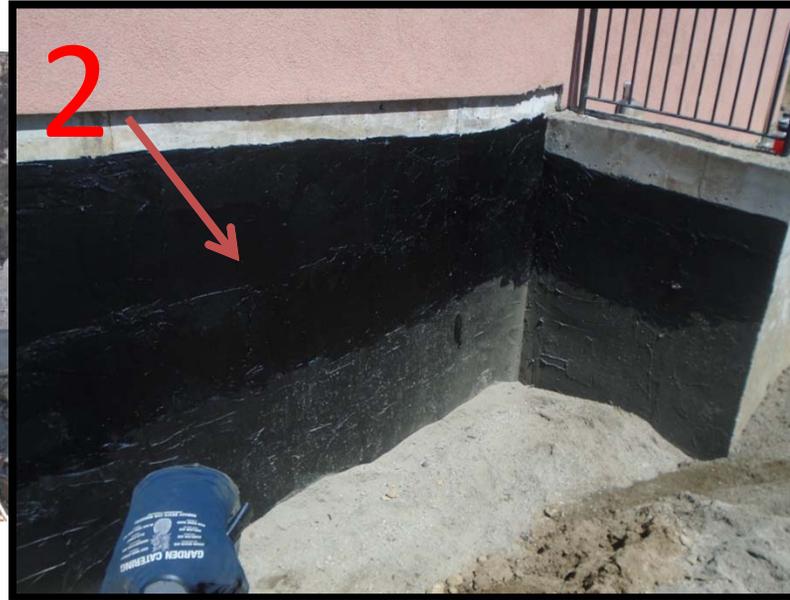
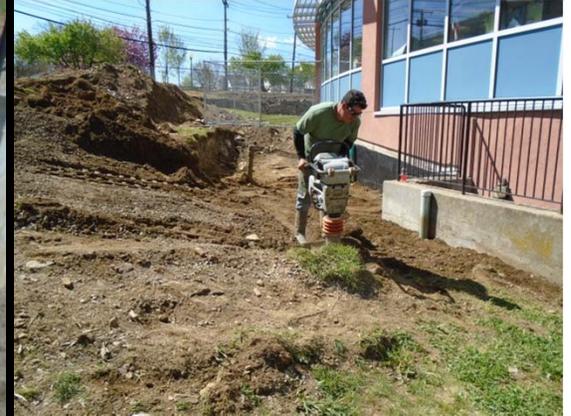
## DAY 5: FURTHER REPAIR

1. Applied hydraulic cement where foundation wall meets footing to cut-off water infiltration here.
2. Applied water proofing layer to the foundation wall and the footing.
3. New footing drain was covered with crushed stone; covered with 1 more layer of filter fabric. Then sand was placed atop the crushed stone to prevent pipe from backfill.
4. Back filled with existing earth. Took out large stones and debris.
5. Compacted soil with hand held compactor in lifts.

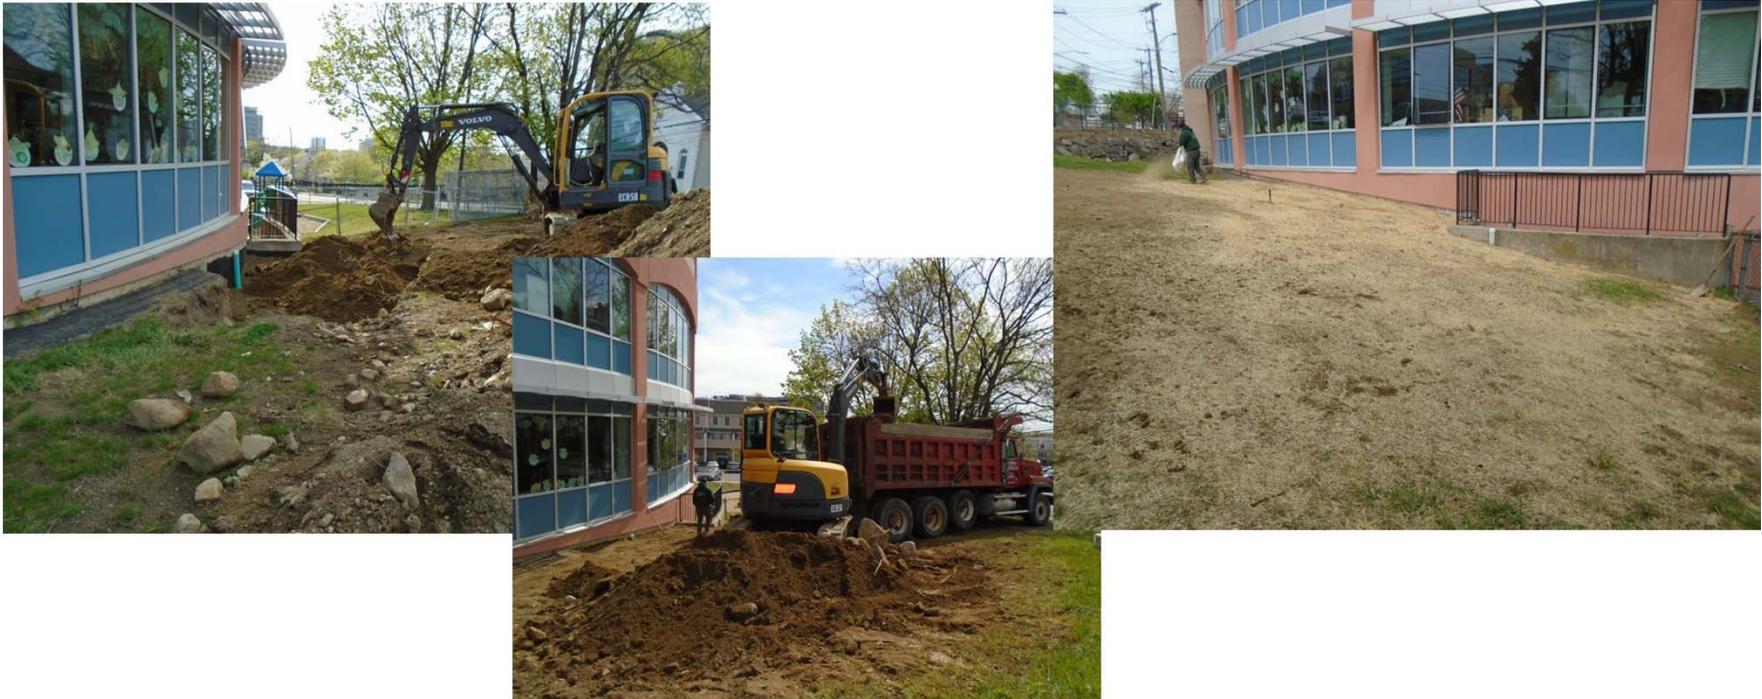
## DAY 6: BACK FILLING ENTIRE SITE & GRADING SOIL

1. Back filled entire site with excavated earth.
2. Compacted soil with compactor.
3. Trucked – off excess material.
4. Re-graded soil away from the building, creating a swale to divert rain water.
5. Re-seeded grass and hay was spread on top.
6. Asked Boys & Girls Club building manager to water the site for seed germination.

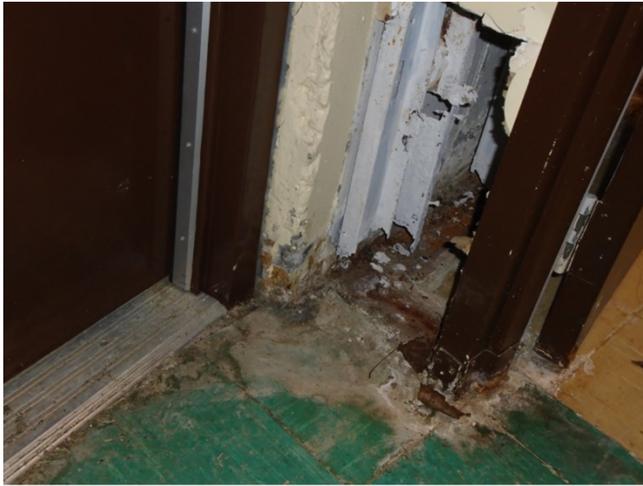
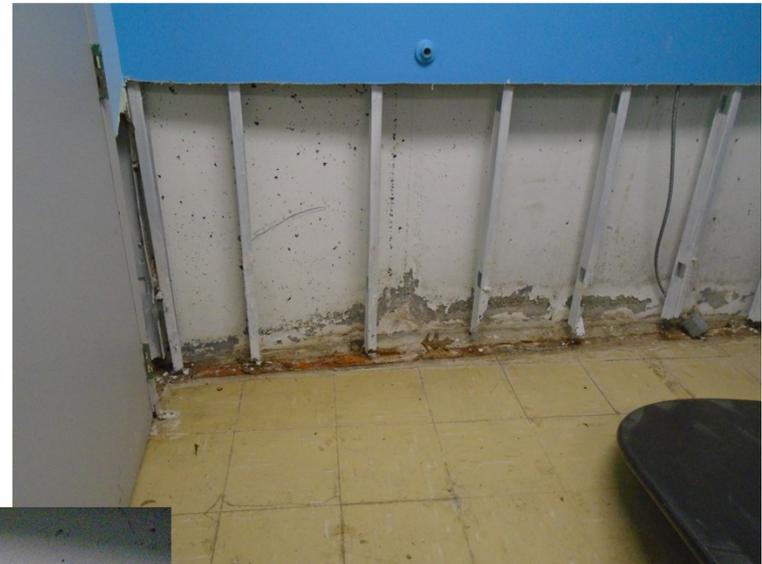
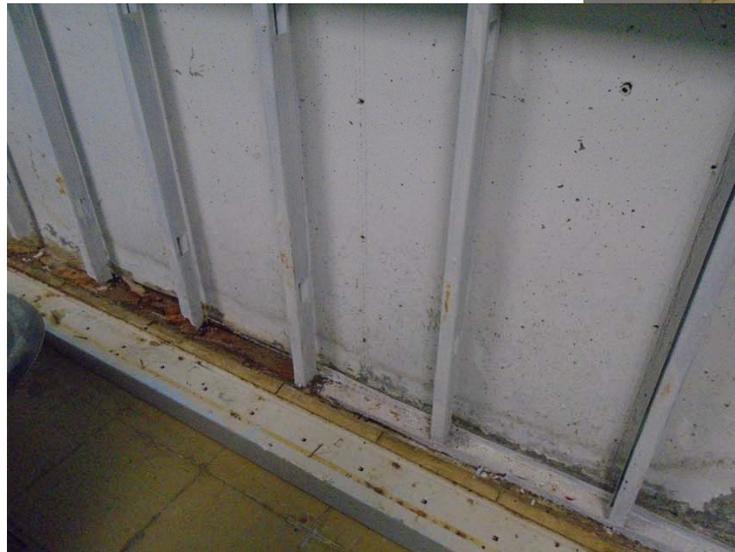
**INSPECTION FOLLOWING REMEDIATION DURING PERIODS OF PRECIPITATION ON 5/1 & 5/2 DRY INSIDE CONDITIONS**
