# **FIGURES**

**SCOFIELDTOWN PARK LANDFILL  
STAMFORD, CONNECTICUT**

**CITY OF STAMFORD**  
SCOFIELDTOWN PARK LANDFILL  
STAMFORD, CONNECTICUT

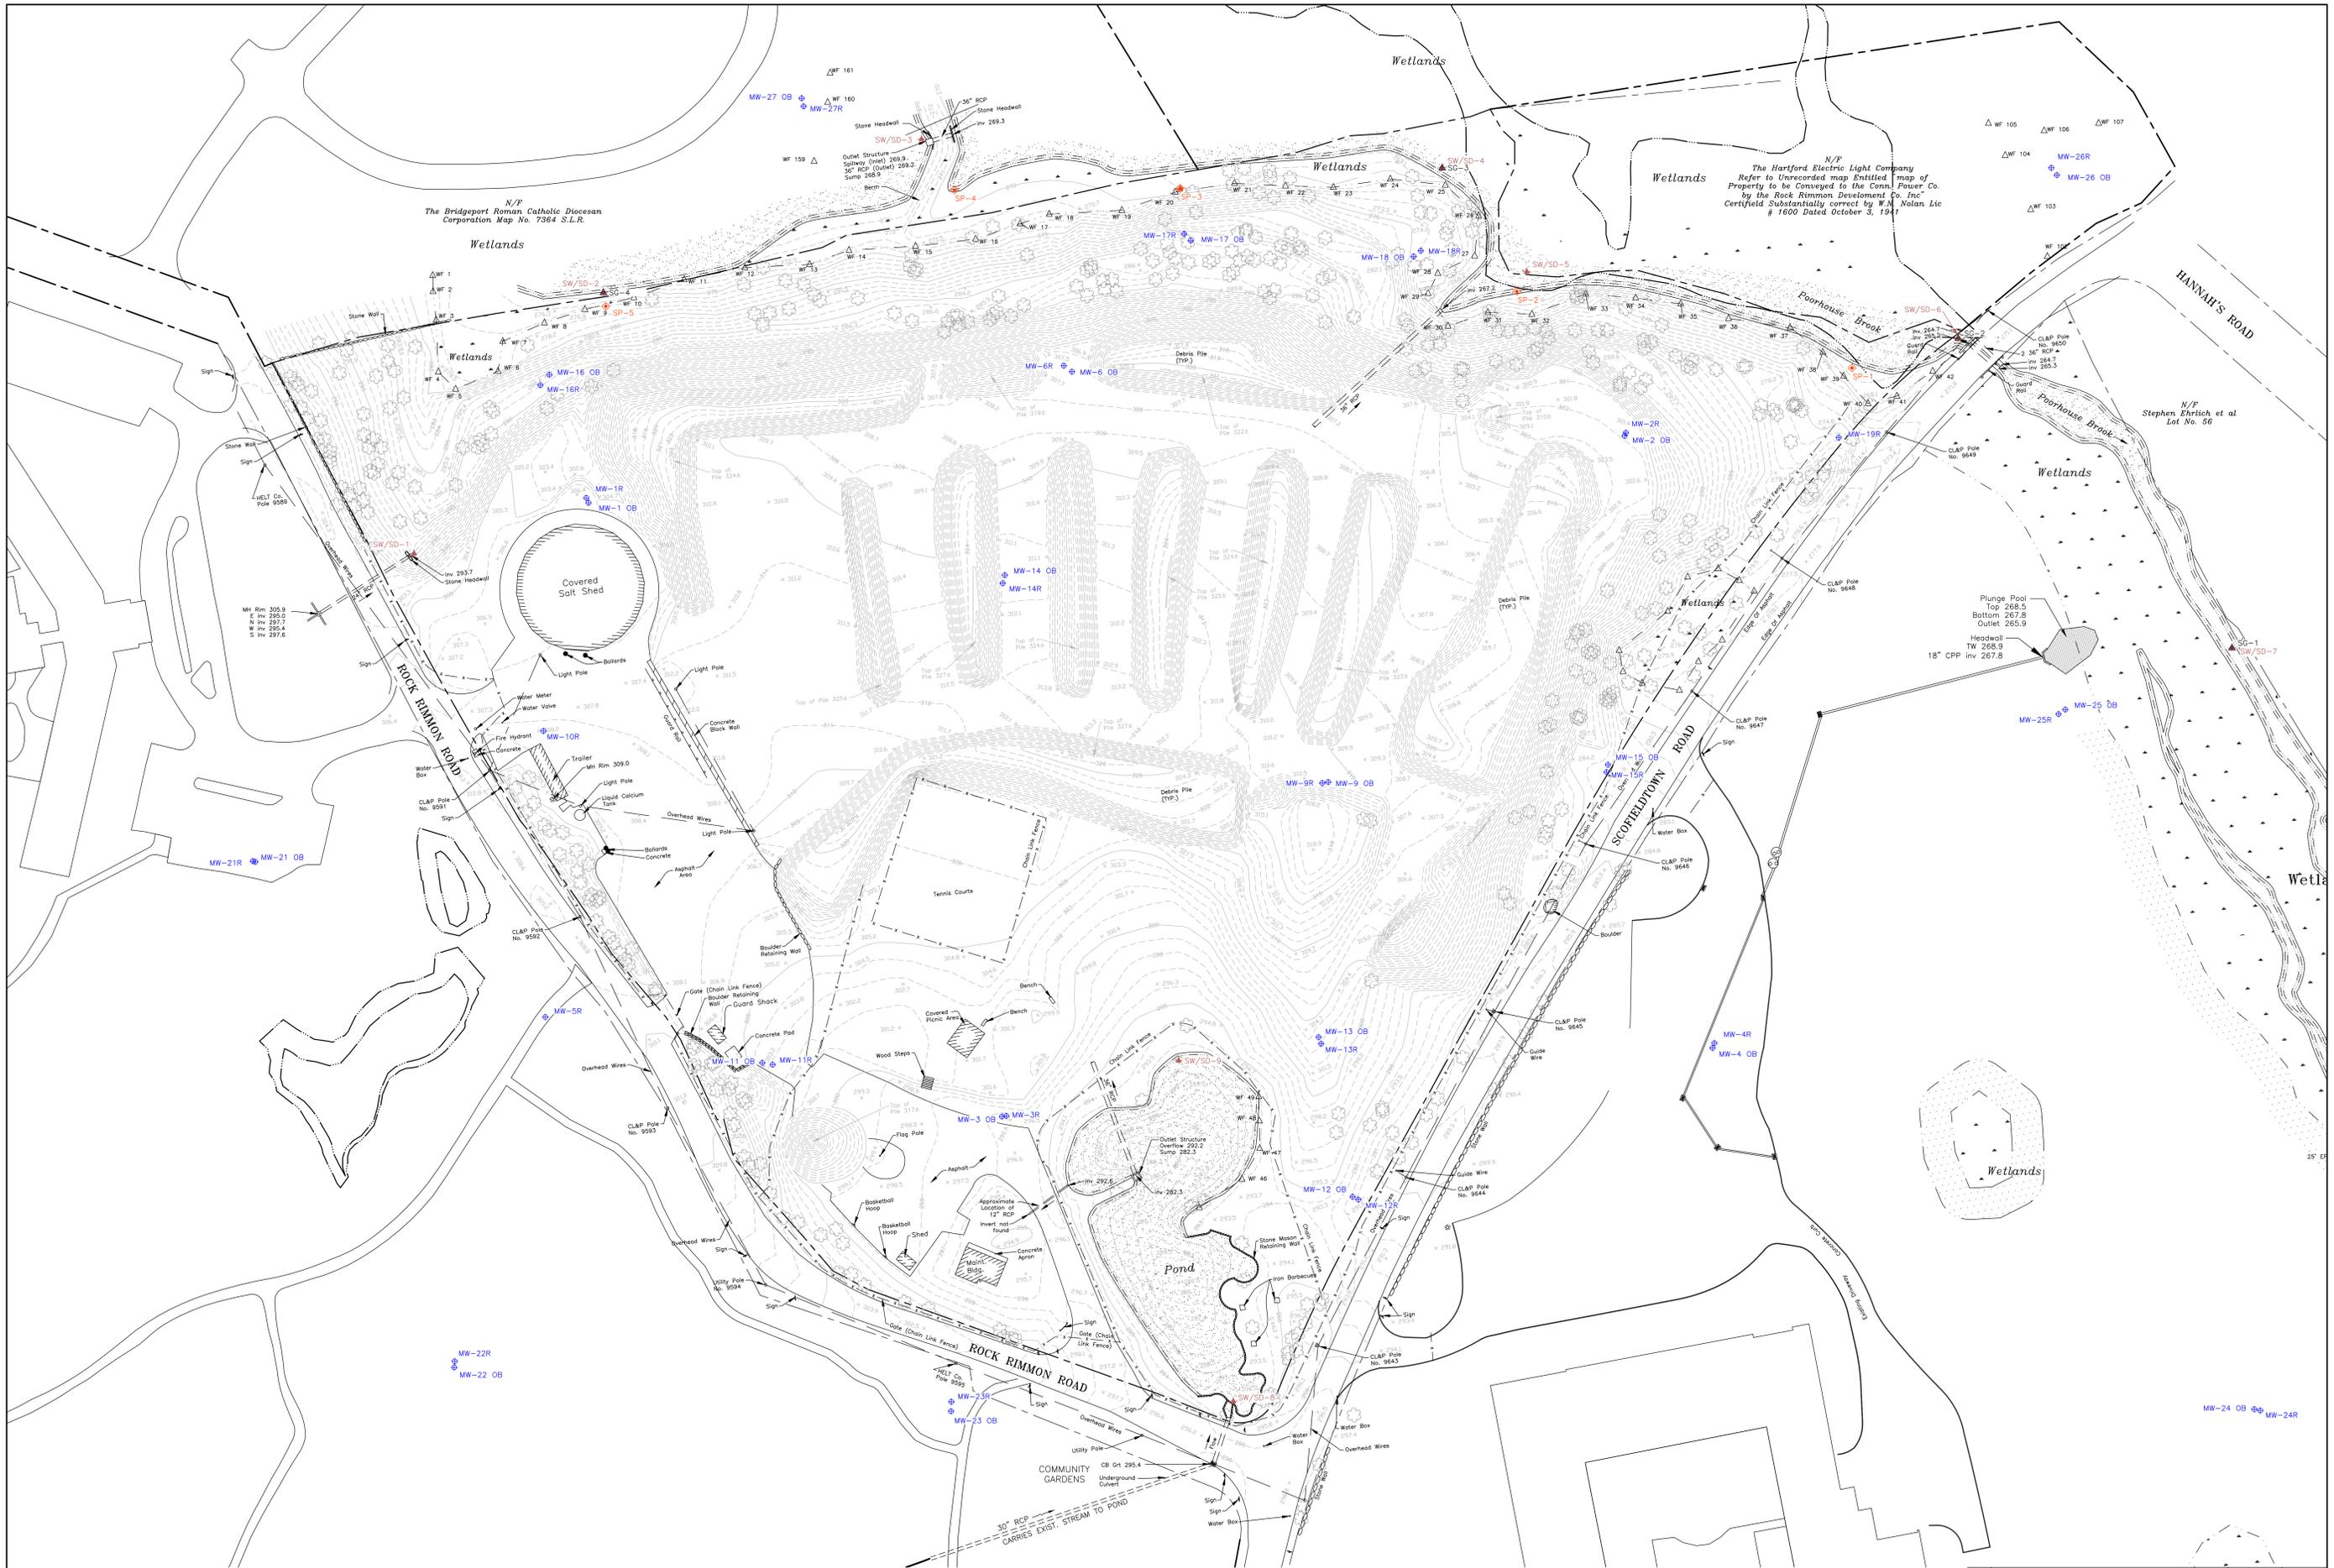
**SITE LAYOUT AND  
MONITORING WELL AND  
SAMPLE LOCATIONS**

- LEGEND**
- MW-1 MONITORING WELLS
  - SP-1 SEEP SAMPLE LOCATION
  - SW/SD-1 SURFACE WATER/SEDIMENT SAMPLE LOCATION

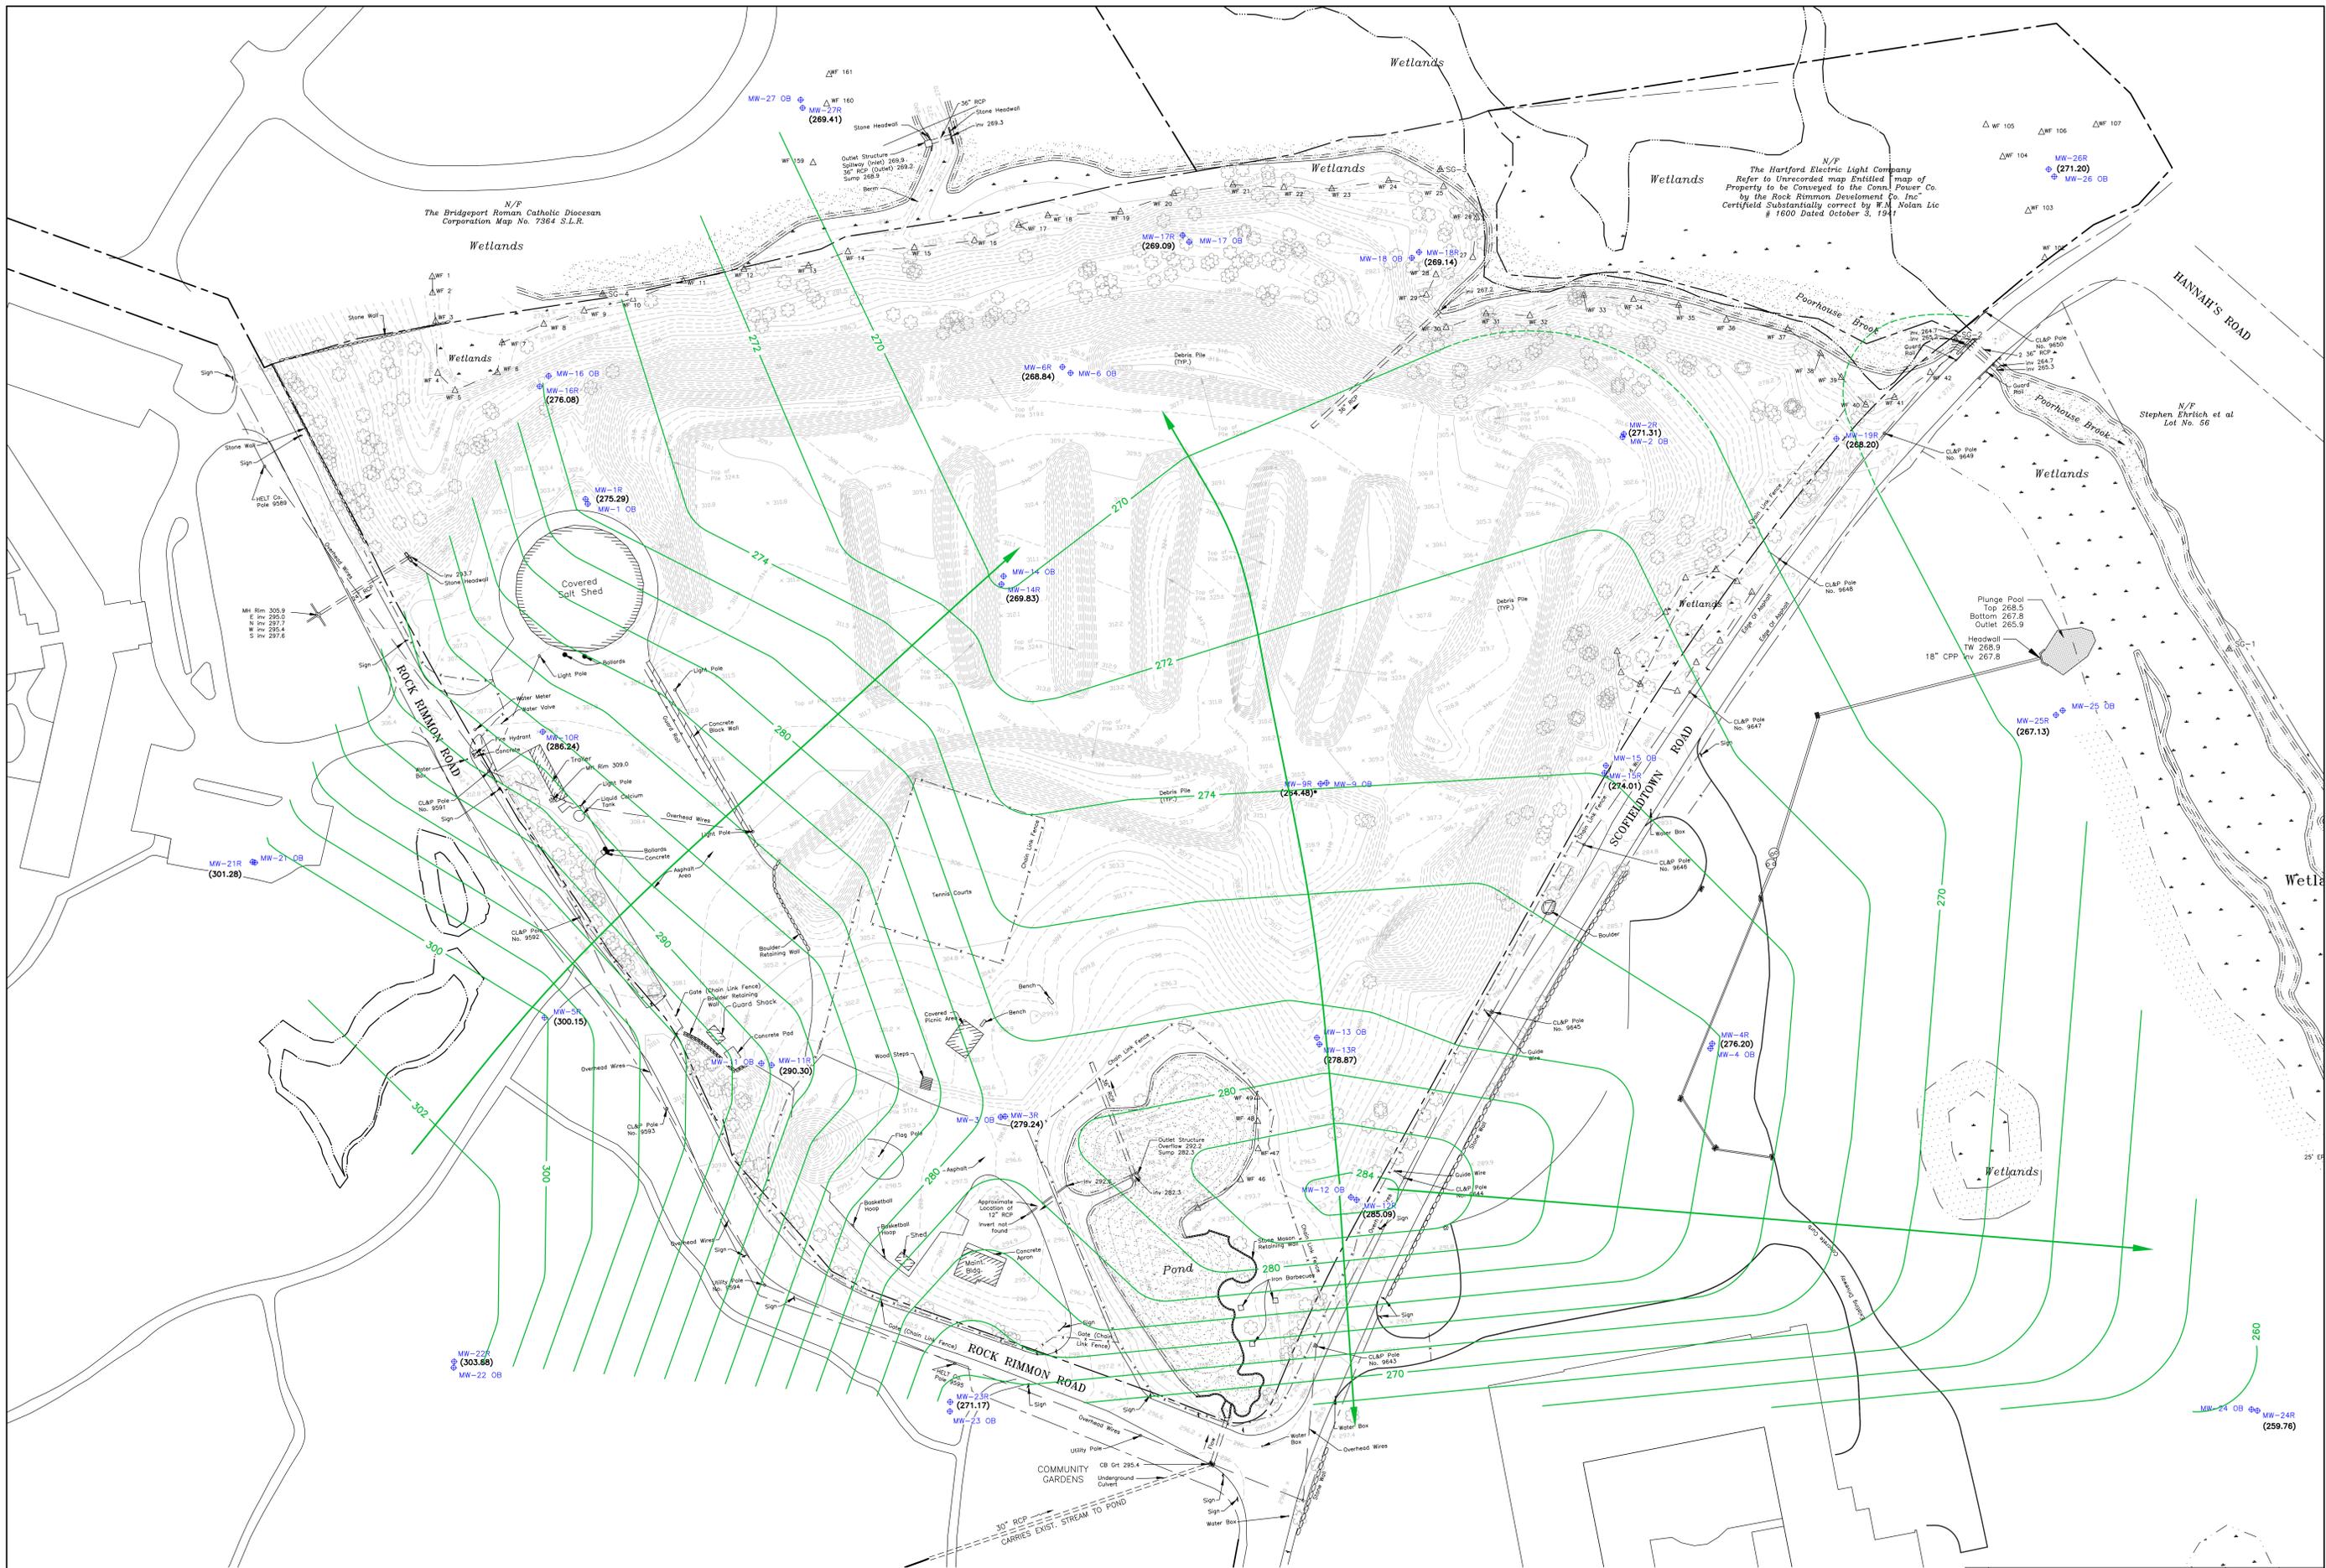
NOTE:  
AT PRESENT TIME, FOUR INSTALLED  
STREAM GAUGES ALONG THE UNNAMED  
BROOK AND POORHOUSE BROOK HAVE  
NOT BEEN SURVEYED AND THEREFORE  
HAVE NOT BEEN INCLUDED IN THE  
DEVELOPMENT OF THESE GROUND WATER  
FLOW CONTOURS.

SG-1	STREAM GAUGE
MW-1	MONITORING WELLS
(280.00)	GROUNDWATER ELEVATION IN WELL IN FEET ON MAY 16, 2012 BASED ON NAVD 88 DATUM
*	GROUNDWATER ELEVATION IN WELL NOT USED
-280-	GROUNDWATER ELEVATION CONTOUR IN FEET ON MAY 16, 2012 BASED ON NAVD 88 DATUM

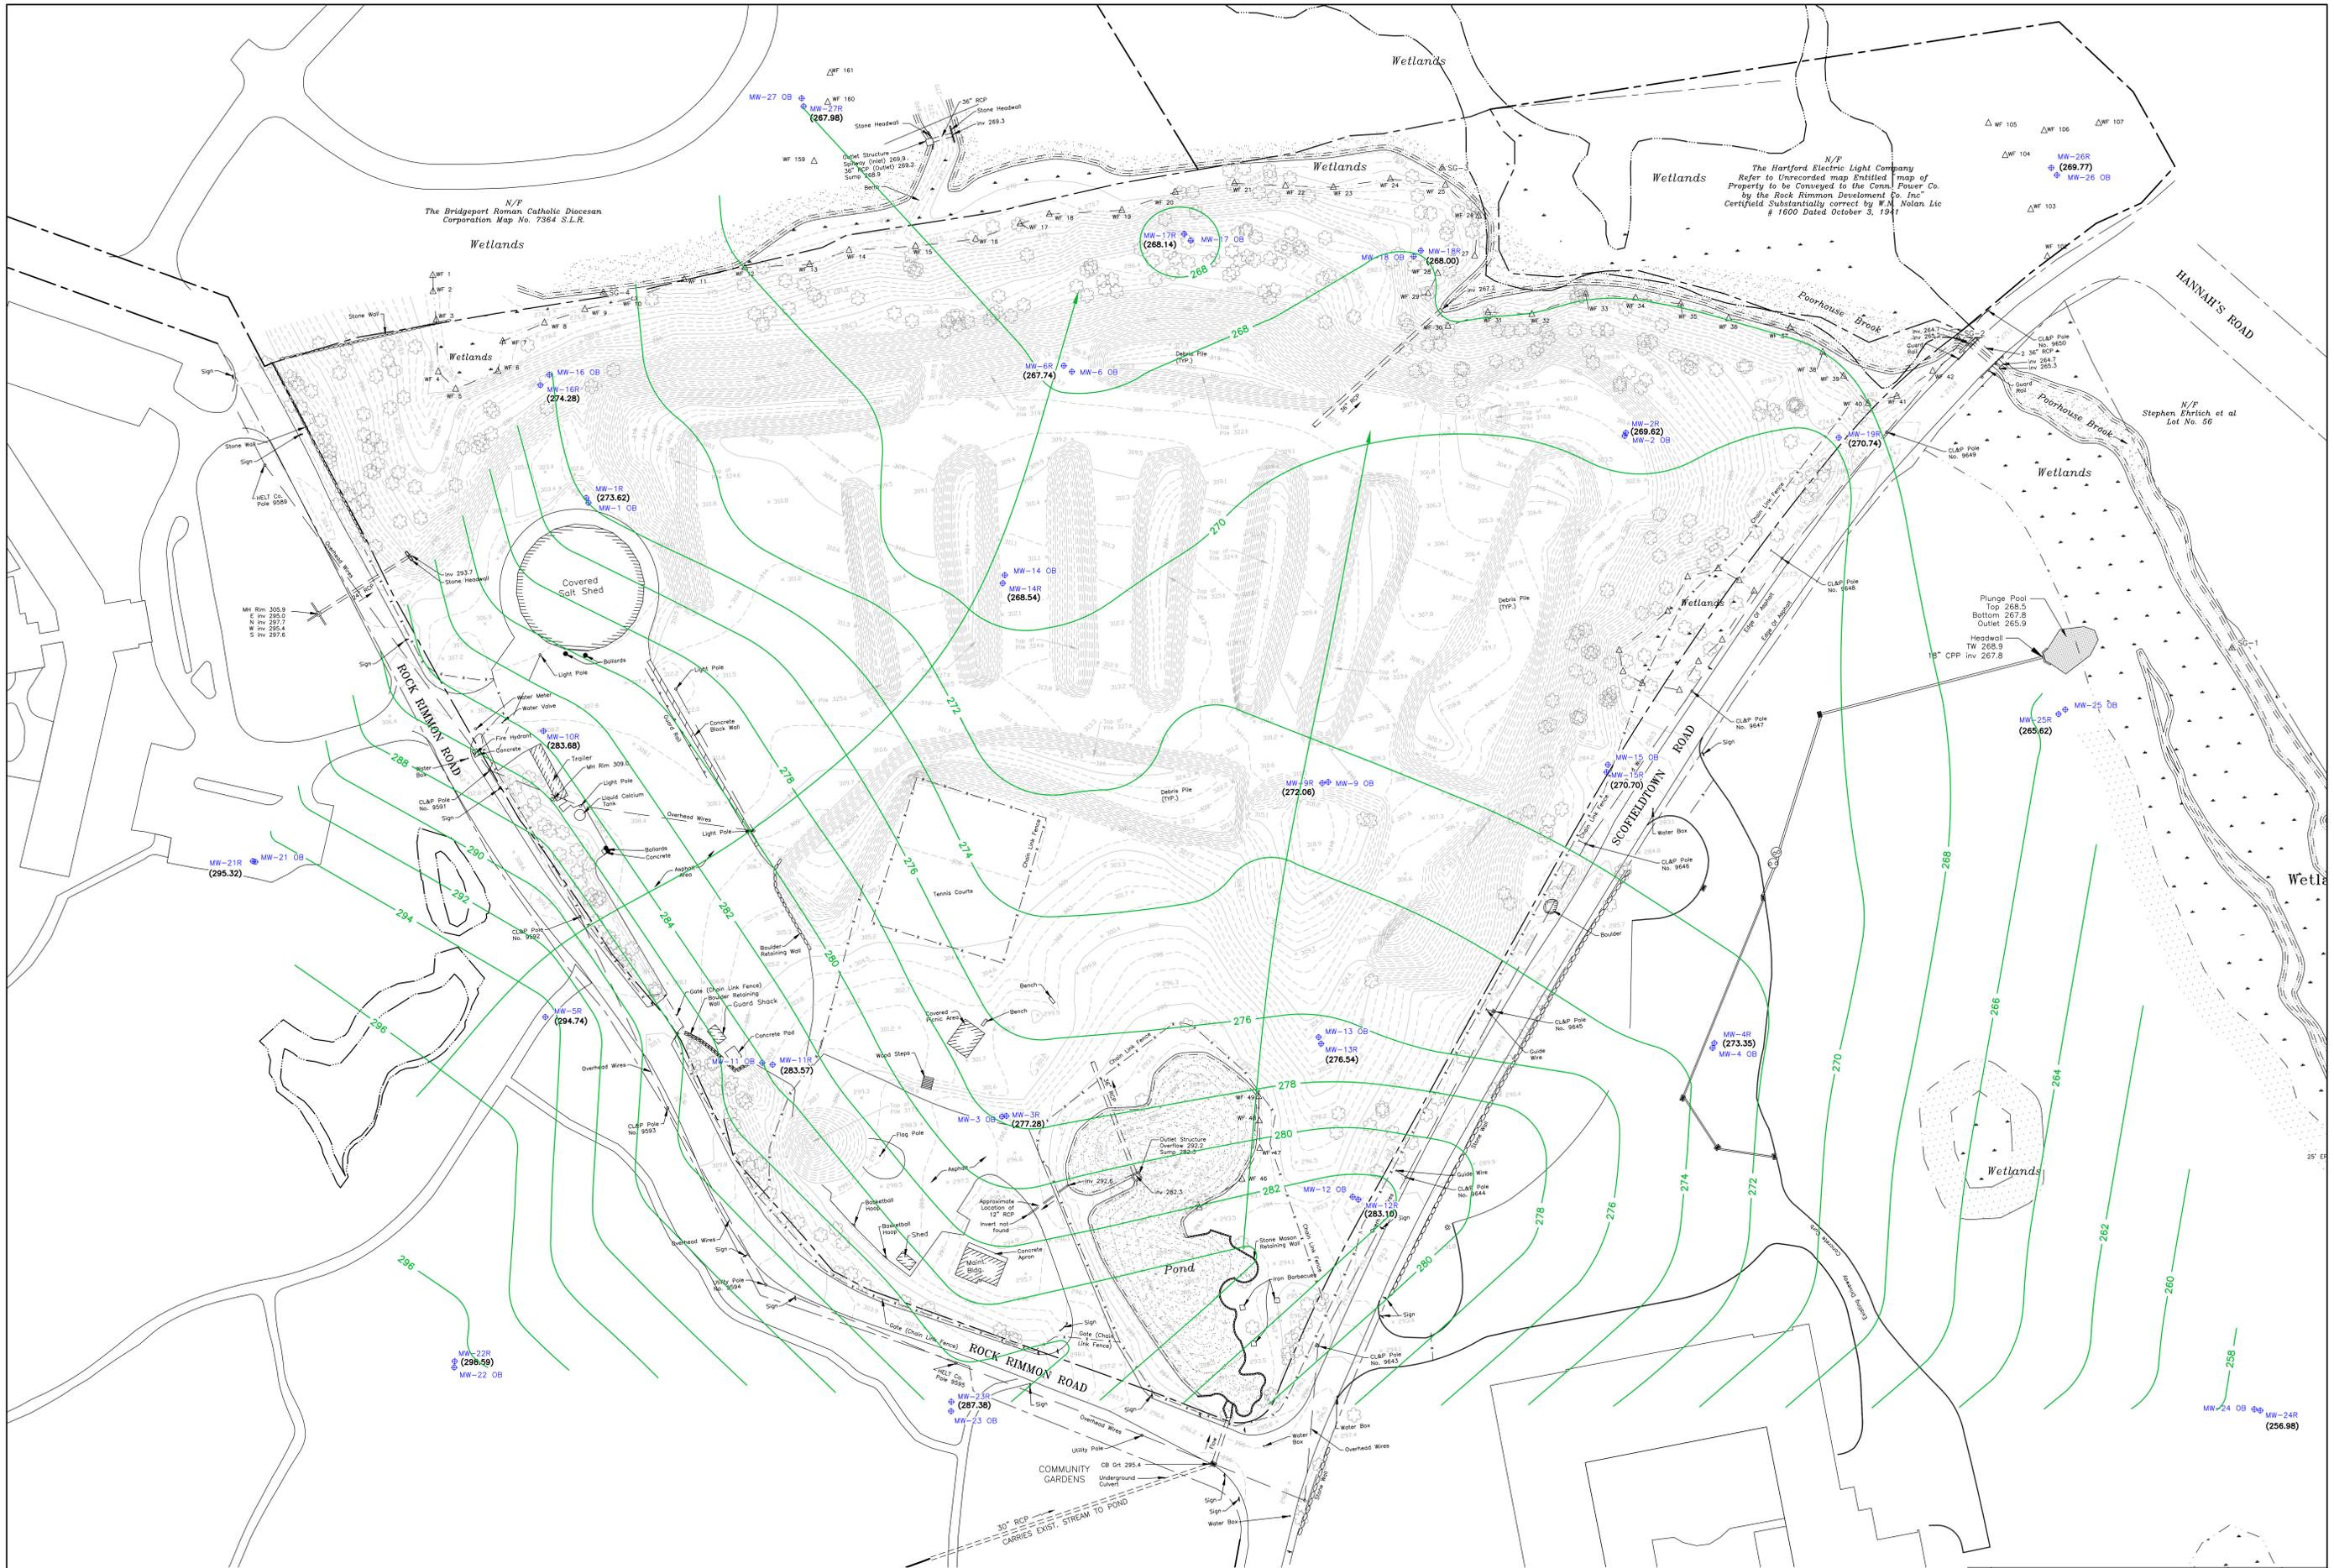
DESIGN: CC	12/11/12
DRAWN: KDH	12/11/12
CHECKED: CWS	12/11/12
SCALE: 1"=40'	
PROJECT: 181277-00007-0000	
FIGURE NO.	FIGURE 4

NOTE:  
AT PRESENT TIME, FOUR INSTALLED  
STREAM GAUGES ALONG THE UNNAMED  
BROOK AND POORHOUSE BROOK HAVE  
NOT BEEN SURVEYED AND THEREFORE  
HAVE NOT BEEN INCLUDED IN THE  
DEVELOPMENT OF THESE GROUND WATER  
FLOW CONTOURS.

- LEGEND**
- SG-1 STREAM GAUGE
  - MW-1 MONITORING WELLS
  - (280.00) GROUNDWATER ELEVATION IN WELL IN FEET ON AUGUST 28, 2012 BASED ON NAVD 88 DATUM
  - GROUNDWATER ELEVATION IN WELL NOT USED
  - 280 GROUNDWATER ELEVATION CONTOUR IN FEET ON AUGUST 28, 2012 BASED ON NAVD 88 DATUM

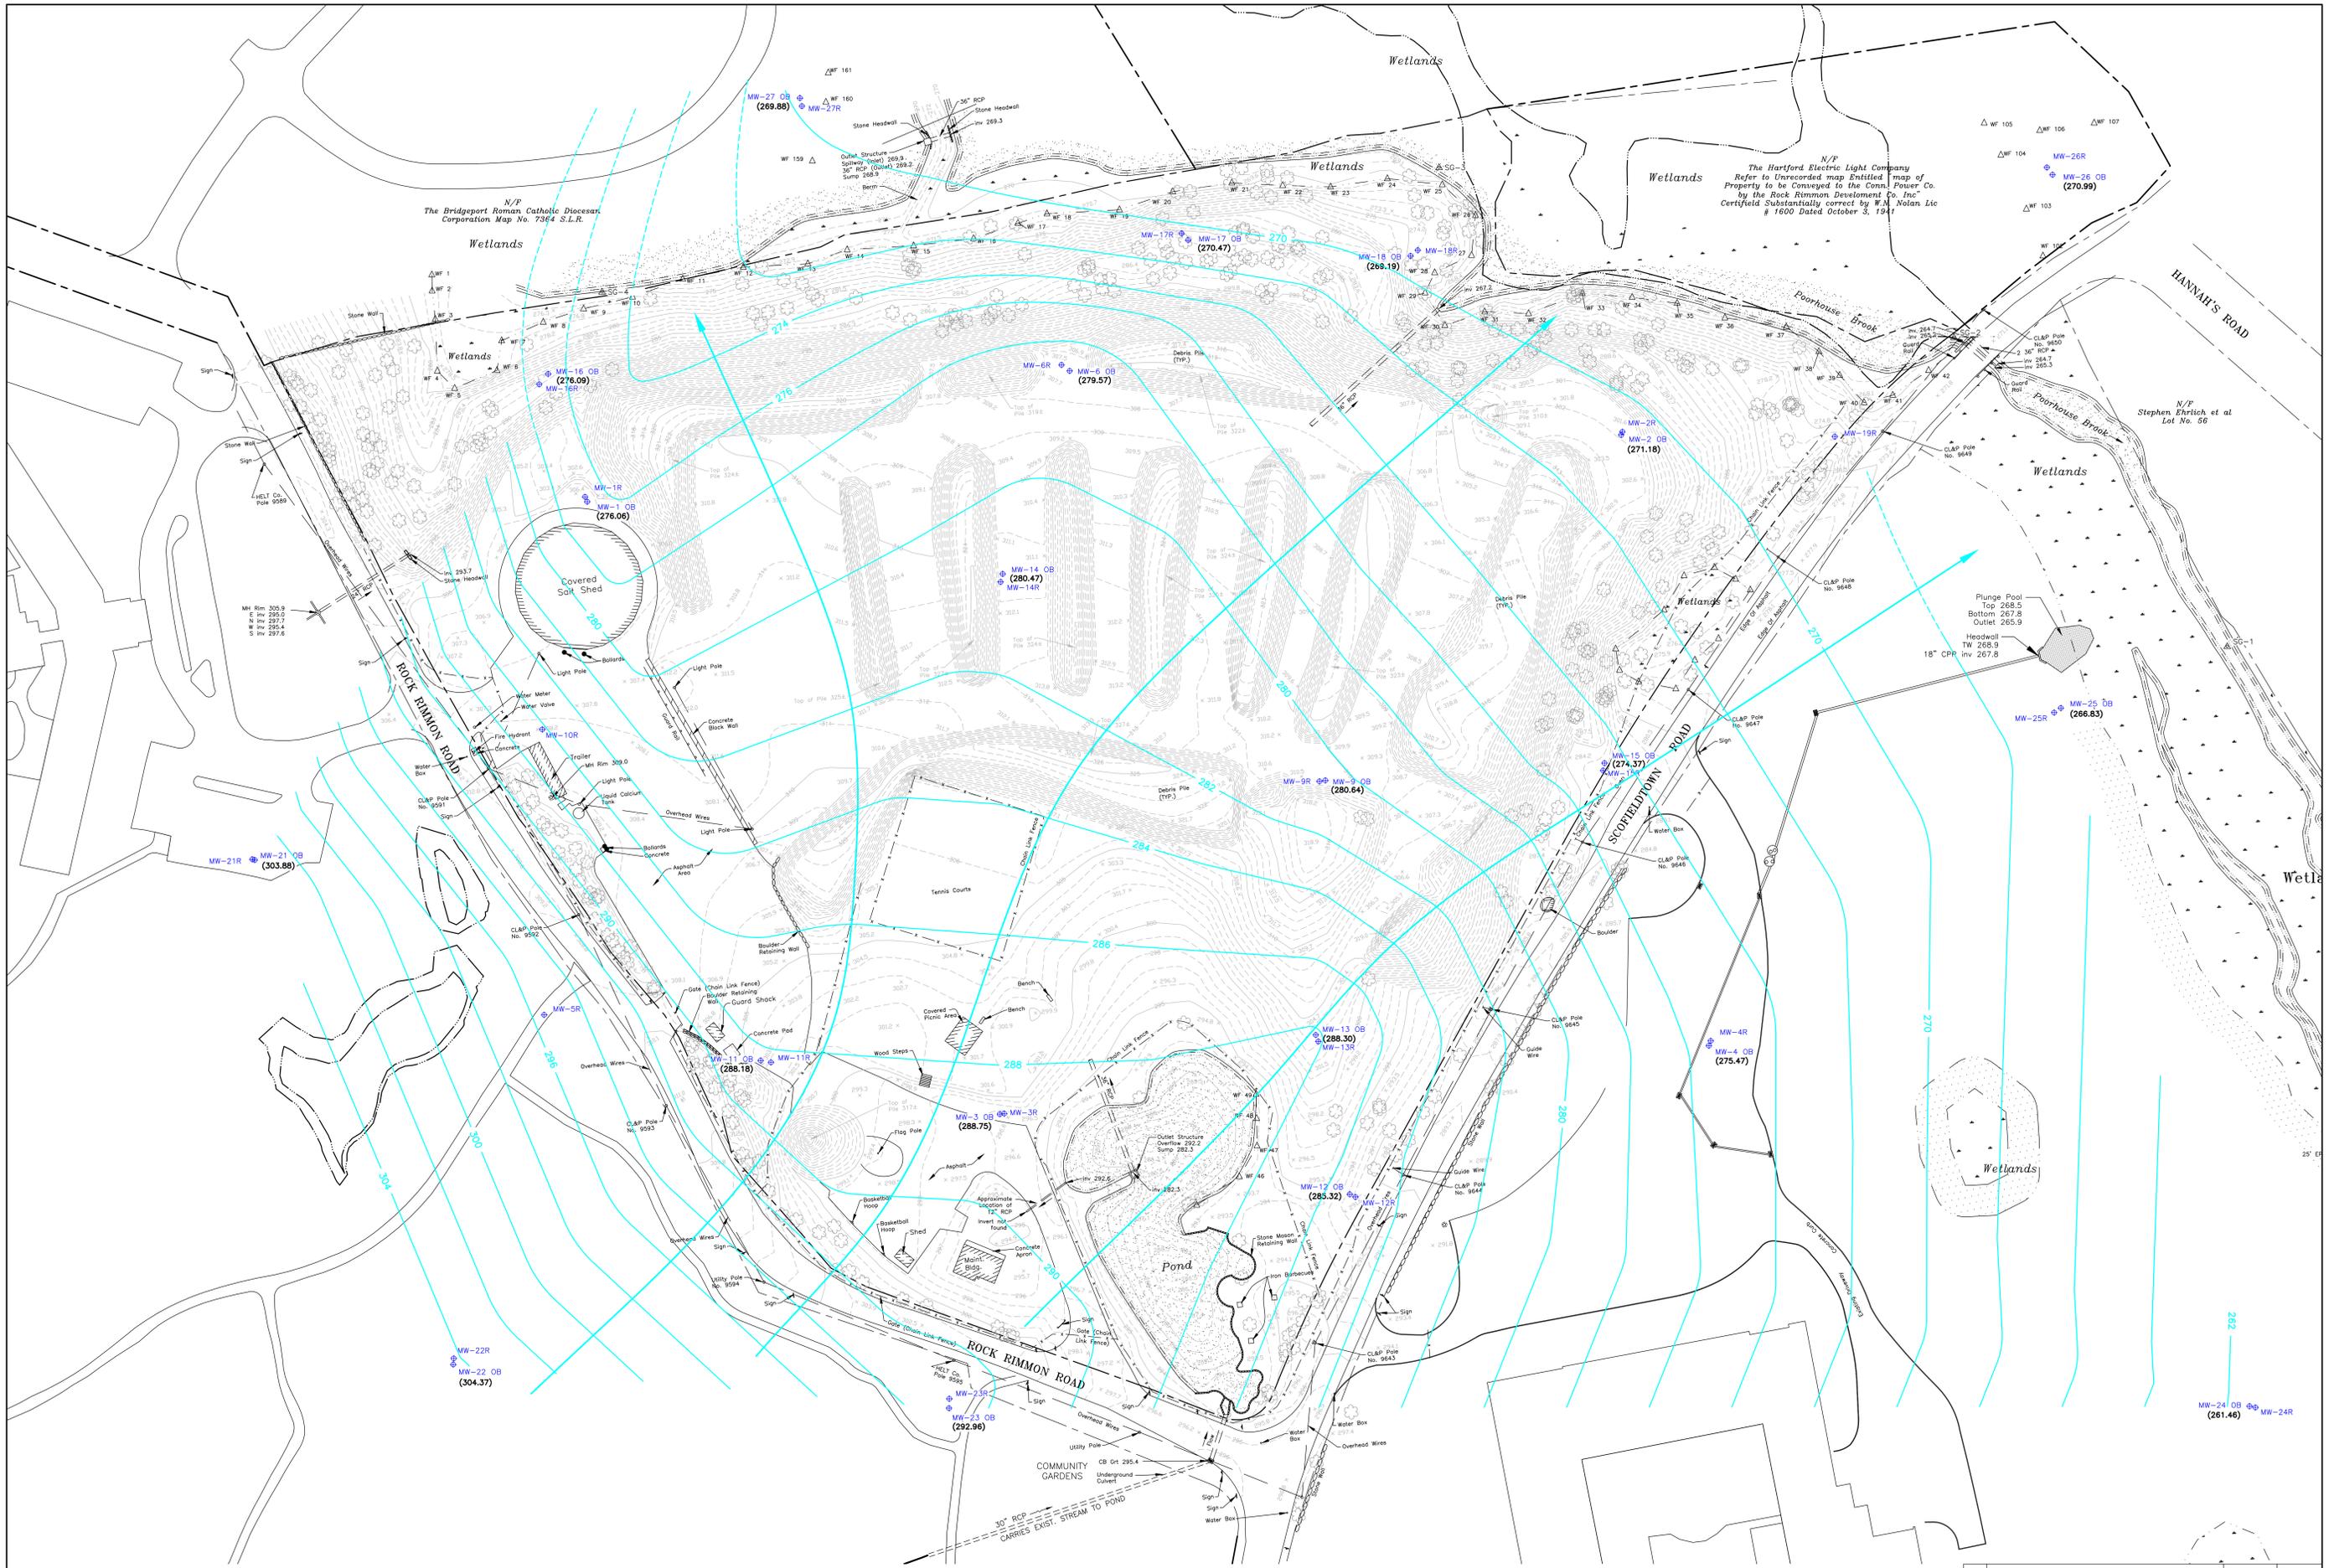
AT PRESENT TIME, FOUR INSTALLED  
STREAM GAUGES ALONG THE UNNAMED  
BROOK AND POORHOUSE BROOK HAVE  
NOT BEEN SURVEYED AND THEREFORE  
HAVE NOT BEEN INCLUDED IN THE  
DEVELOPMENT OF THESE GROUND WATER  
FLOW CONTOURS.

- SG-1 STREAM GAUGE
- MW-1 MONITORING WELLS
- (280.00) GROUNDWATER ELEVATION IN  
OVERBURDEN WELL IN FEET ON MAY  
16, 2012 BASED ON NAVD 88 DATUM
- 280 GROUNDWATER ELEVATION  
CONTOUR IN FEET ON MAY 16,  
2012 BASED ON NAVD 88 DATUM

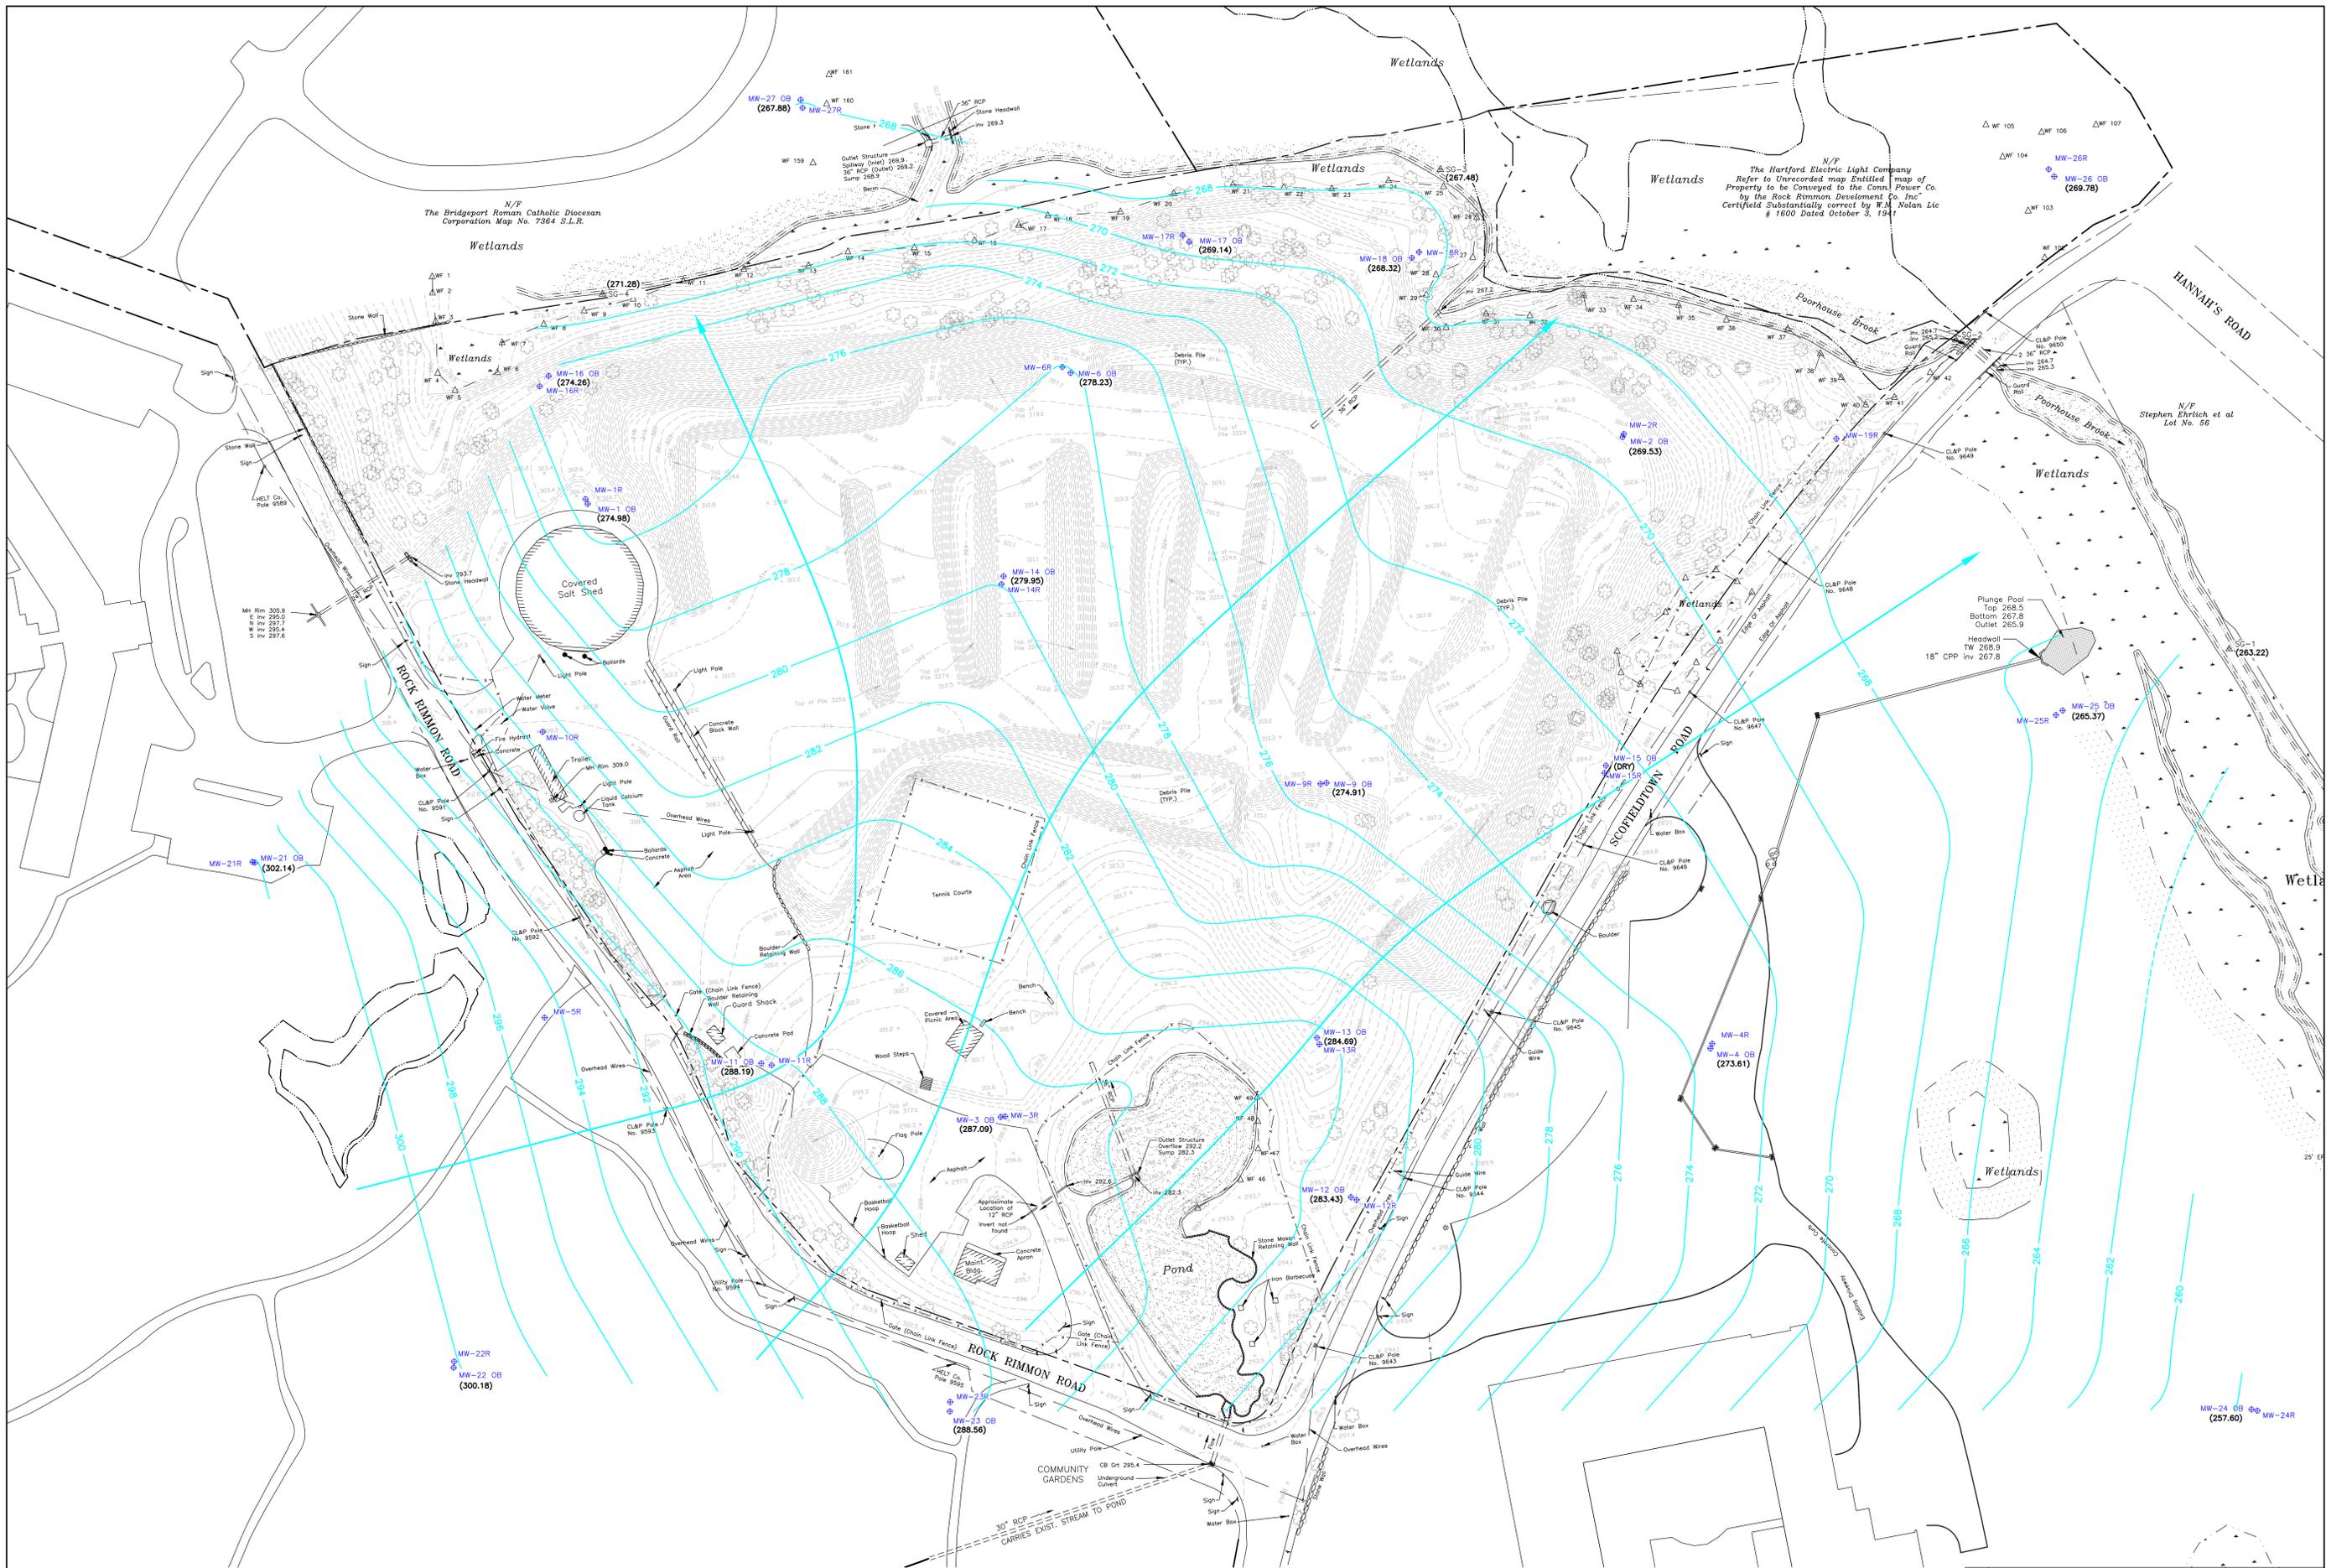
NOTE:  
AT PRESENT TIME, FOUR INSTALLED  
STREAM GAUGES ALONG THE UNNAMED  
BROOK AND POORHOUSE BROOK HAVE  
NOT BEEN SURVEYED AND THEREFORE  
HAVE NOT BEEN INCLUDED IN THE  
DEVELOPMENT OF THESE GROUND WATER  
FLOW CONTOURS.

SG-1 STREAM GAUGE  
MW-1 MONITORING WELLS  
 GROUNDWATER ELEVATION IN  
OVERBRIEN WELL IN FEET ON AUGUST  
28, 2012 BASED ON NAVD 88 DATUM  
 GROUNDWATER ELEVATION  
CONTOUR IN FEET ON AUGUST 28,  
2012 BASED ON NAVD 88 DATUM

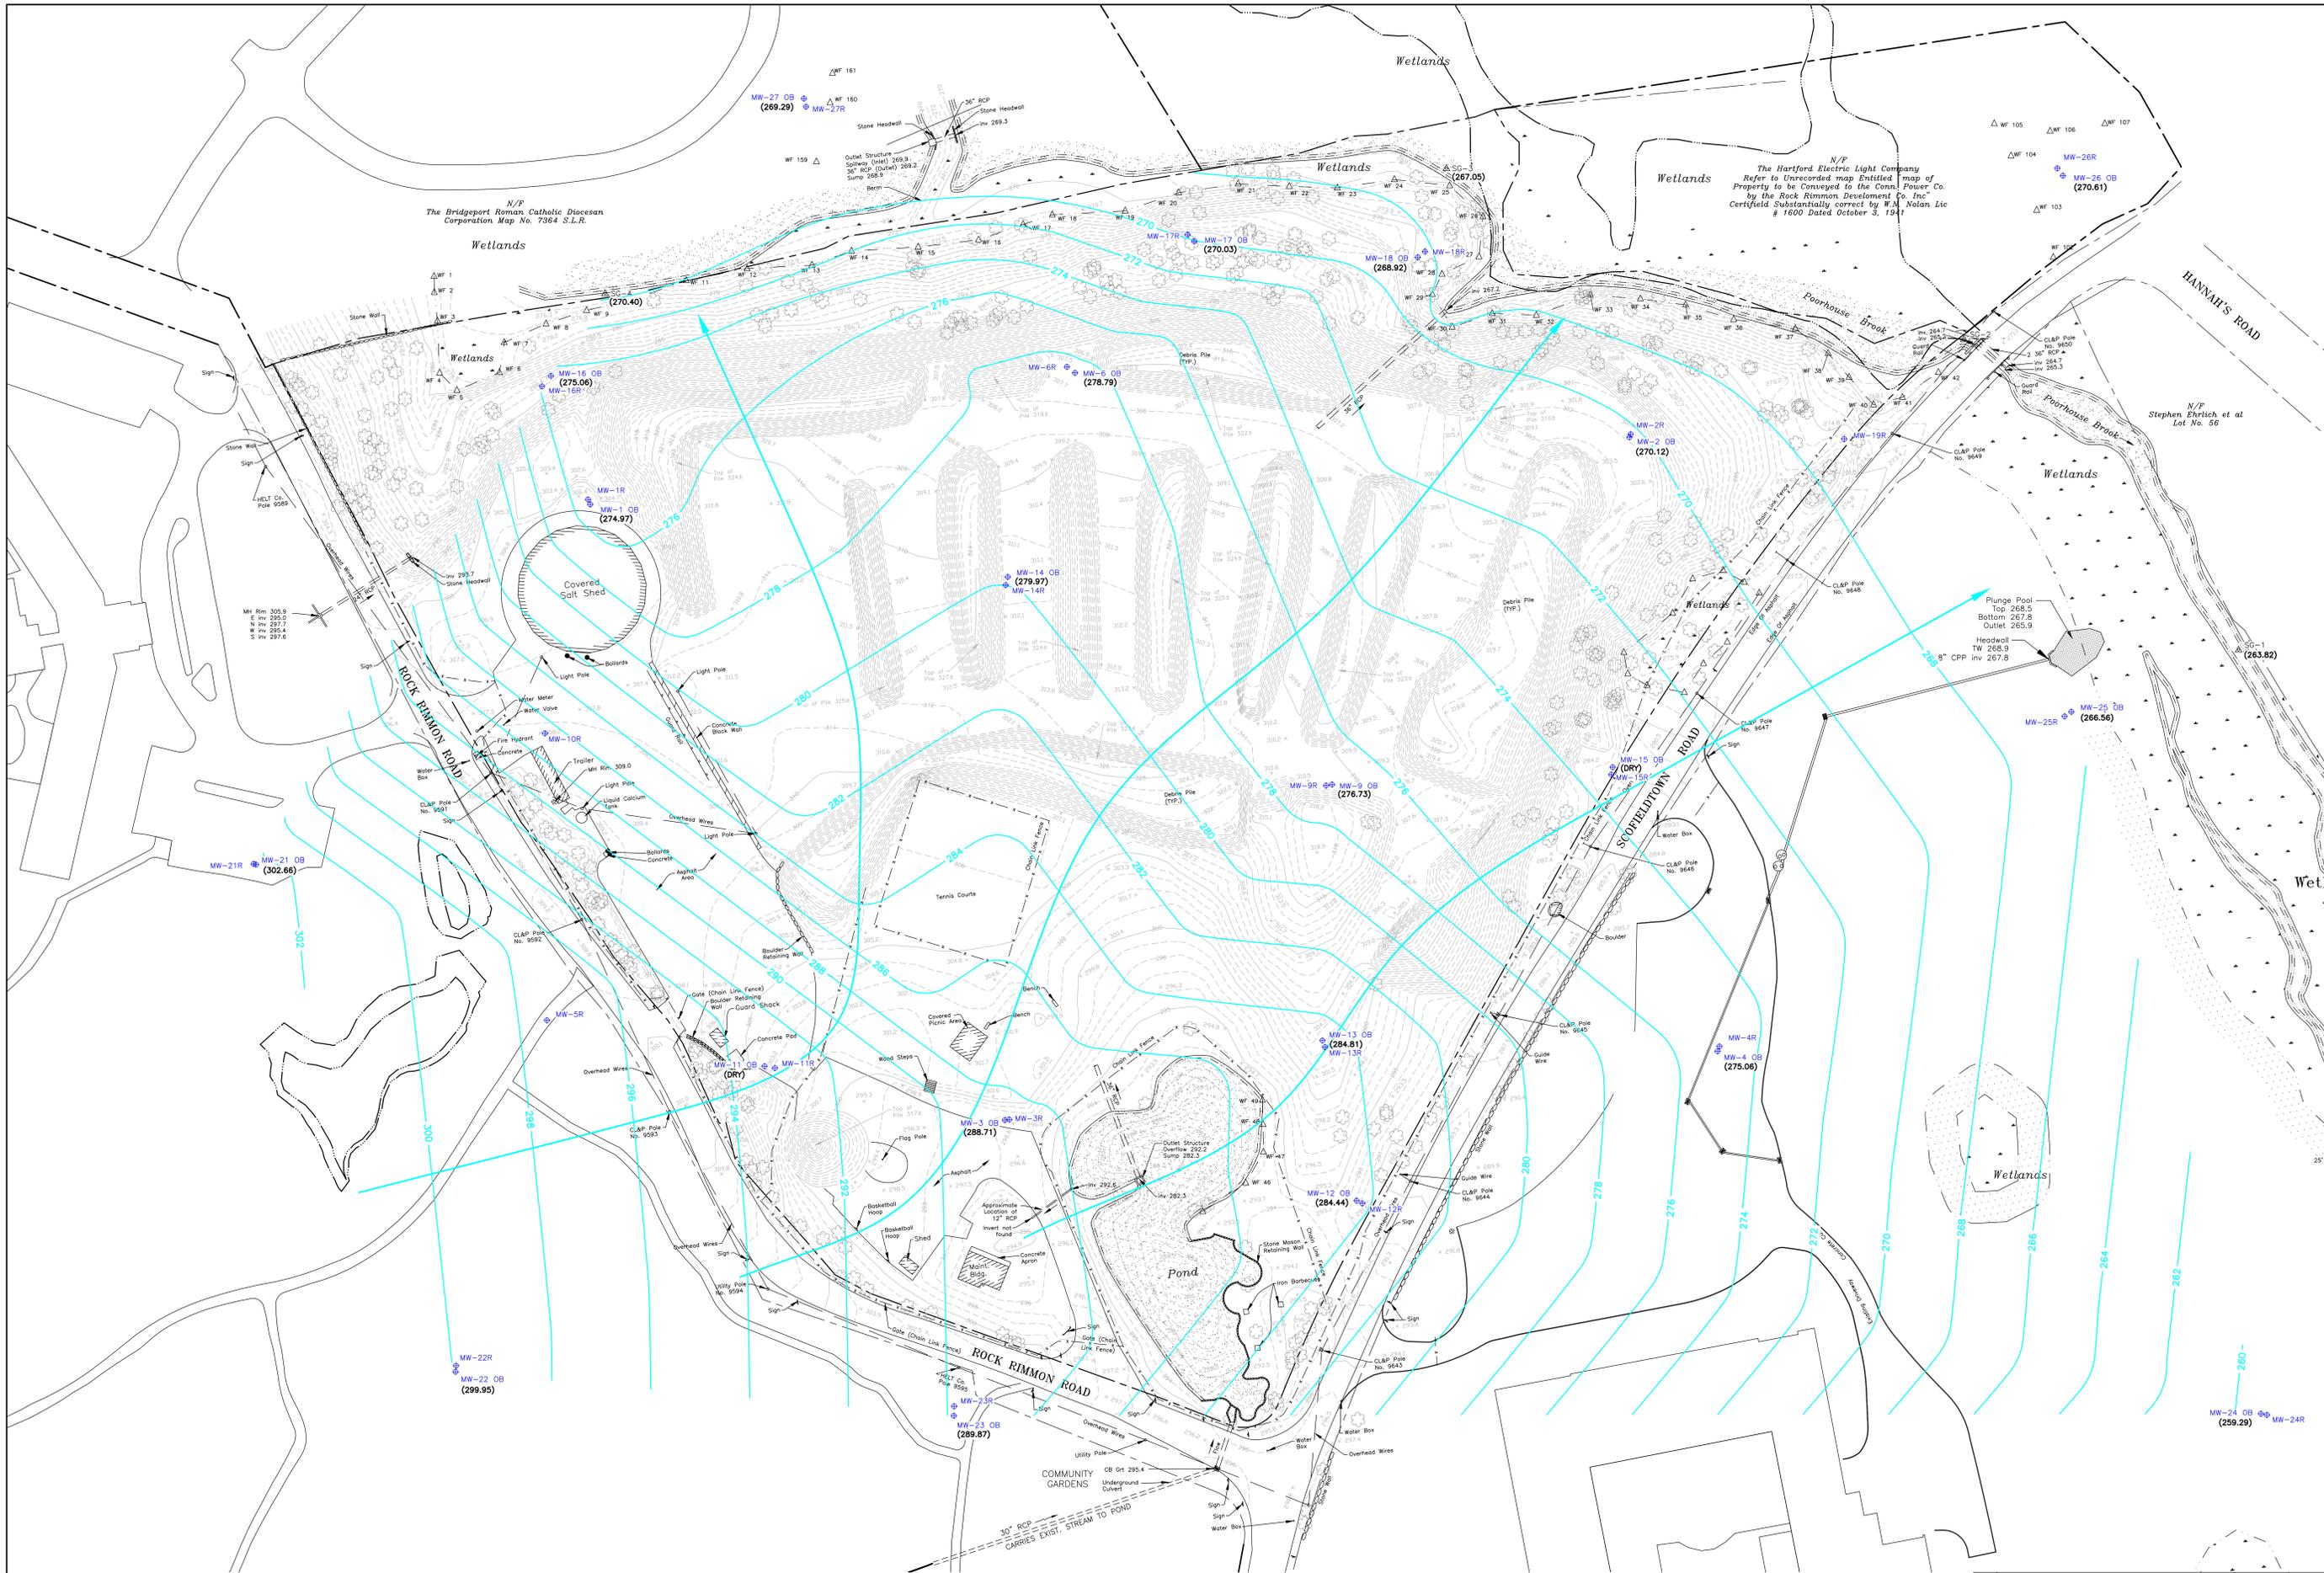
NOTE:  
AT PRESENT TIME, FOUR INSTALLED  
STREAM GAUGES ALONG THE UNNAMED  
BROOK AND POORHOUSE BROOK HAVE  
NOT BEEN SURVEYED AND THEREFORE  
HAVE NOT BEEN INCLUDED IN THE  
DEVELOPMENT OF THESE GROUND WATER  
FLOW CONTOURS.

- SG-1 STREAM GAUGE
- MW-1 MONITORING WELLS
- (280.00) GROUNDWATER ELEVATION IN OVERBURDEN  
WELL IN FEET ON NOVEMBER 5, 2012  
BASED ON NAVD 88 DATUM
- 280 GROUNDWATER ELEVATION CONTOUR IN  
FEET ON NOVEMBER 5, 2012 BASED  
ON NAVD 88 DATUM
