# **FIGURES**

**SCOFIELDTOWN PARK LANDFILL  
STAMFORD, CONNECTICUT**

**CITY OF STAMFORD**  
SCOFIELDTOWN PARK LANDFILL  
STAMFORD, CONNECTICUT

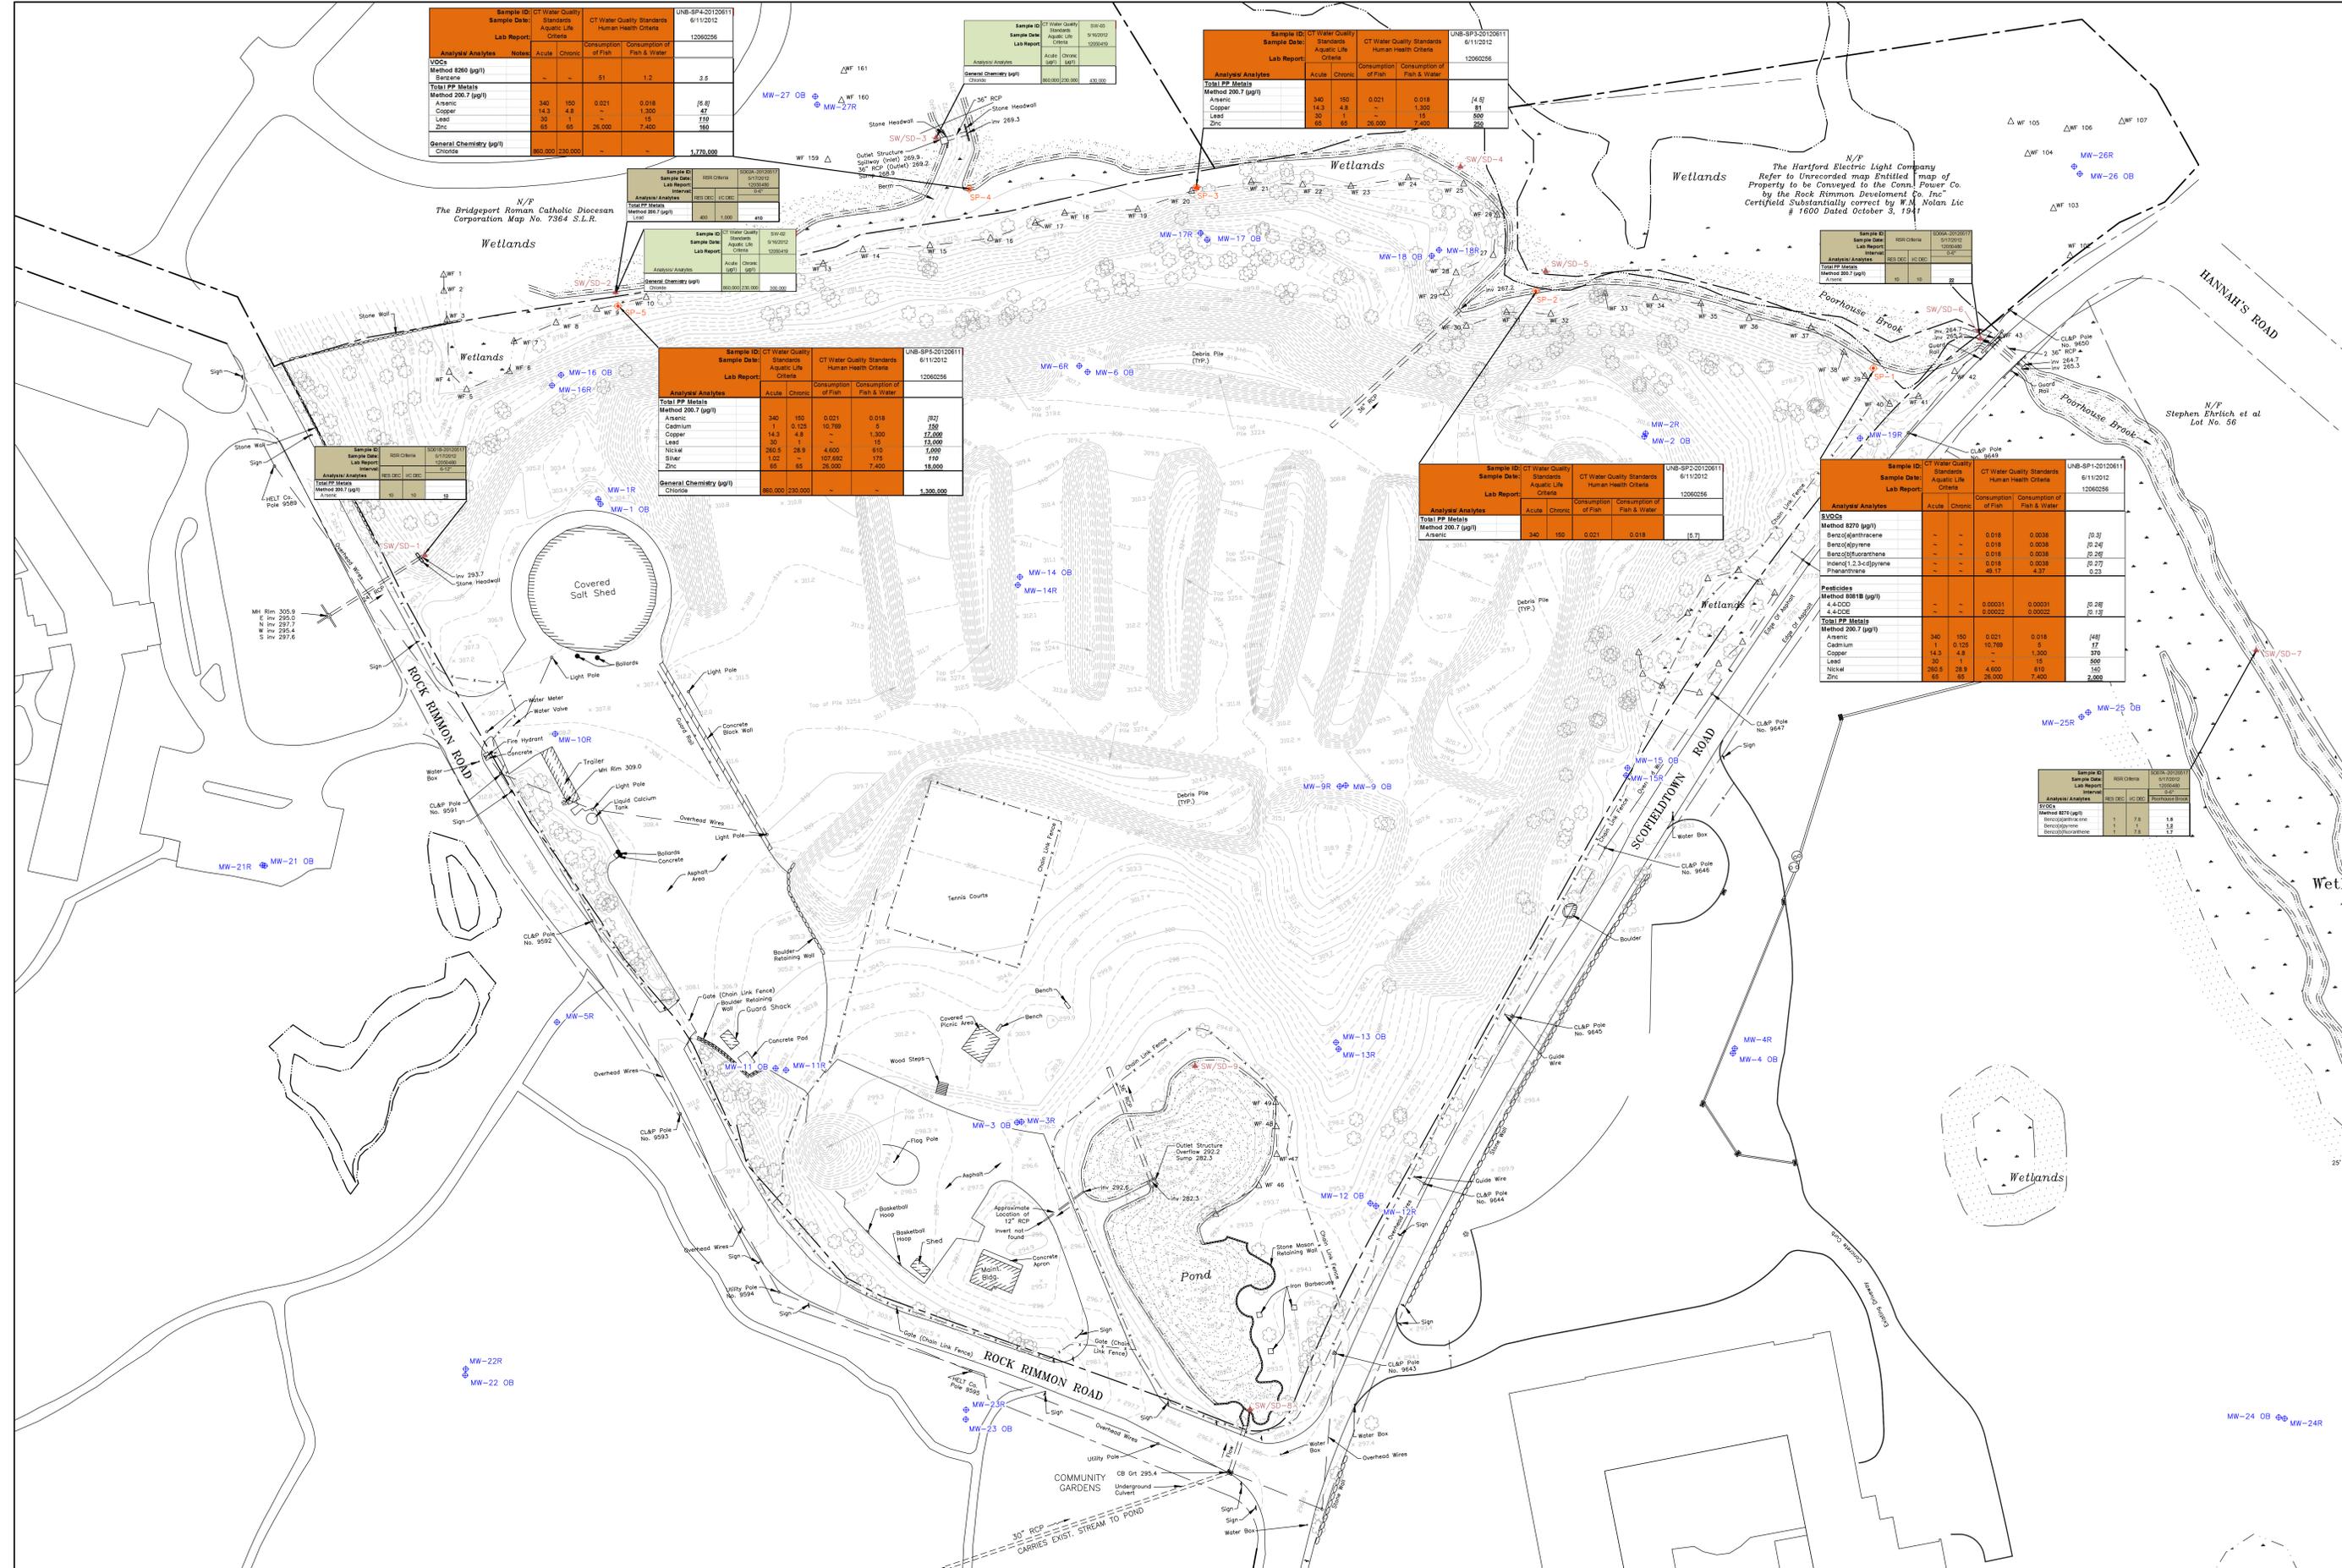
DESIGN: CC 07/12/12  
DRAWN: KDH 07/12/12  
CHECKED: ONS 07/12/12  
SCALE: 1"=40'  
PROJECT: 181277-00007-0000  
FIGURE NO.  
**FIGURE 15**

Sample ID	CT Water Quality Standards	Aquatic Life Criteria	Human Health Criteria	Consumption of Fish & Water
UNB-SP-20120611	6/11/2012	12060256		
Sample Date	6/11/2012	12060256		
Lab Report				
Analysis Analytes	Acute	Chronic	Consumption of Fish & Water	Consumption of Fish & Water
Method 8260 (µg/l)	-	-	51	1.2
Method 200.7 (µg/l)	-	-	-	3.5
Total PP Metals				
Arsenic	340	150	0.021	0.018
Cadmium	1	0.028	10,789	5
Copper	14.3	4.8	-	1,300
Lead	30	1	15	1,000
Nickel	260.2	28.8	4,600	610
Silver	1.02	-	107,652	175
Zinc	65	65	25,000	7,400
General Chemistry (µg/l)				
Chloride	860,000	230,000	-	-
				1,770,000

**FIRST QUARTER:**  
**SEEP AND SURFACE**  
**WATER/SEDIMENT SAMPLE**  
**EXCEEDANCES**

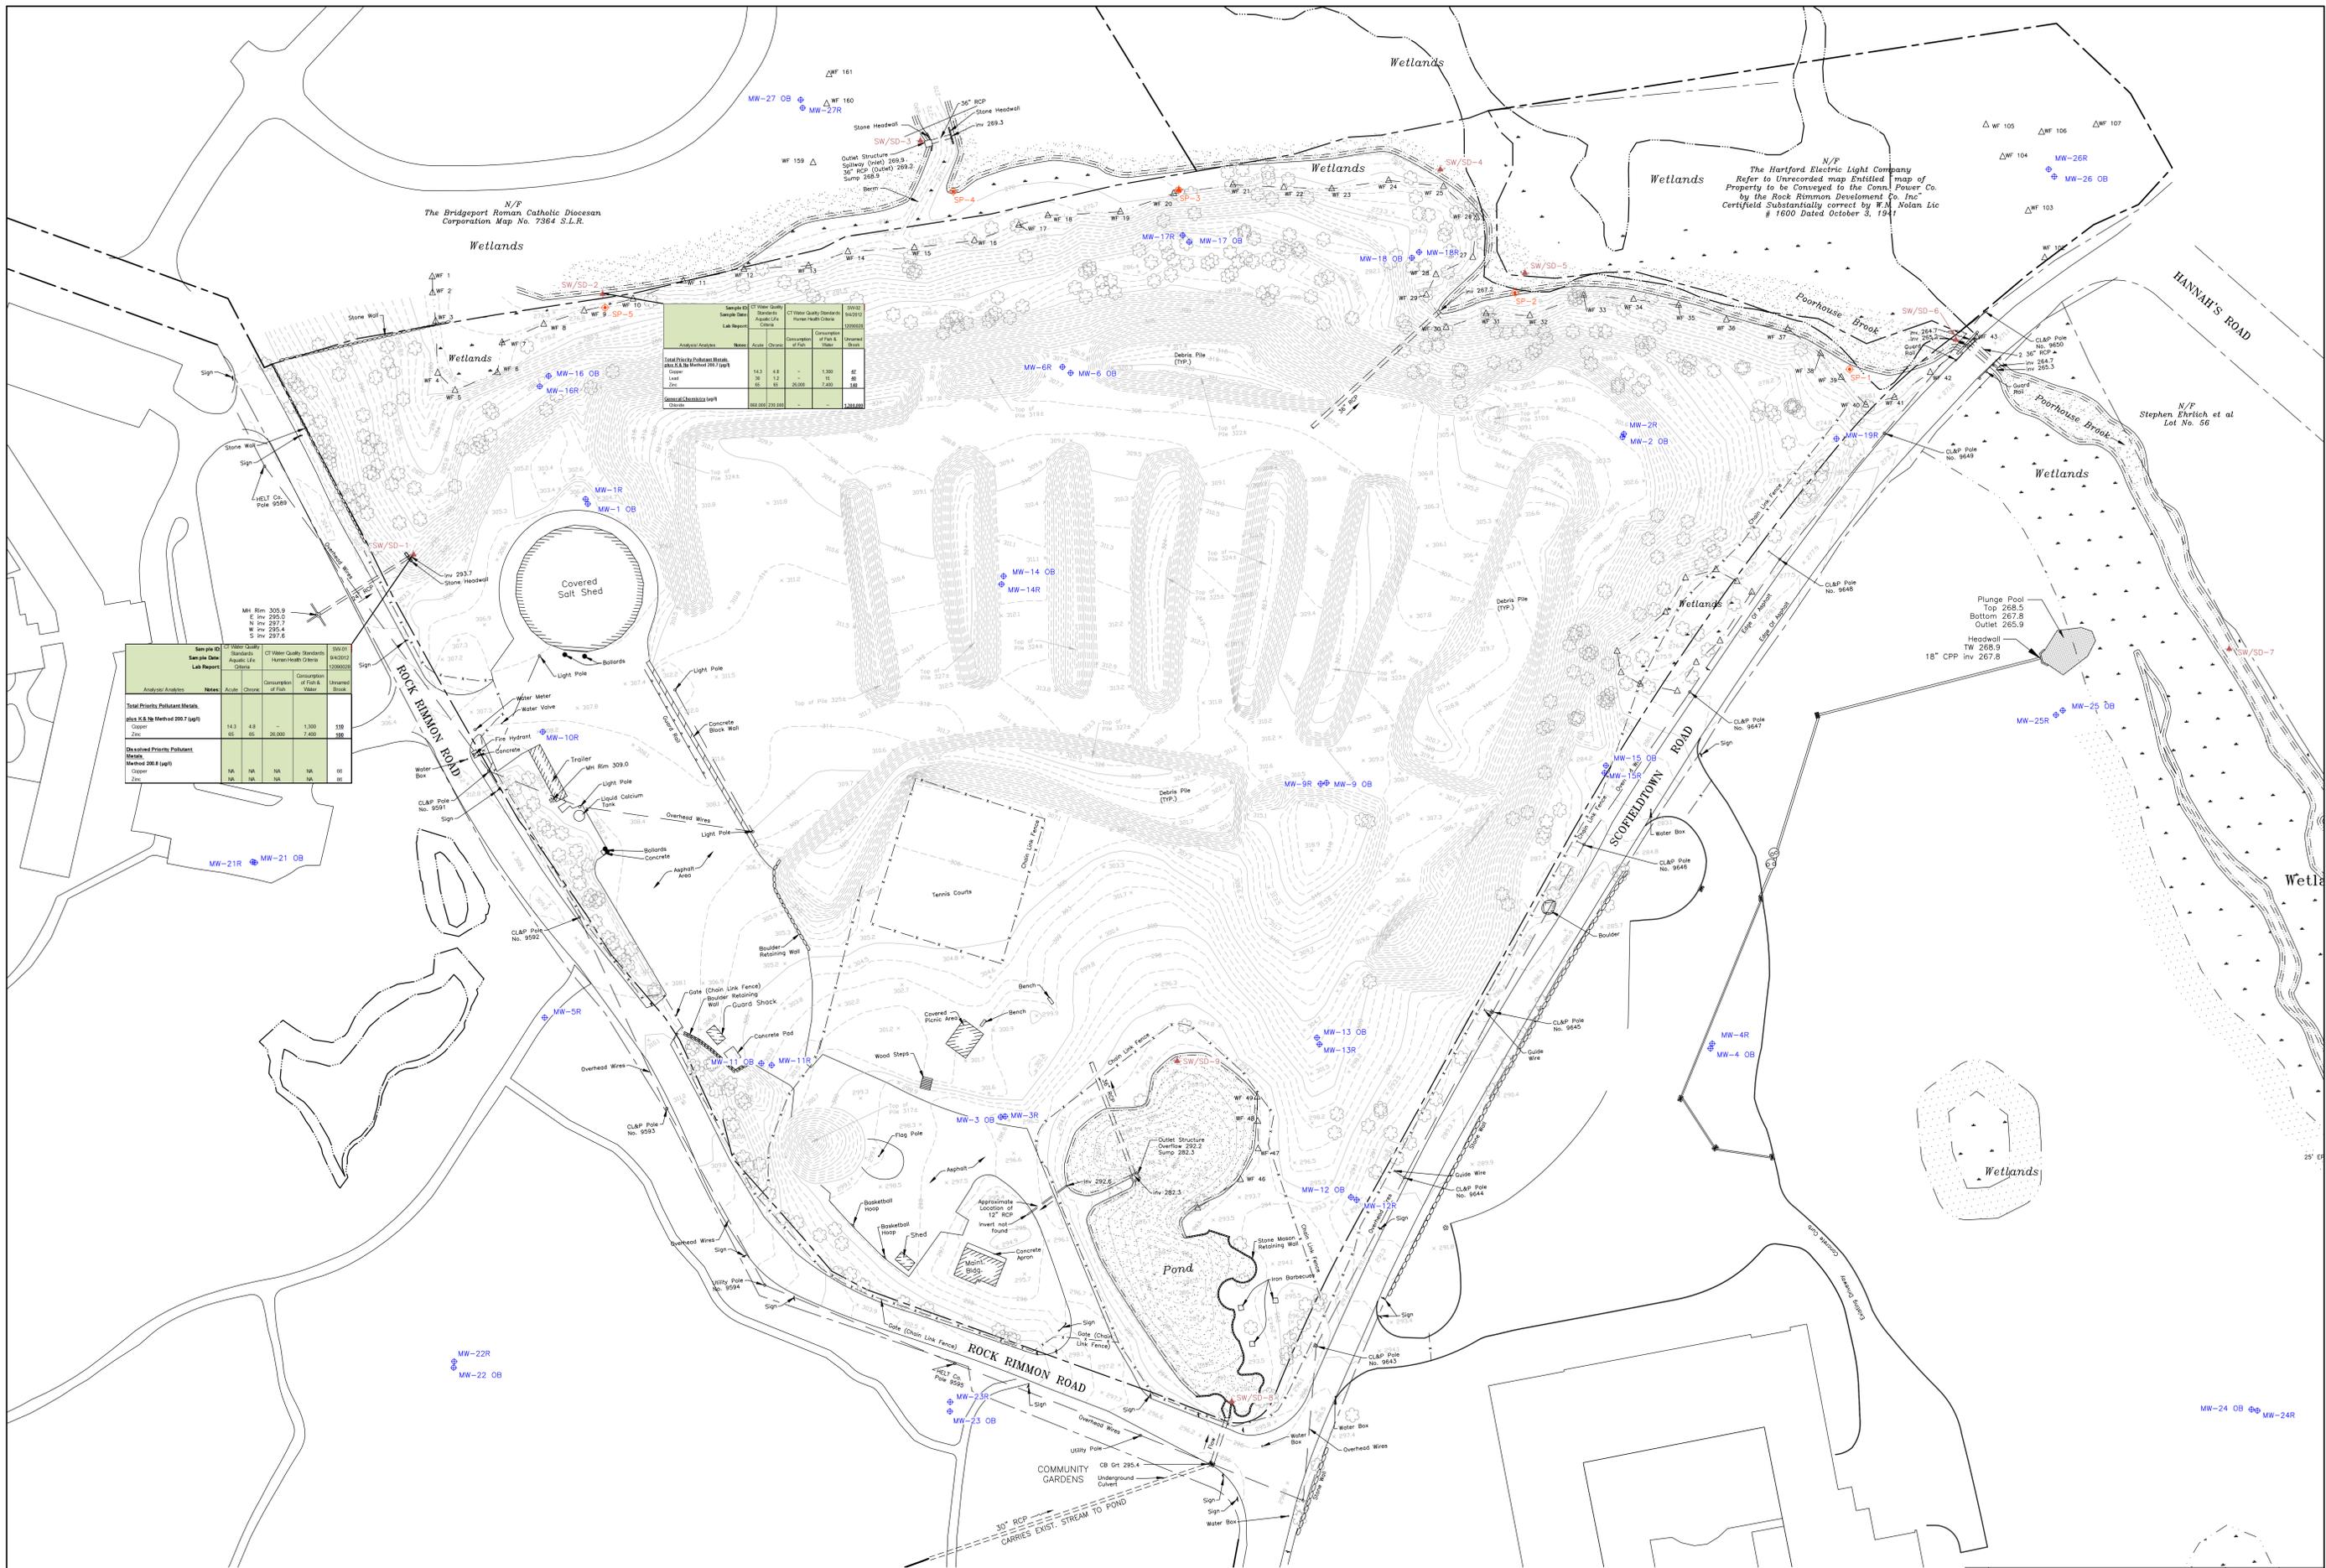
**FIGURE 16**

Sample ID	Sample Date	CT Water Quality Standards Aquatic Life Criteria	CT Water Quality Standards Human Health Criteria	SWQI
Total Priority Pollutant Metals (plus H.C. by Method 200.7 (up))		14.3	4.8	1.300
Copper		65	65	7.400
Zinc		NA	NA	NA
Lead		NA	NA	NA
Chromium		NA	NA	NA
Mercury		NA	NA	NA
Other		NA	NA	NA

**SECOND QUARTER:  
SURFACE WATER  
SAMPLE EXCEEDANCES**

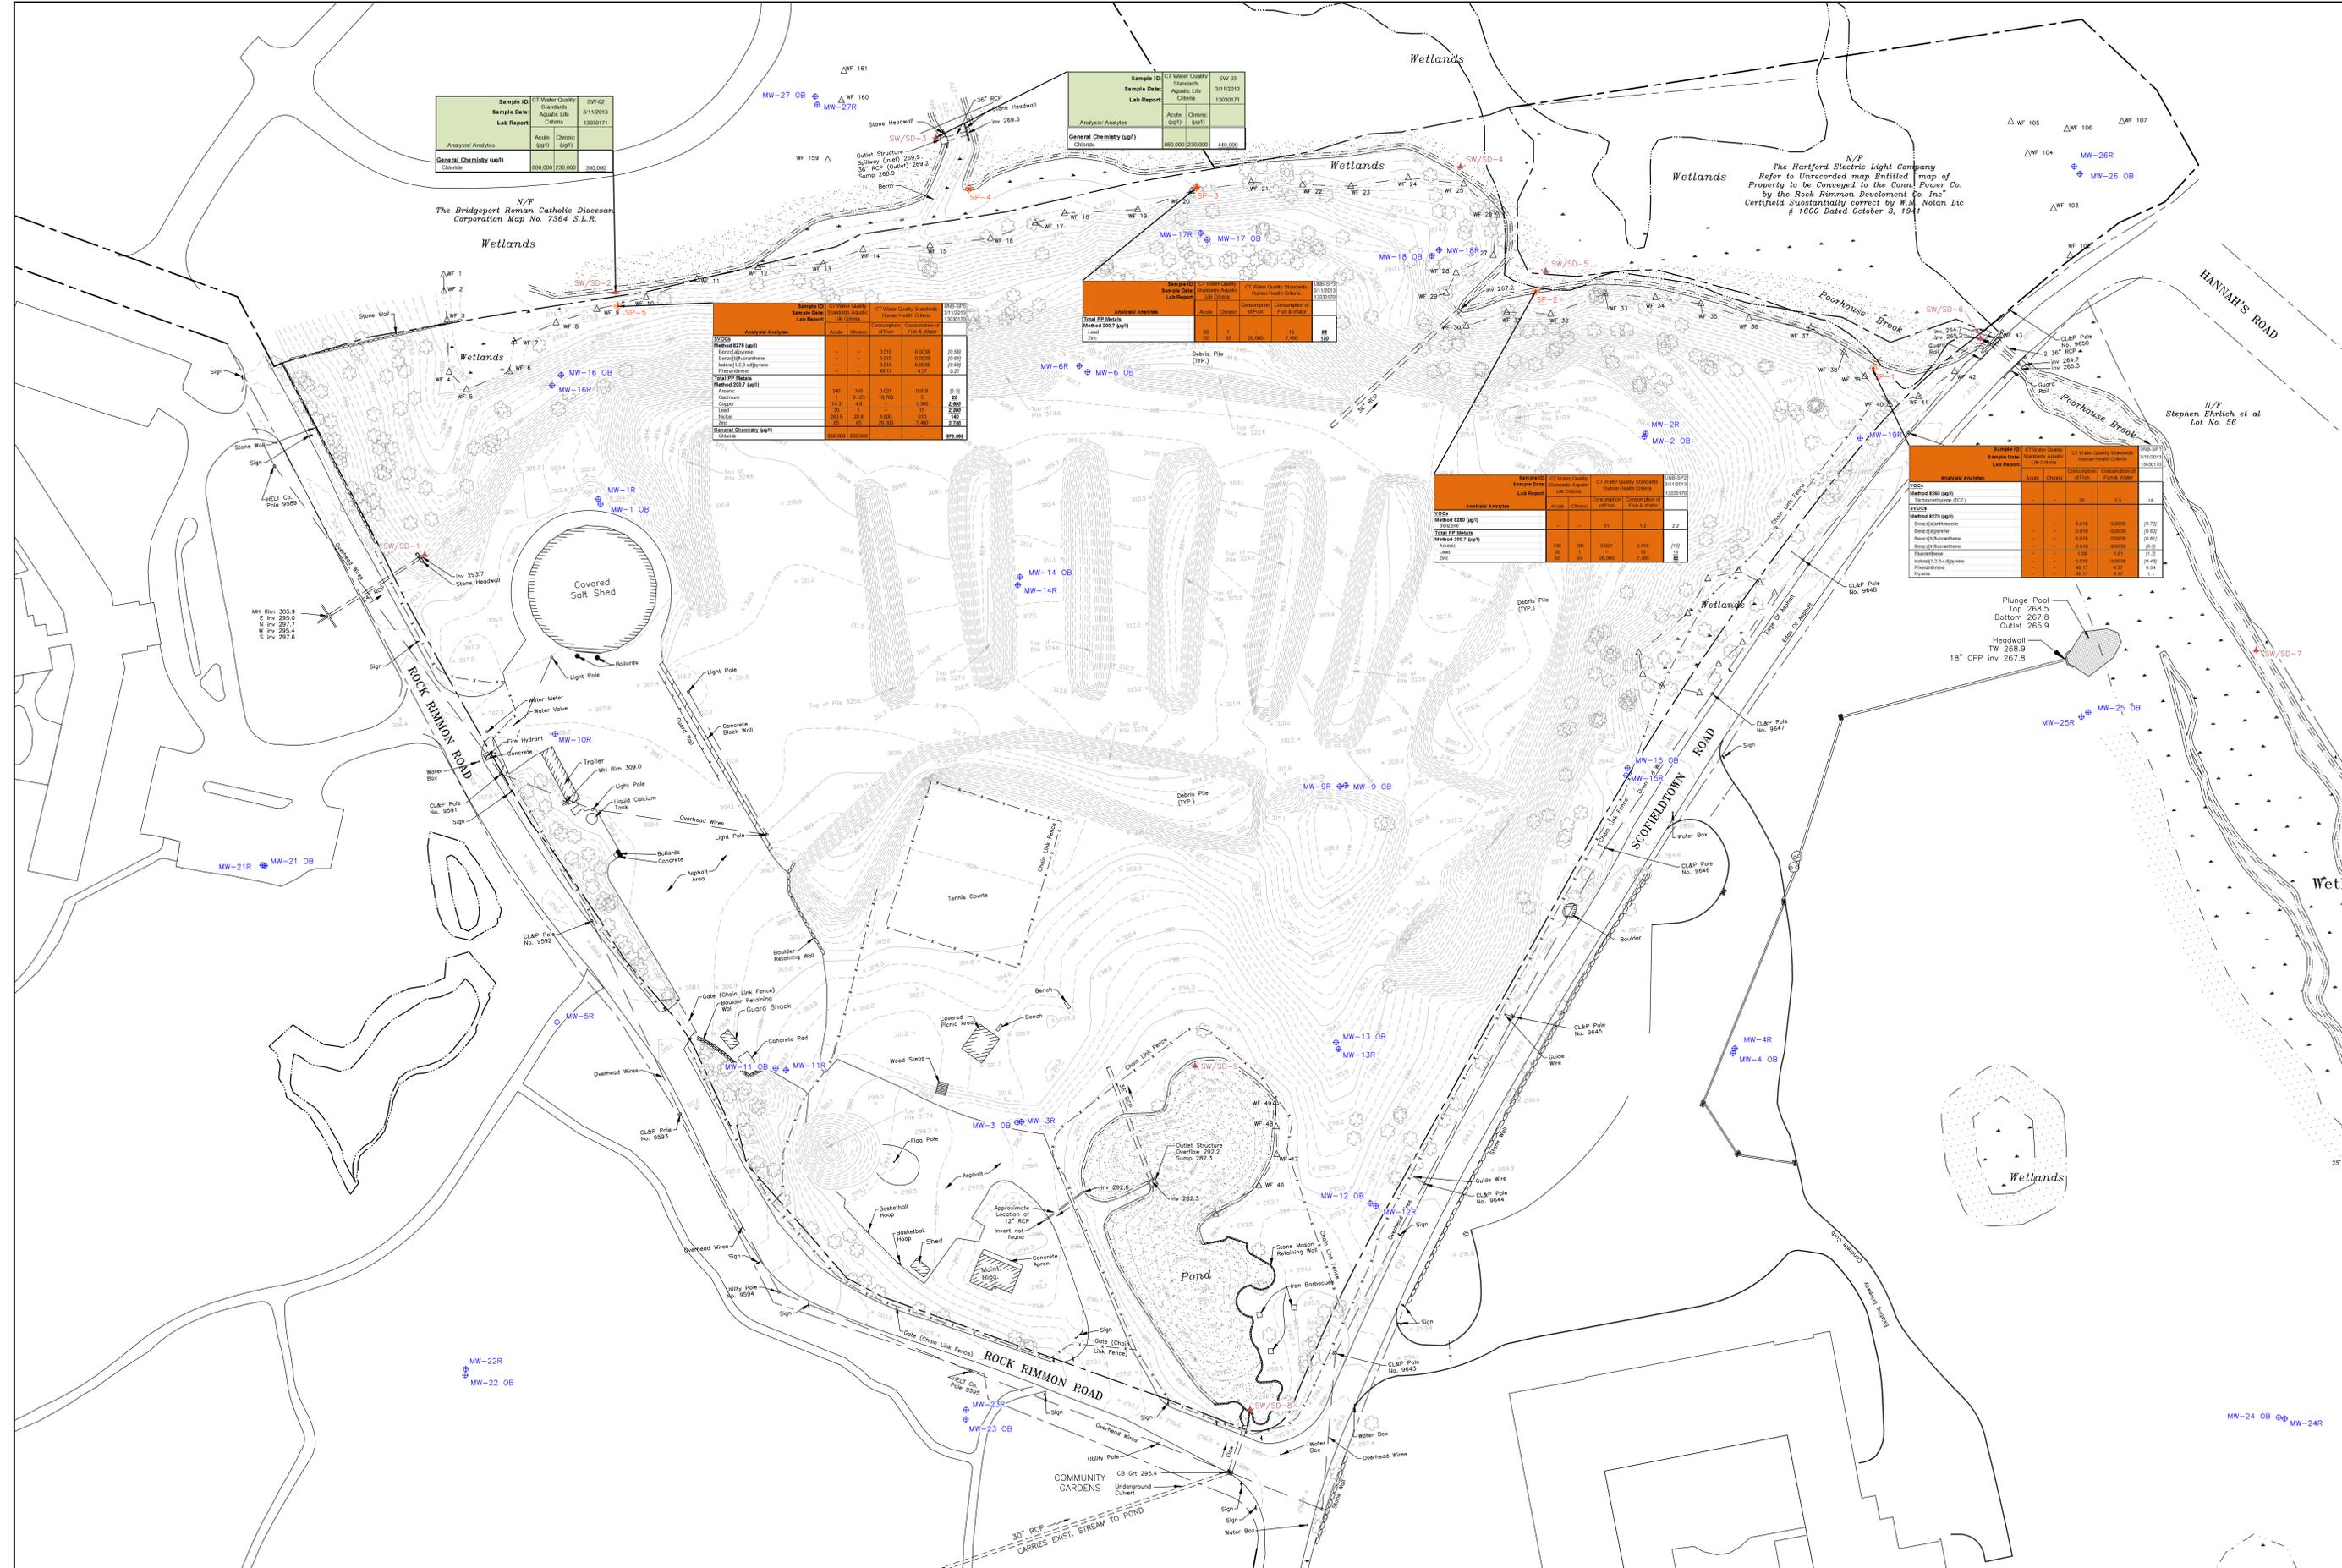
Sample ID	Water Quality Standards	SW-03
Sample Date	Acetic	3/11/2013
Lab Report	Chlorine (ppm)	1300071
Analyst/Analyses	Acetic Chlorine (ppm)	
General Chemistry (ppm)	Chlorine	880,000 230,000 440,000

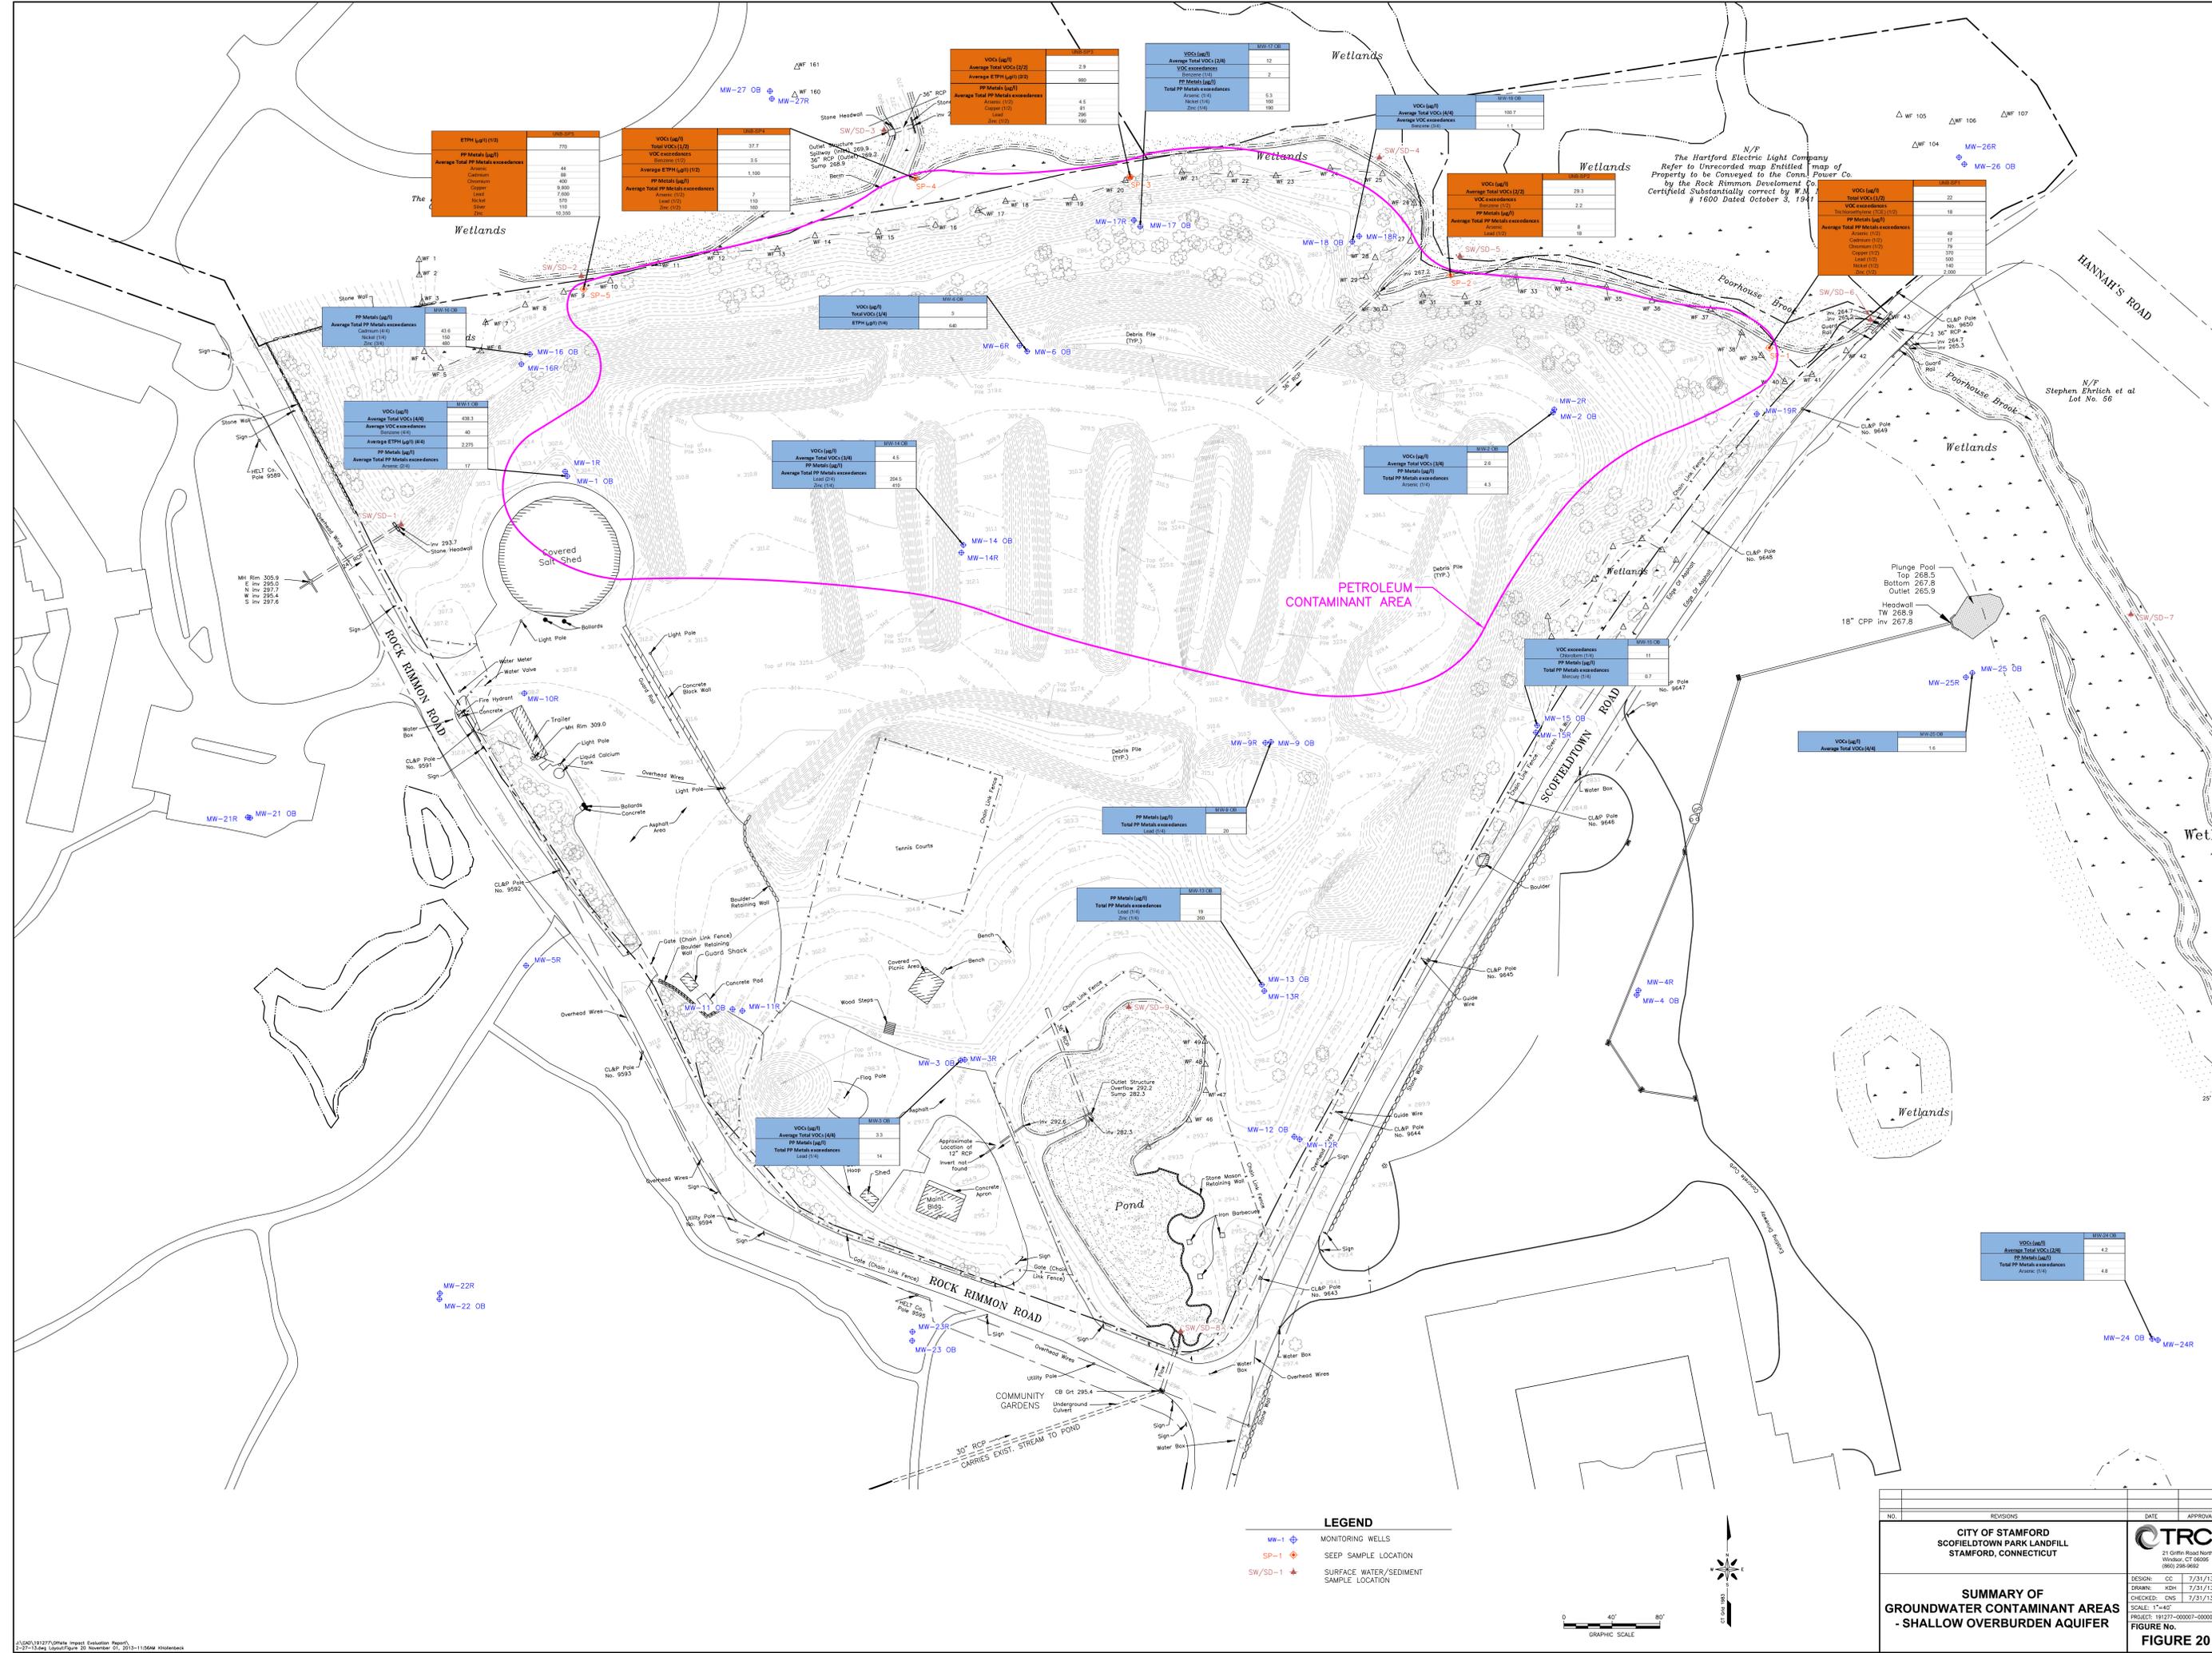
ETPH (µg/l) (12)	
PP Metals (µg/l)	770
Average Total PP Metals exceedances	44
Asbestos	400
Chromium (VI)	88
Copper	9,800
Lead	7,600
Nickel	370
Silver	110
Zinc	10,300

VOCs (µg/l)	
Average Total VOCs (12)	431.3
VOCs Exceedances	40
Average ETPH (µg/l) (12)	2,275
PP Metals (µg/l)	17
Average Total PP Metals exceedances	17
Asbestos (12)	100
Lead (12)	100
Silver (12)	100

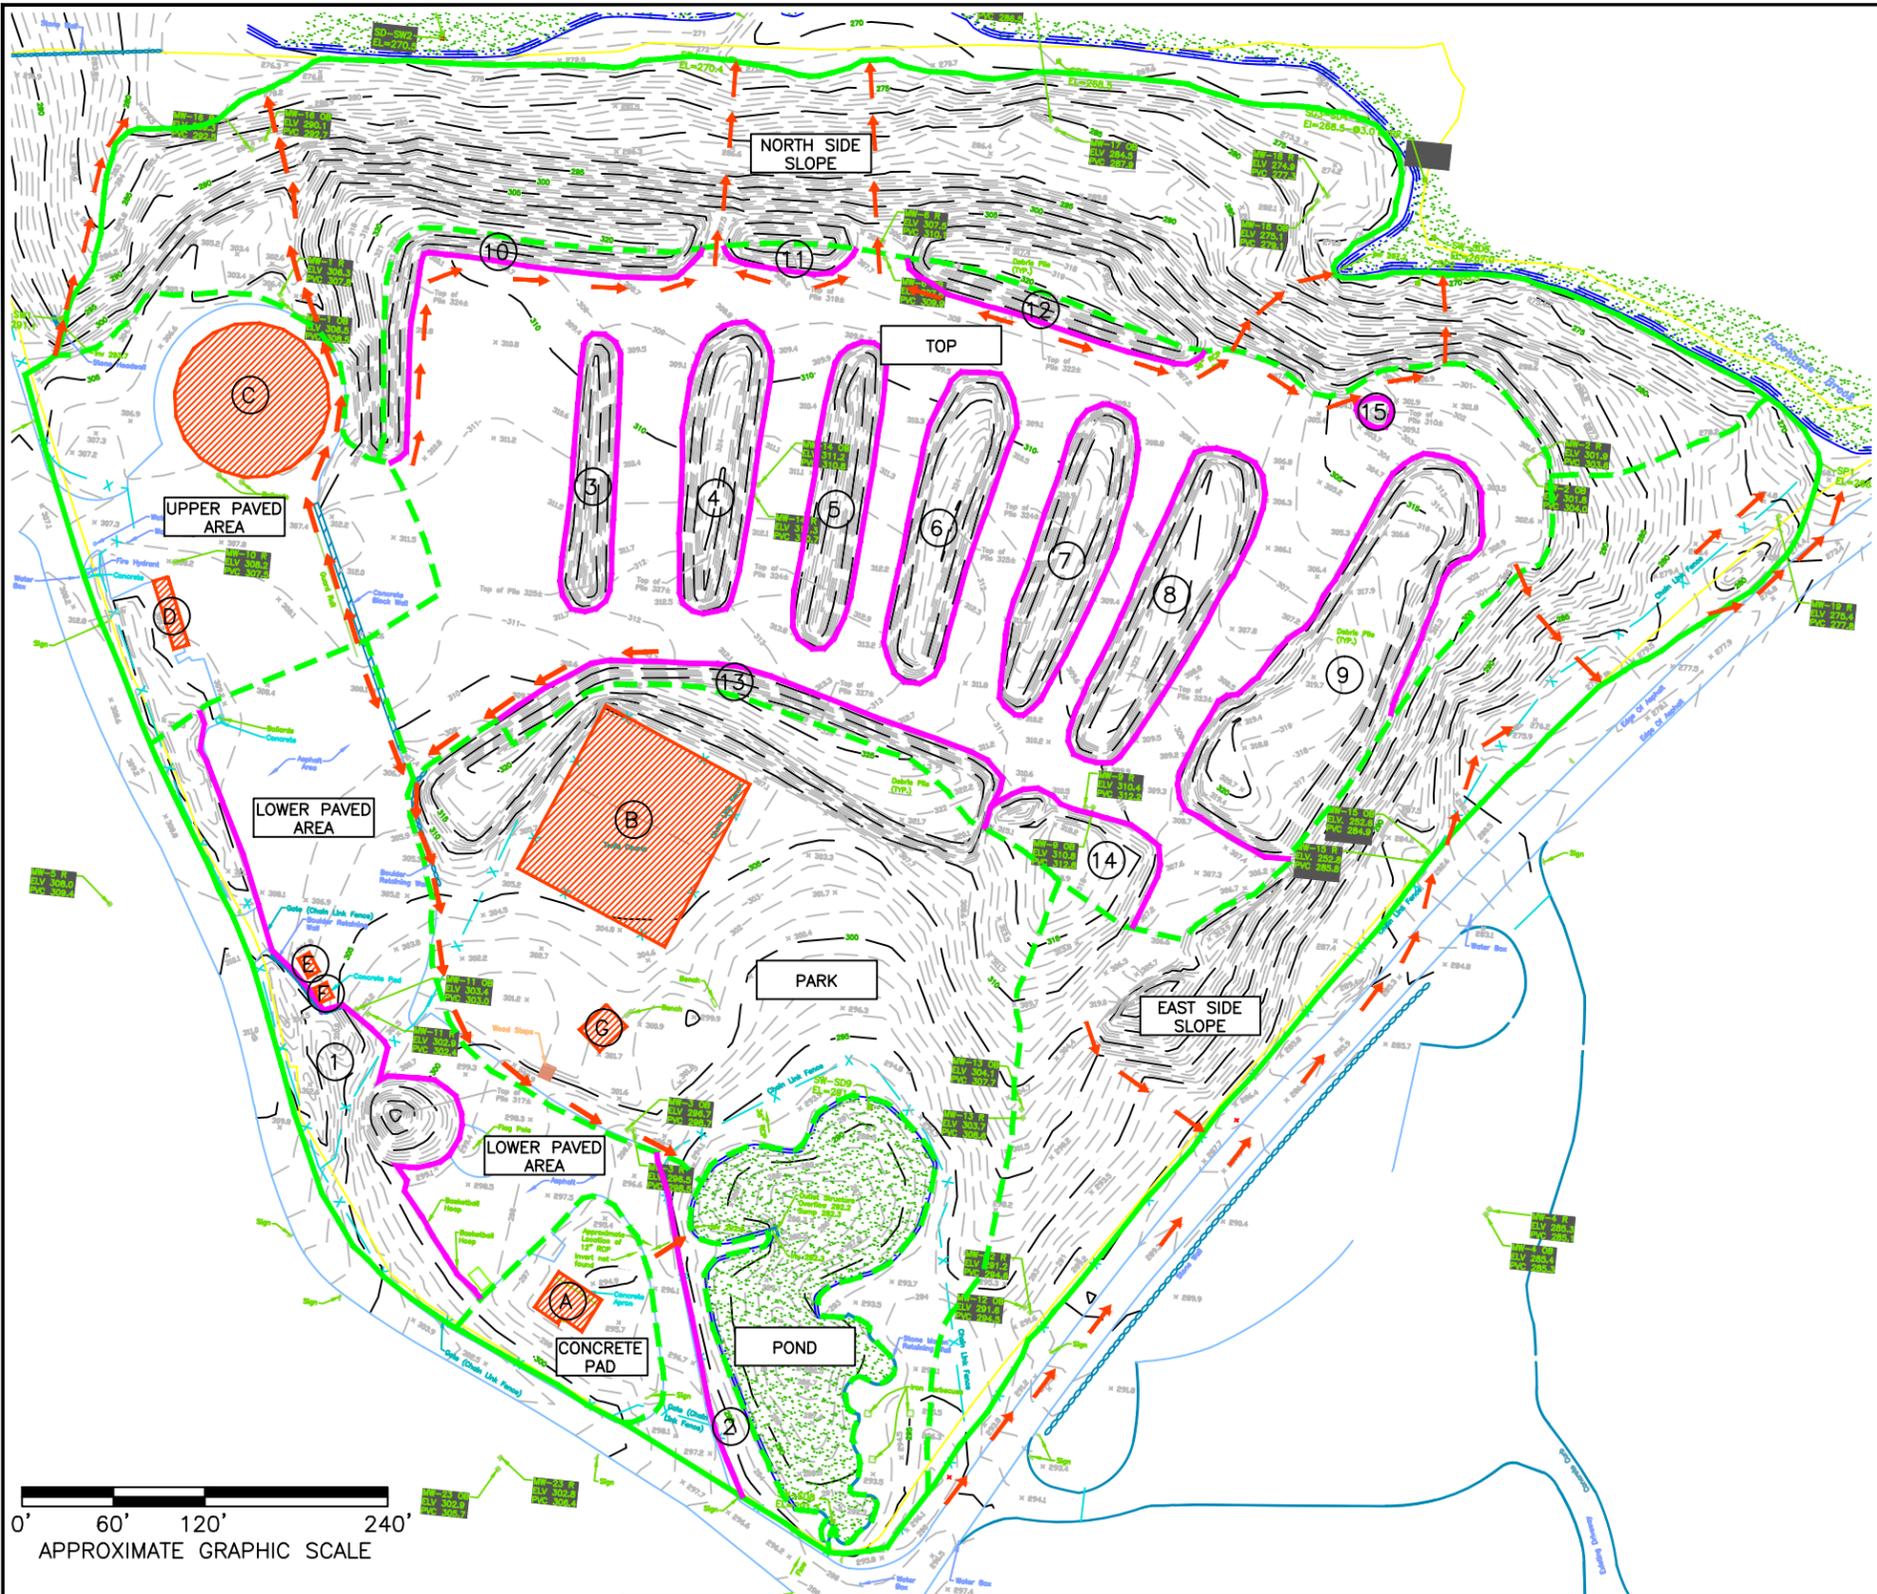
FIGURE 21

AREA NAME	SQUARE FEET
LANDFILL FOOTPRINT	719,306 SQ.FT.
UPPER PAVED	49,992 SQ.FT.
LOWER PAVED	70,140 SQ.FT.
CONCRETE PAD	11,726 SQ.FT.
POND	25,808 SQ.FT.
EAST SIDE SLOPE	80,833 SQ.FT.
PARK	112,950 SQ.FT.
TOP	231,042 SQ.FT.
NORTH SIDE SLOPE	136,815 SQ.FT.
1	18,989 SQ.FT.
2	5,148 SQ.FT.
3	5,082 SQ.FT.
4	8,411 SQ.FT.
5	7,075 SQ.FT.
6	9,228 SQ.FT.
7	9,036 SQ.FT.
8	11,019 SQ.FT.
9	22,231 SQ.FT.
10	5,570 SQ.FT.
11	1,272 SQ.FT.
12	3,361 SQ.FT.
13	6,909 SQ.FT.
14	5,409 SQ.FT.
15	353 SQ.FT.
A	902 SQ.FT.
B	13,077 SQ.FT.
C	7,984 SQ.FT.
D	469 SQ.FT.
E	114 SQ.FT.
F	94 SQ.FT.
G	469 SQ.FT.

EXISTING CONDITIONS  
HELP MODEL AREA PLAN  
SCOFIELDTOWN LANDFILL

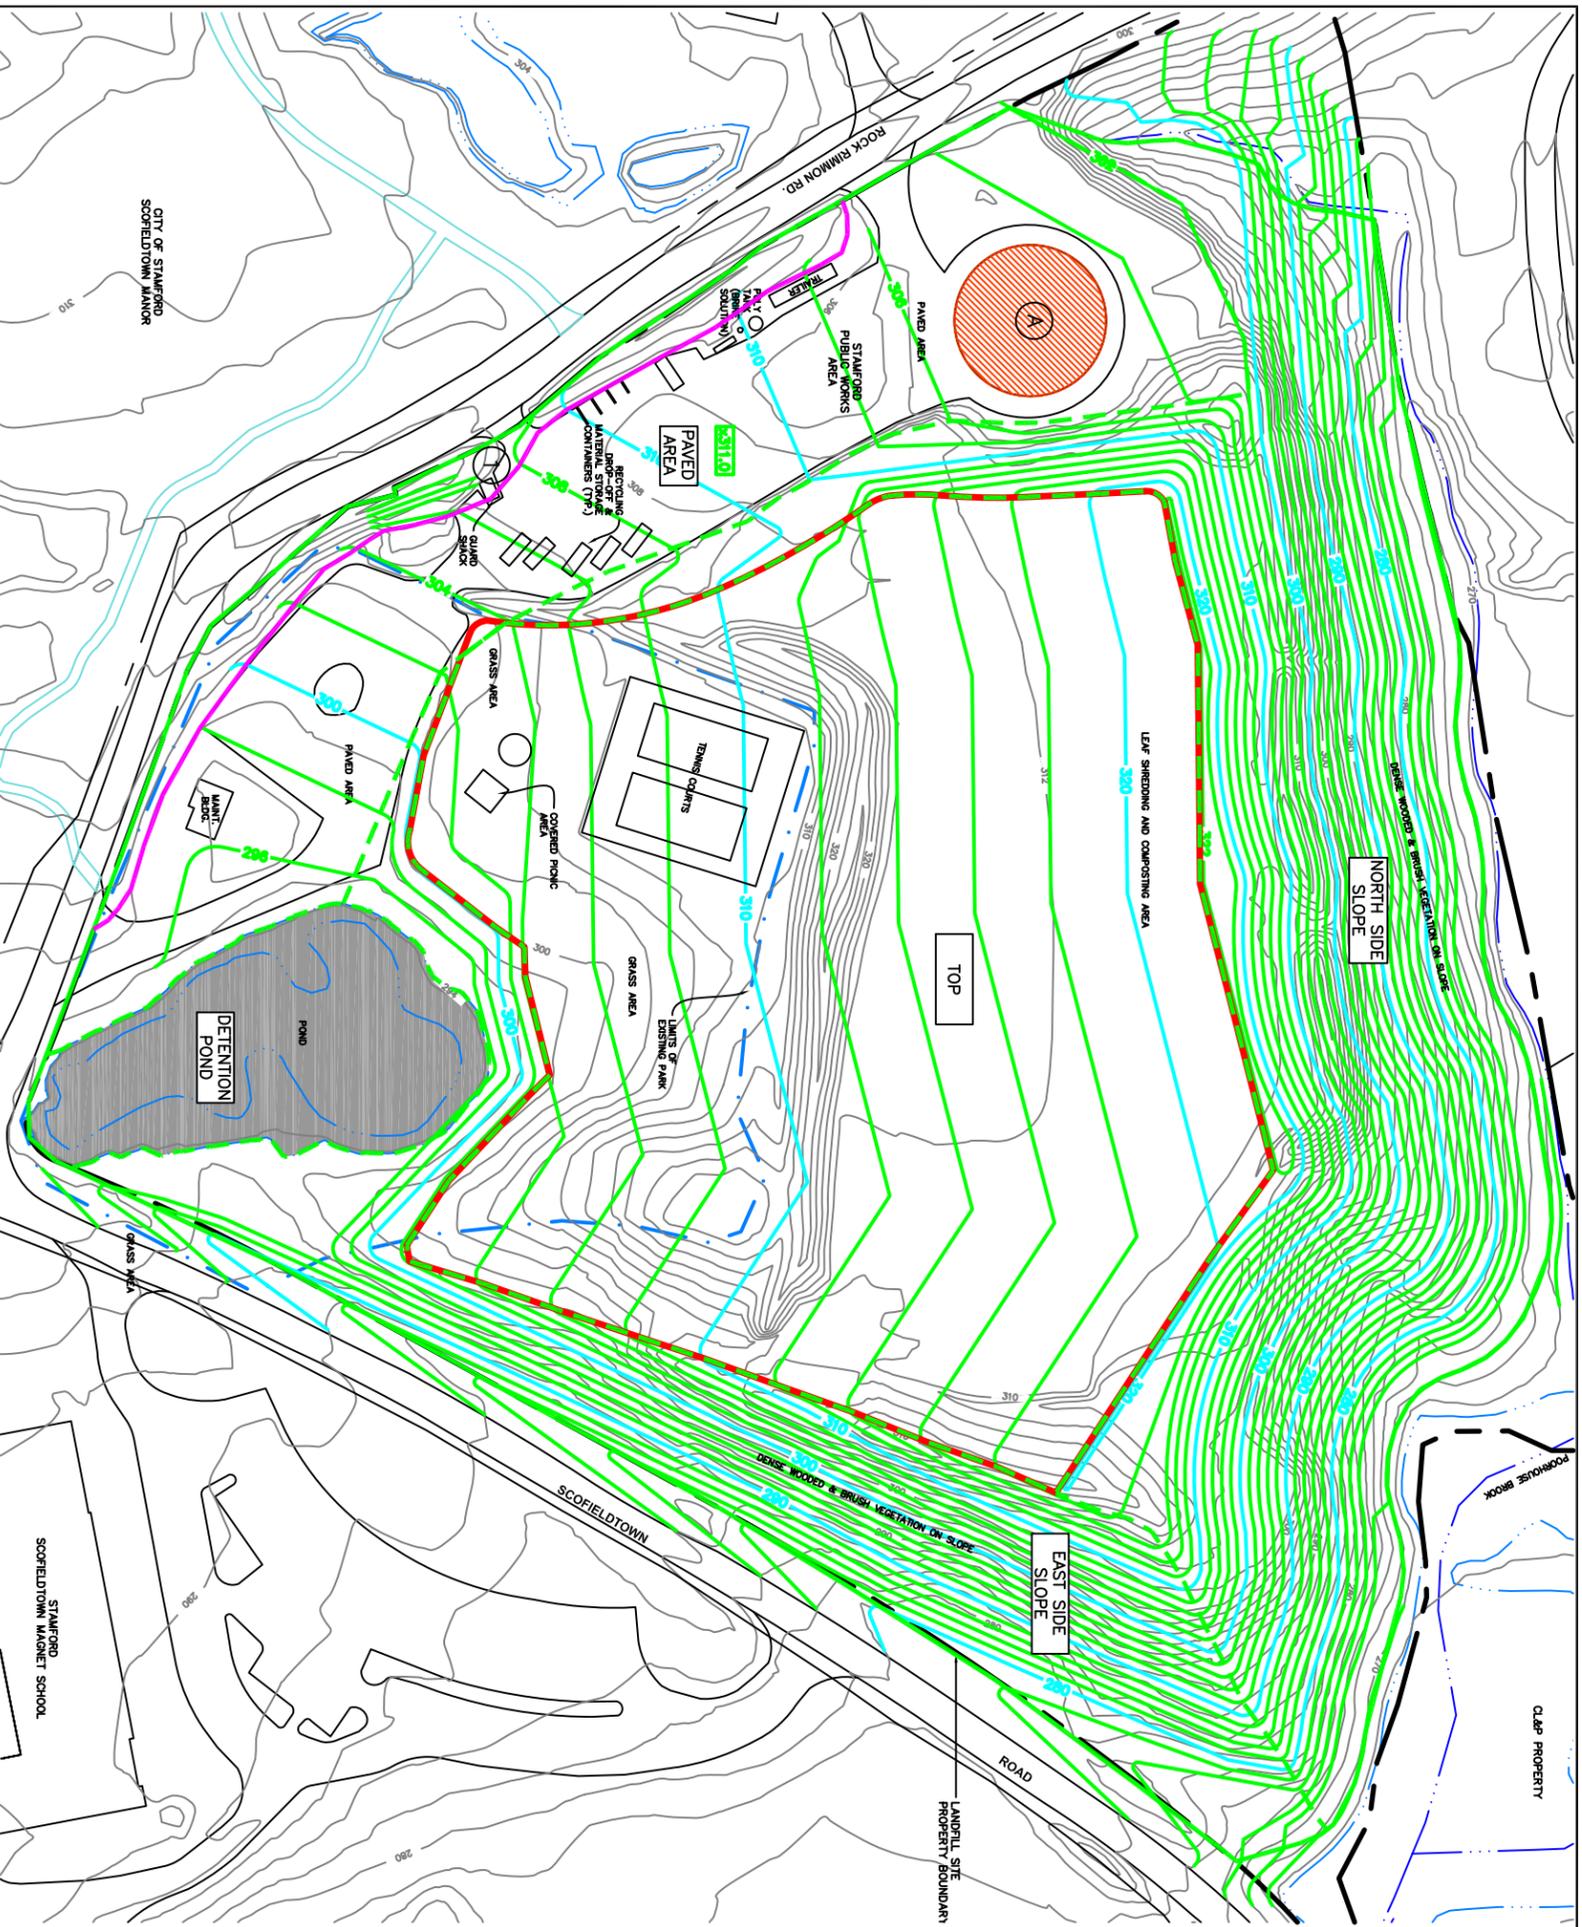
FIGURE 22

AREA NAME	SQUARE FEET
LIMIT OF GEOMEMBRANE	709,145 SQ.FT.
PAVED AREA	127,352 SQ.FT.
DETENTION POND	34,595 SQ.FT.
EAST SIDE SLOPE	90,353 SQ.FT.
TOP	266,980 SQ.FT.
NORTH SIDE SLOPE	189,865 SQ.FT.
1	15,518 SQ.FT.
A	7,740 SQ.FT.

CAPPED LANDFILL  
 HELP MODEL AREA PLAN  
 SCOTFIELDTOWN LANDFILL
